SERVICE INFORMATION FROM HEWLETT-PACKARD

2nd Quarter 1989

Fiber-Optic Troubleshooting

Brett Frymire Hewlett-Packard

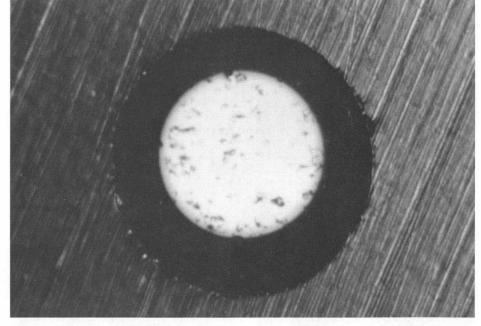
Figure 9. Example of a damaged fiber-optic cable end with embedded metal particles.

Inspect the ends of the fiber for dark spots, chips or scratches. Figure 9 shows an example of a damaged fiber end with embedded metal particles. Magnification of at least 50x will be required because of the small fiber diameter (about 50-100 microns), which cannot be easily viewed with the naked eye. (Plastic fiber is the exception as it is about 1 mm in diameter.) Remember. Do not use the transmitter as the light source for inspecting the fiber (see accompanying article on fiber-optic safety). If small scratches exist, it is possible to remove them with polishing. Be careful not to excessively polish the connector as this increases the distance separating the cable from the

lens or IC, which increases the optical power losses at the connection. Use the correct polishing equipment for the connector installed on the cable. Any attempt to polish the cable without the fixture, which maintains the cable and connector perpendicular to the polishing paper, will increase the loss. Make sure that the cable is clean as polishing is a last resort before installing a new connector. If

either of the ends are damaged beyond cleaning or polishing, cut off the damaged end and install a new connector.

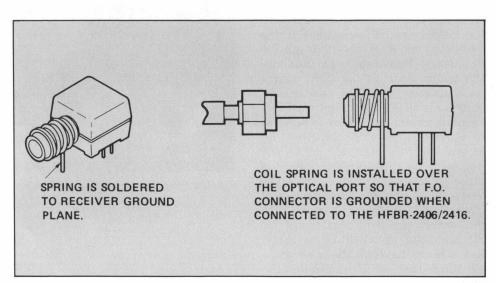
Figure 13. Metal spring used to ground cable's metal ferrule to the receiver ground plane.

a bad receiver, open by-pass capacitor, overdrive, long-tail effects, or any part of the power supply filter. In fact, the problem could be noiserelated where the metal ferrule of the fiber-optic connector acts as an EMI source by inducing electrical noise into the receiver. If the environment in which the fiber-optic link is used is extremely noisy and a metal ferrule is used, it is recommended that a metal spring contact be used to ground the cable's metal connector to the receiver ground plane (see Figure 13). If this spring is missing or has a poor connection, oscillations can occur that may not be readily visible on an oscilloscope. The symptoms may include ringing, overshoot, or decreased sensitivity. Install a spring if it is missing, or clean the surface between the connector, metal ferrule, and spring, or resolder the spring to the printed circuit ground plane. Another method that reduces the effects of EMI pickup by the fiberoptic connector is to use a connector with a non-conductive plastic or ceramic ferrule. Note that some receivers incorporate a shield into the case or housing of the component, so it is important on these receivers that the case is grounded. The example of jitter shown in Figure 12 was caused by underdrive, which could result from either a contaminated fiber cable or a weak LED.
