The Yorkville In-House Method for Repairing AP Series Amps

M1146 AP-4040

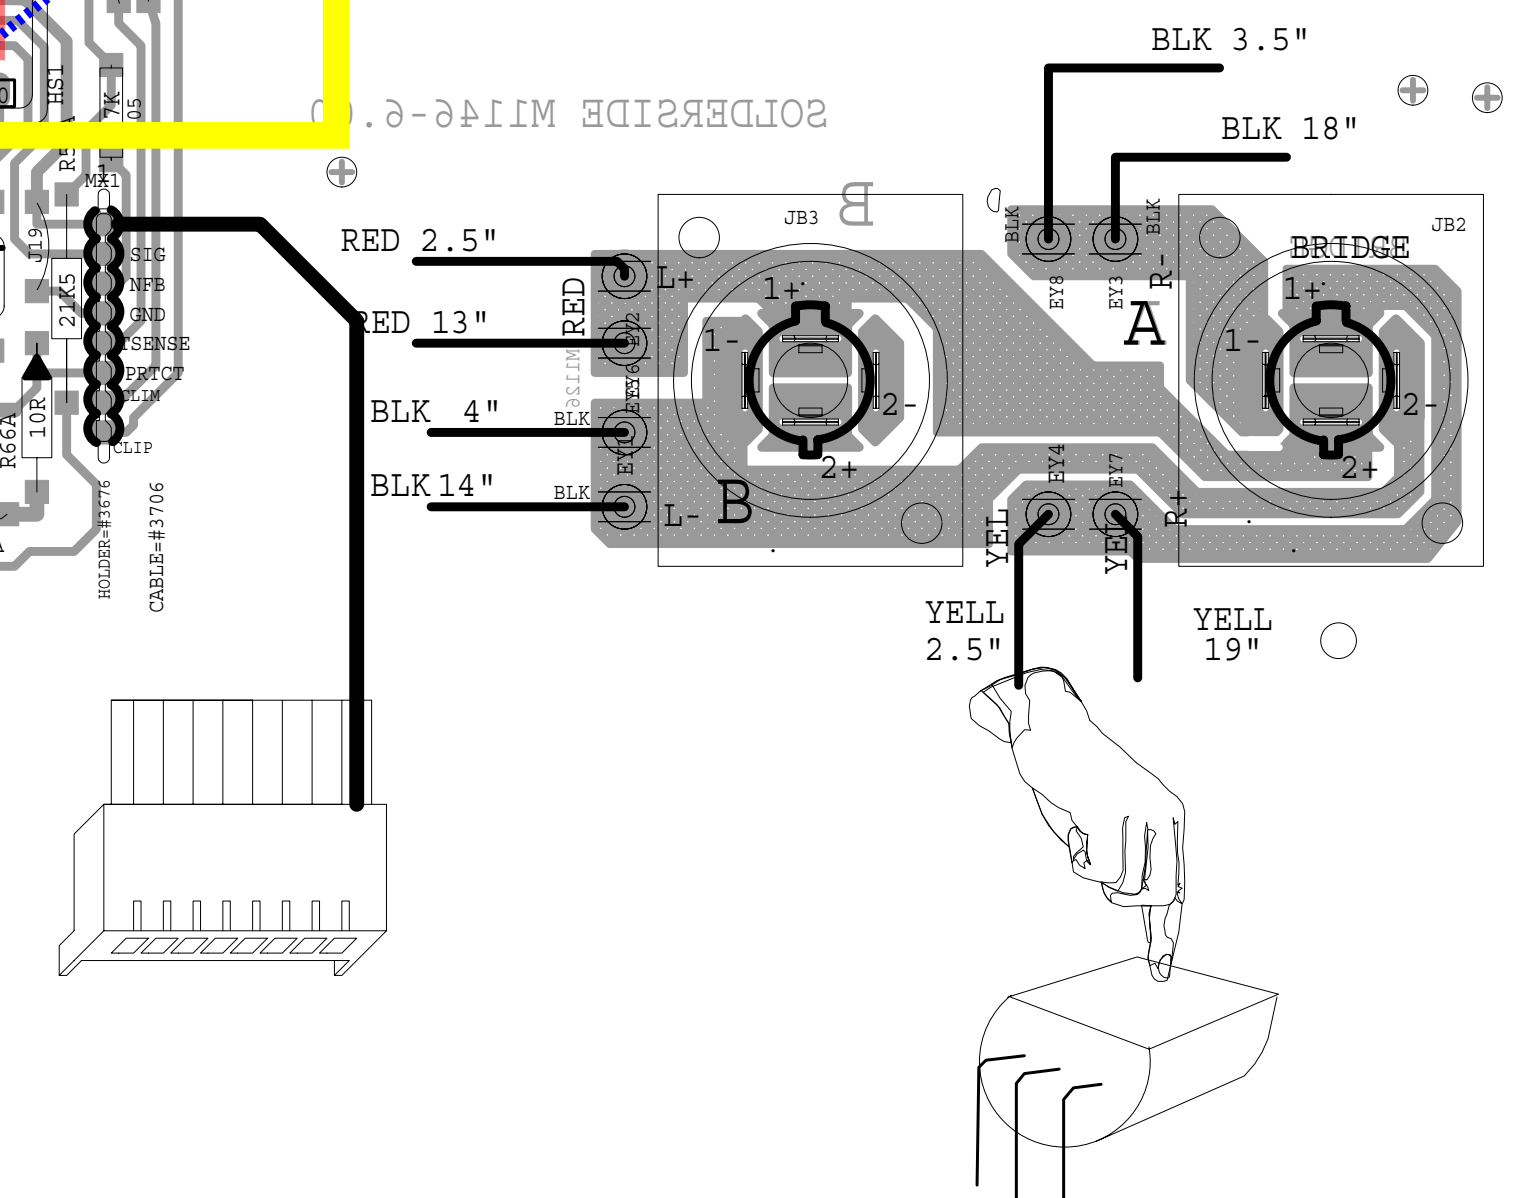
In order to separate the voltage amp from the current amp. It is only necessary to remove jumpers J11 and J12 (highlighted in red) and then make the two new connections as shown by the BLUE dotted lines.

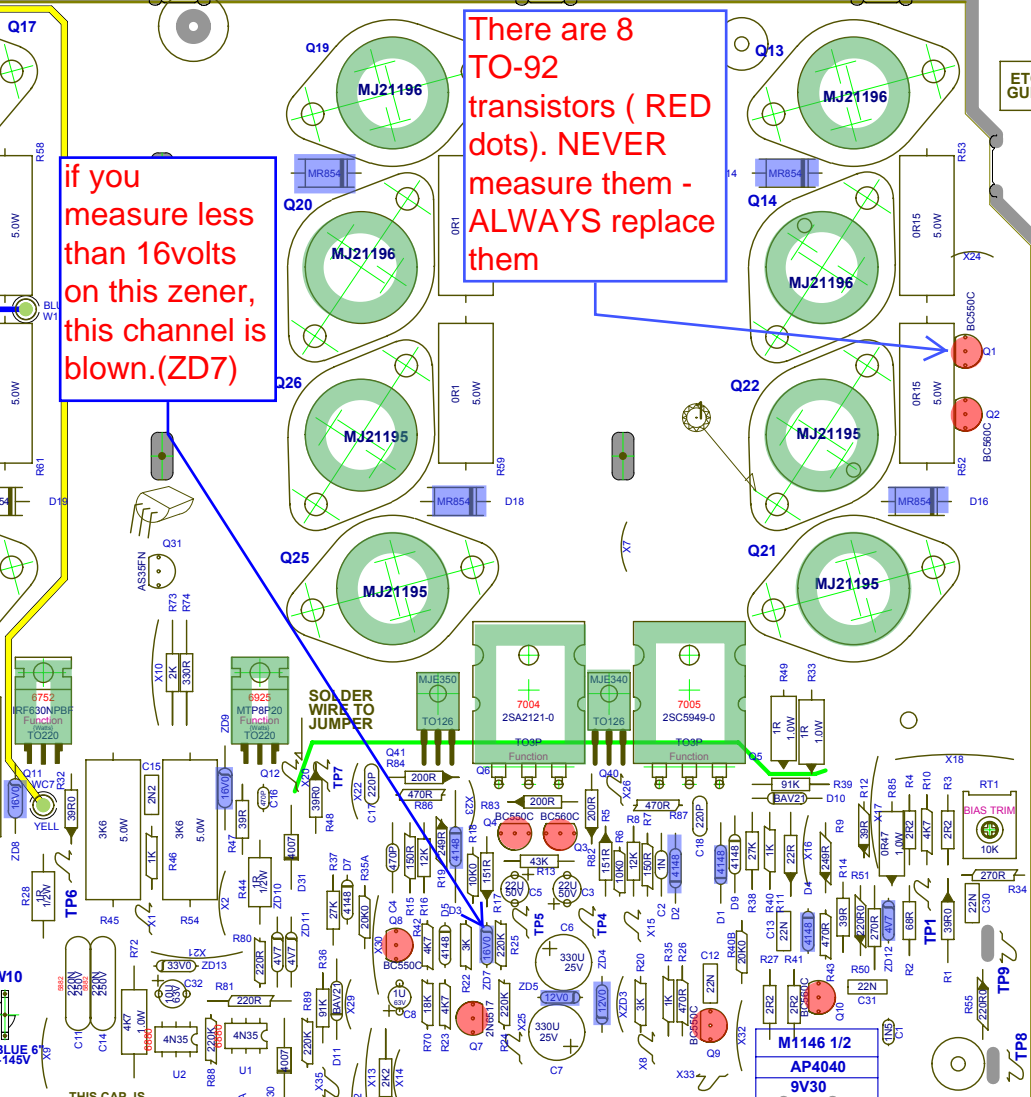
if you measure less than 16volts on this zener, this channel is blown.(ZD7)

There are 8 TO-92 transistors (RED dots). NEVER measure them - ALWAYS replace them

Red NEVER MEASURE THESE, Always replace these 8 transistors

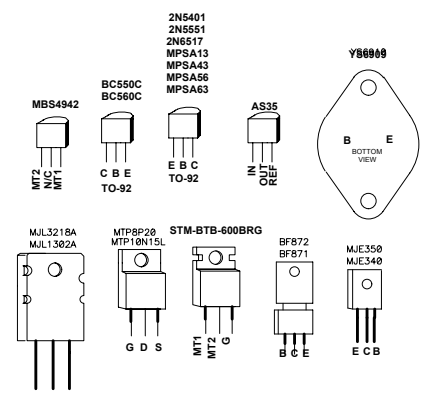
these are the transistors (8pcs in red) which we always replace
