# KENWOOD TR-751

## EXPANDED RF M/C

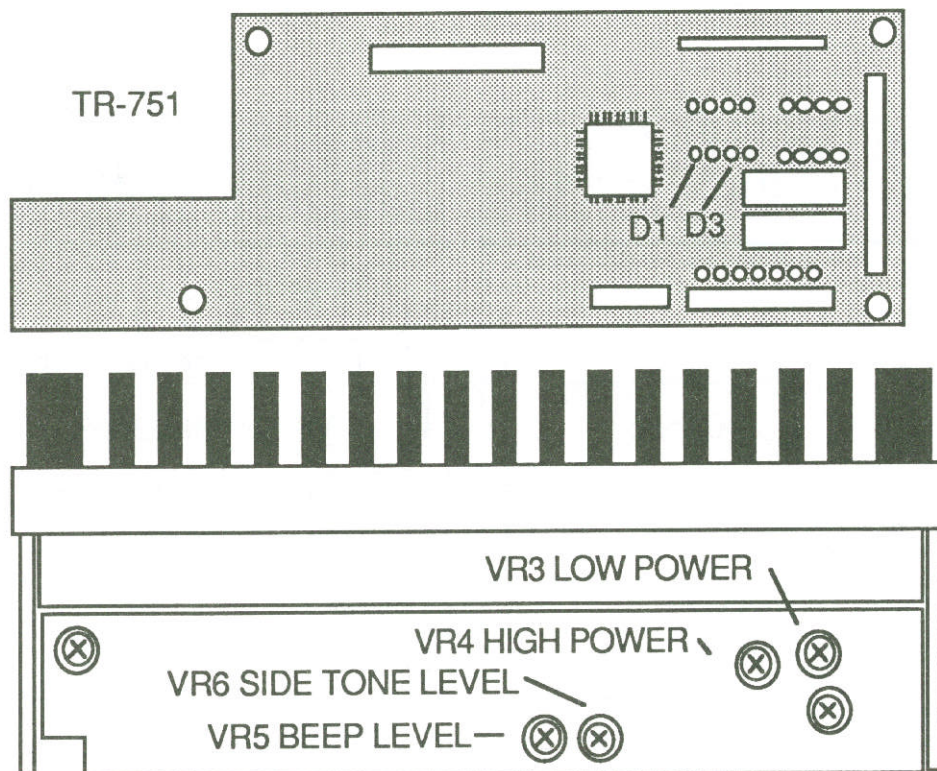
1. Disconnect the power and antenna.
2. Remove the case .
3. Locate the Control Unit on the radio.
4. CUT diodes D1 & D3. They are located to the left of IC3.
5. Reassemble the radio.
6. RESET the CPU. (Hold [M] key and turn on power)

DEVIATION - VR7 ON RX UNIT (OTHER SIDE)
