EB5AGV's JRC JST-245 page

Welcome to my *JRC JST-245* HF/6m Transceiver page!

JRC JST-245 HF/6m Transceiver

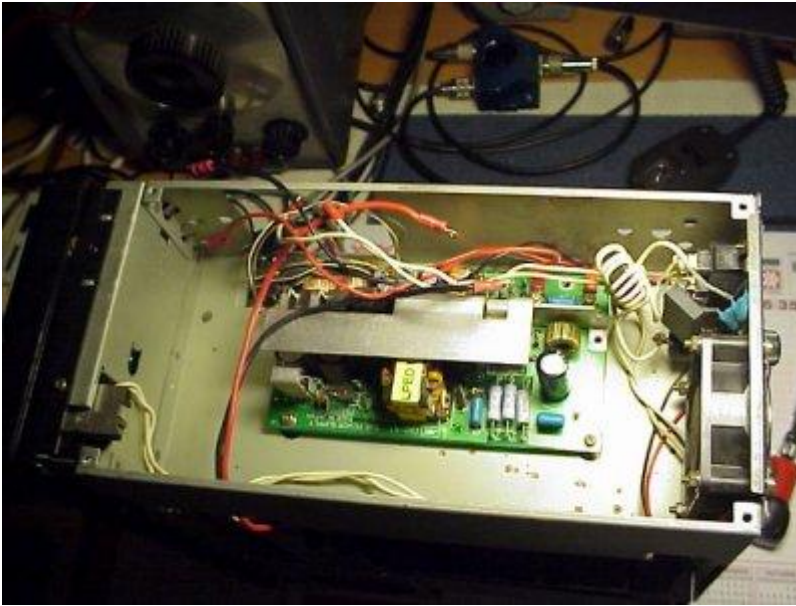
Auxiliary Power Supply (and missing Main PS!)

- **SERIOUS PROBLEMS**
 - Unworking (and badly butchered, including some missing components) Main Power Supply
 - Faulty auto tuner (checked in the working JST-145)
 - Faulty PA (hard short on power supply line; about 0.2 Ohm!)
 - Deaf receiver

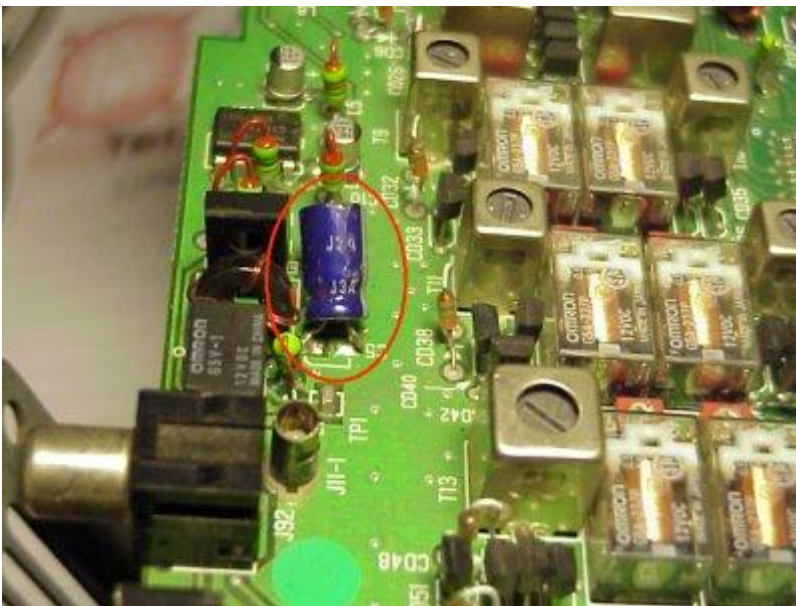
Previous work sample

As I had already played with the JST-145 and I knew its wonderful low-hiss receiver was exactly the same in the JST-245 (except for the 50MHz band, only present in the 245), I felt it was a pity to trash that unit. I looked in detail and there were clear signs of some job done to it. And it was not a very good one!

Looking at the RX/TX PCB, it was evident somebody had been there before, also on the other (solder) side, which was plenty of SMD parts. Just by optical exploration, I found that several components had been replaced with sometimes better and sometimes worse workmanship: some were barely visible and other were loopy jobs. All in all, a lot of work had been put on it by somebody but, obviously, had not completely fixed the rig... so I had a real challenge ahead!

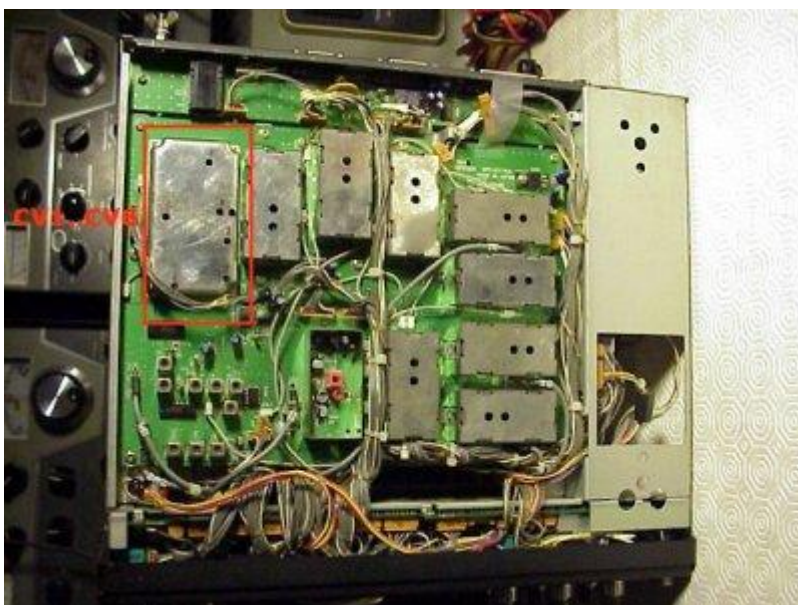
All in all, I was happy. So happy that I decided to check BBC at 9410kHz... I got no signal in AM nor in SSB!. Bad thing, as it was being received perfectly in my Yaesu FT-890. Then I checked, with a -73dBm (50uV) signal (S9 calibration level), all the receiver range. I found that it worked fine from 100kHz to 54MHz except for 7.500 to 9.999 kHz. Checking Service Manual, only reason to this seemed to be a faulty DDS (nooooo!) or some VCO trouble. Praying for the later to be truth I found that VCO check voltages were out of range (also, an unlock LED lighted when receiver was in the faulty frequency range). Just tweaking CV1 to CV6 trimmers in the Synthesizer Unit while monitoring voltages at test points got back a general coverage receiver :-)!

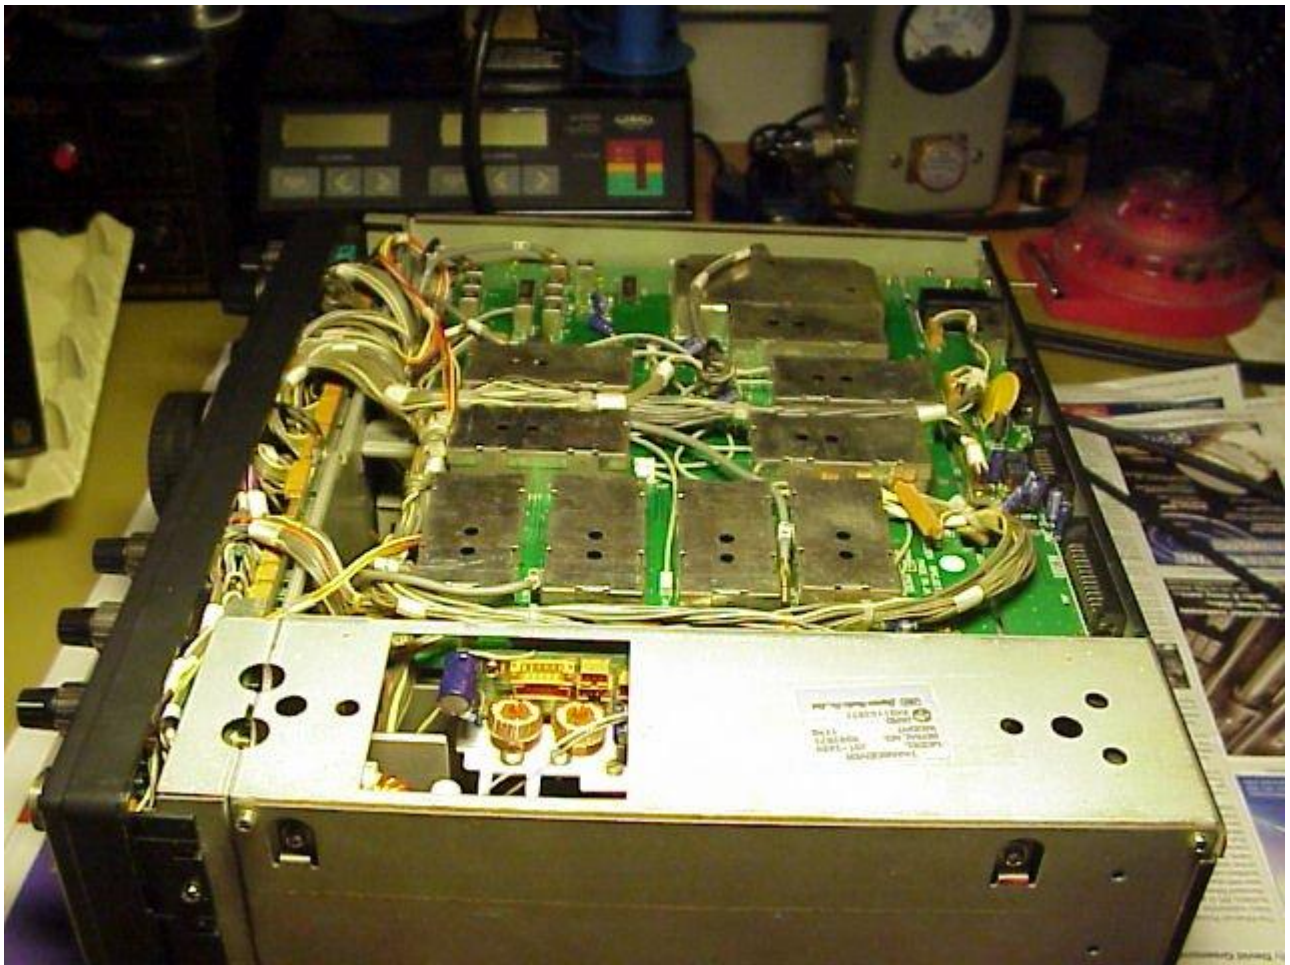
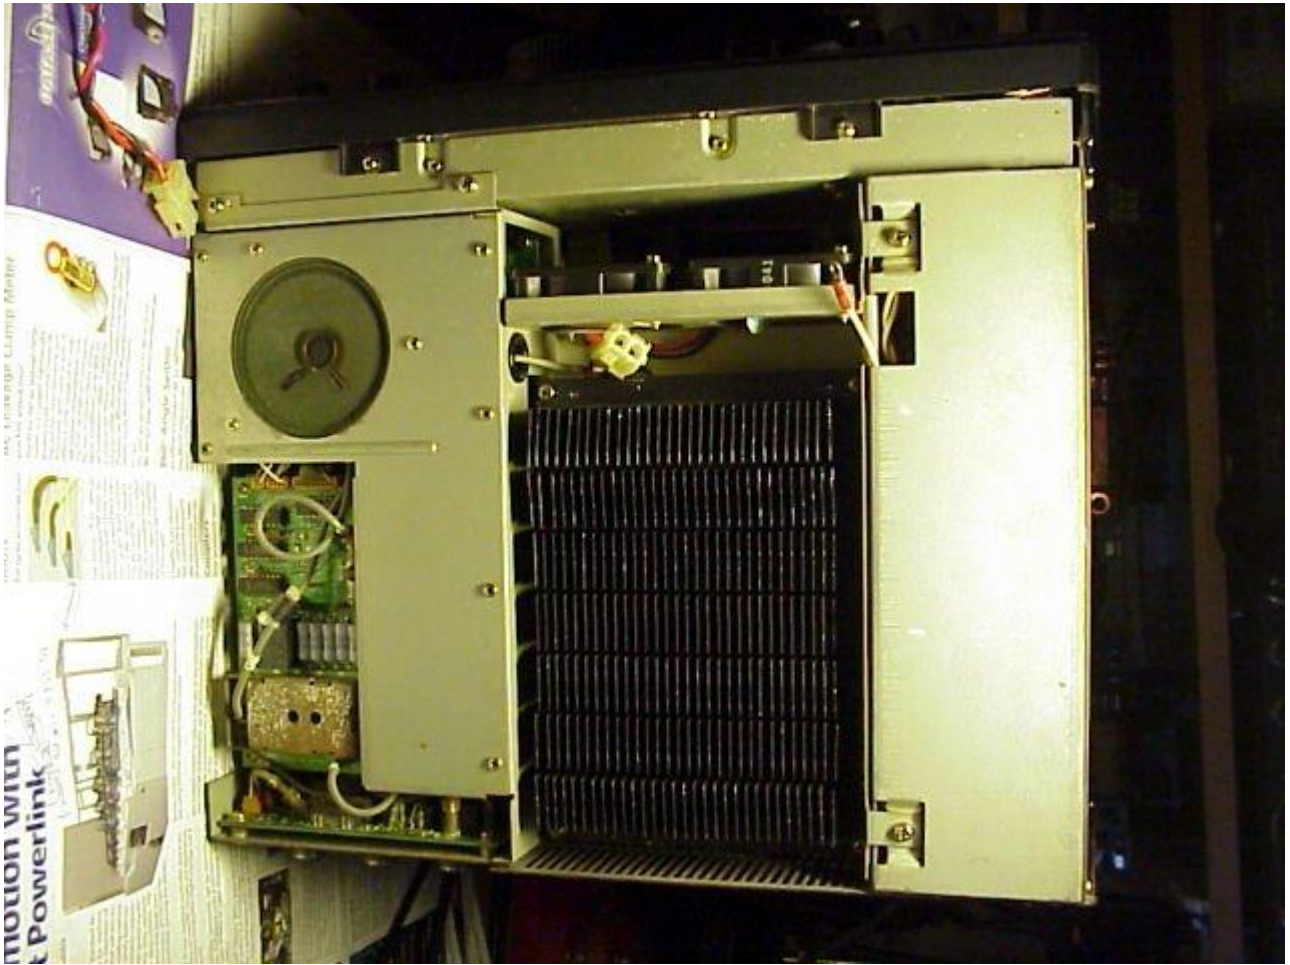
Unit finally arrived and what I found was a nice front panel, with just some scratches in the frame and a generally nice looking unit, except for some oxide in metal parts (*later I found that it had been used in a merchant ship*). It was a more recent unit than mine (serial RG03571 versus RG01346), made about 1995. Here you have some pictures of this unit:

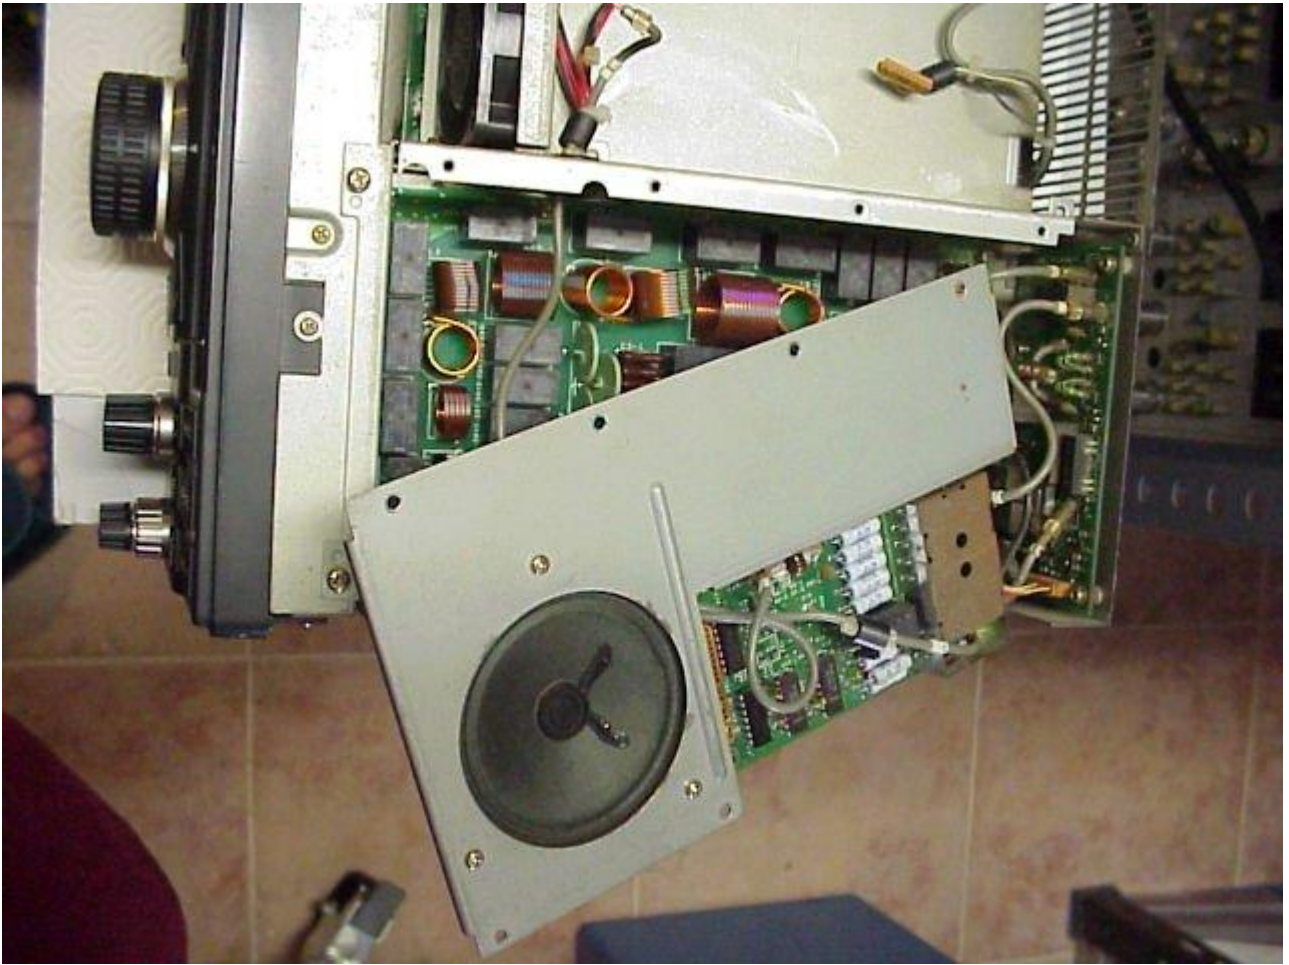
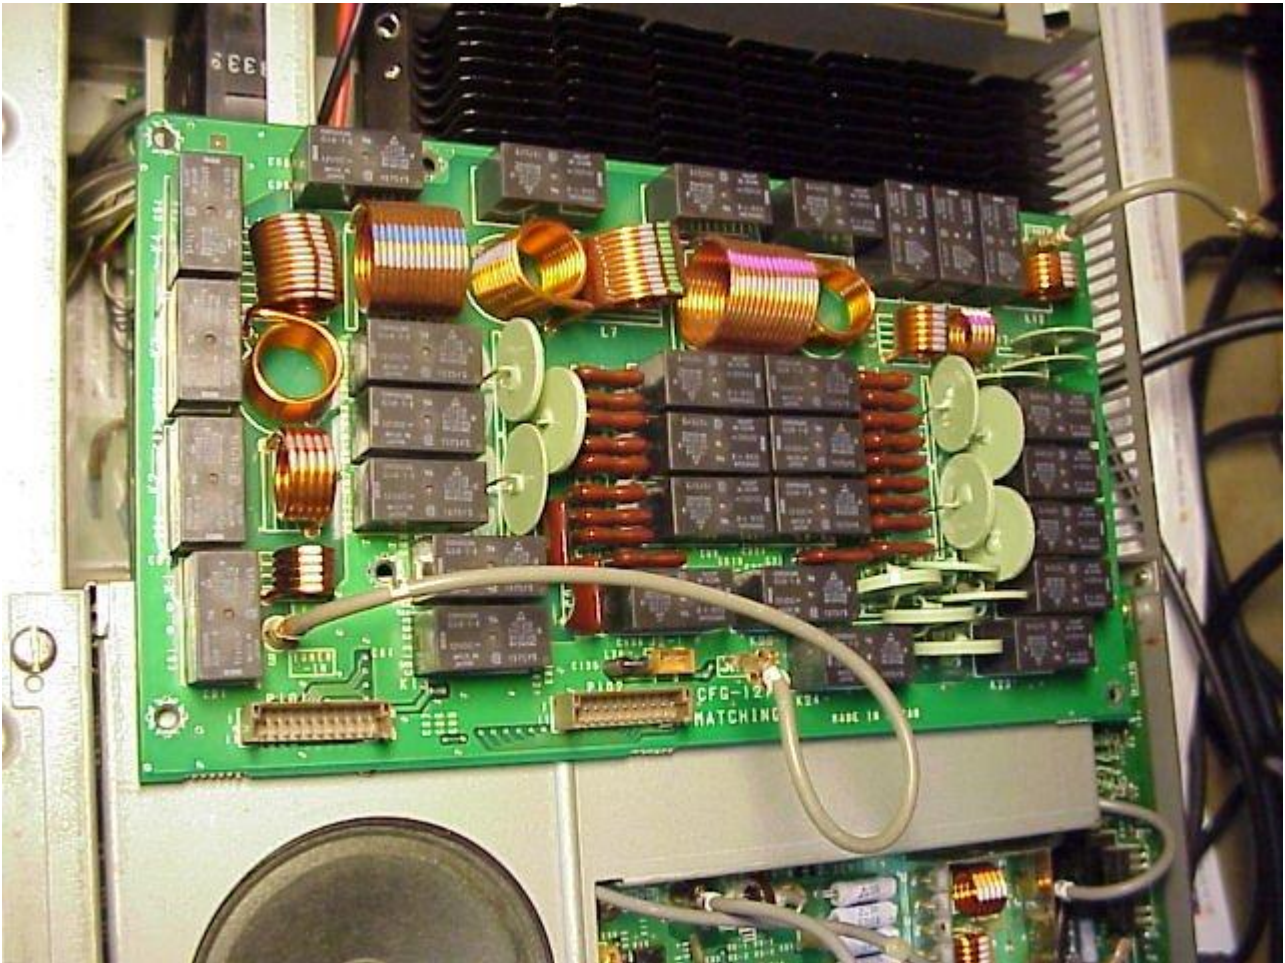
Next step was to check all transceiver functions. And then some problems arised: microphone PROCessor didn't work. And I found that I was using the rig **WITHOUT ANY OUTPUT BAND-PASS FILTERING!**. Yes, as Auto Tuner (AT) in my unit was faulty (I had checked it in a JST-145), I had removed it and connected directly the PA output to the antenna relays PCB... well, so it was the turn for checking again the old AT, just in case. And, as I suspected, it didn't work. I replaced it (all three PCBs: first sensor one and then relays and control ones) and ended with a working AT. Another milestone covered!. Here you have some pictures of the process:

It worked fine on my Windom antenna. There is a problem with the 245 SWR indication: it is taken *before* AT so you don't know the SWR *after* the AT. But I found an easy way to know it did something: an external watt meter showed improvement (a bit more power) when AT was ON.

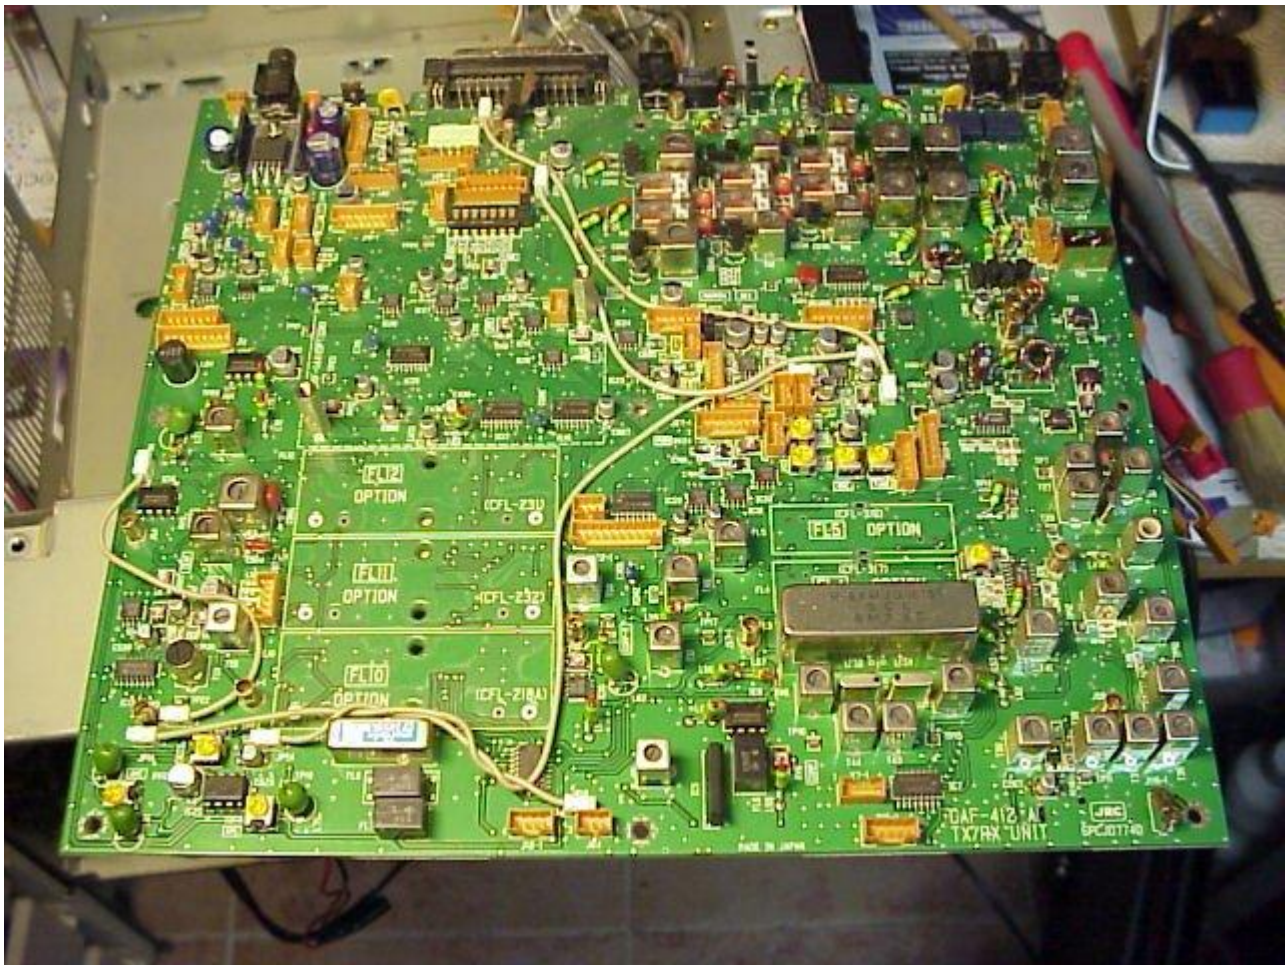
Ok, so now my *JRC hybrid* worked fine on TX (I did a couple more QSOs in 20 and 40 meters)... but it still had some problems: unworking PROC and unworking AM mode (with AGC ON it just kept muted and with AGC OFF it distorted and had too low volume). I checked the RXTX BOARD in the second unit. It looked fine and was a newer revision than mine (D versus B). So I got out all the connectors (about 50 or so!). They are numbered, which saves lots of time doing it by yourself. Here you have the RXTX unit once it was out of the second 245:

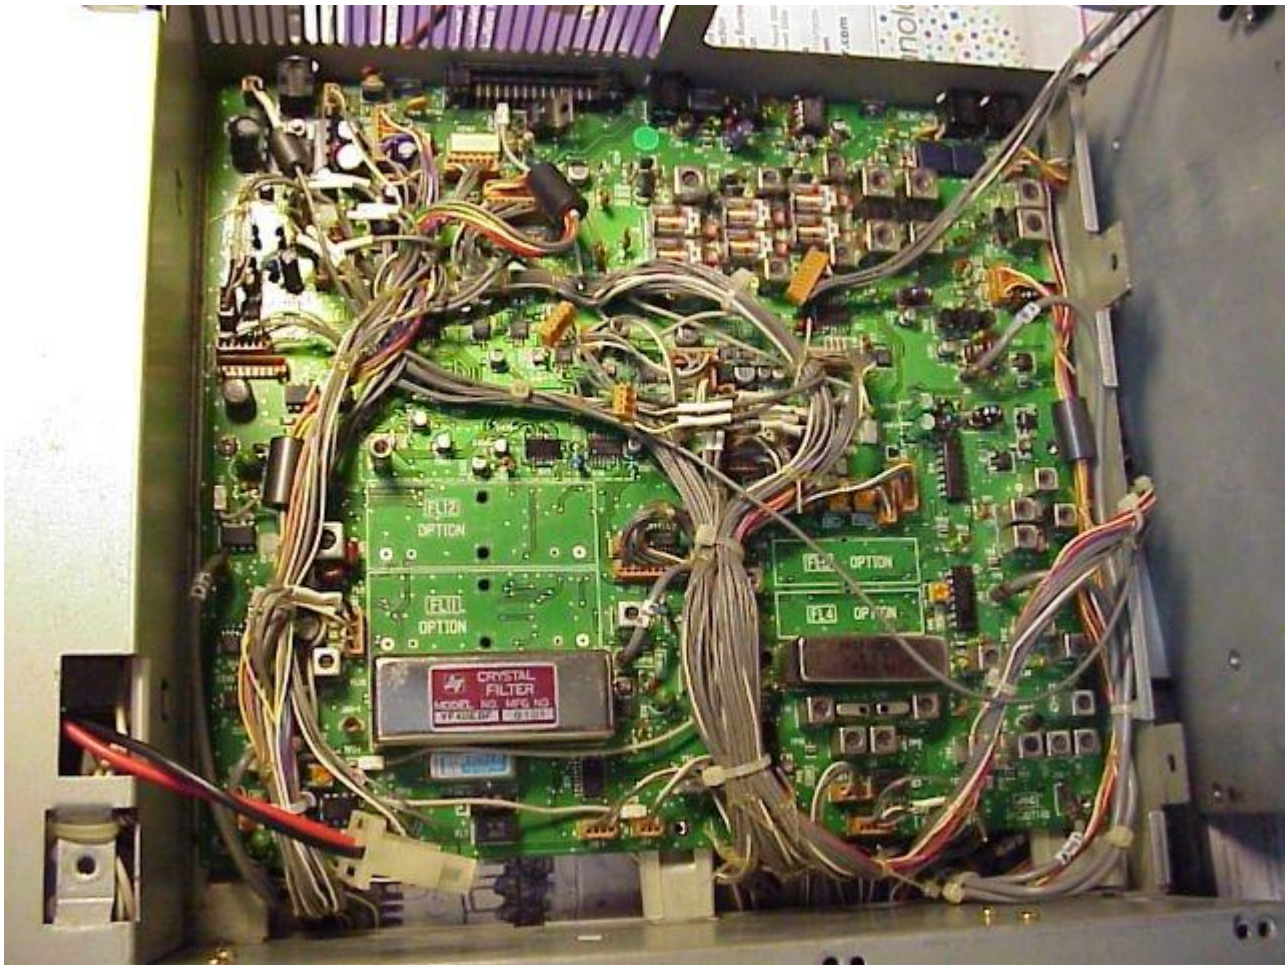
My 245 had an extra filter on it (in FL-10 position):

So I carefully removed it (not easy as it is a multilayer circuit and has huge ground layers), translated it to the *new* RXTX board and put it back in place (not forgetting to toggle the DIP switch which tells the CPU it has the FL-10 filter), along the MONitor UNIT:

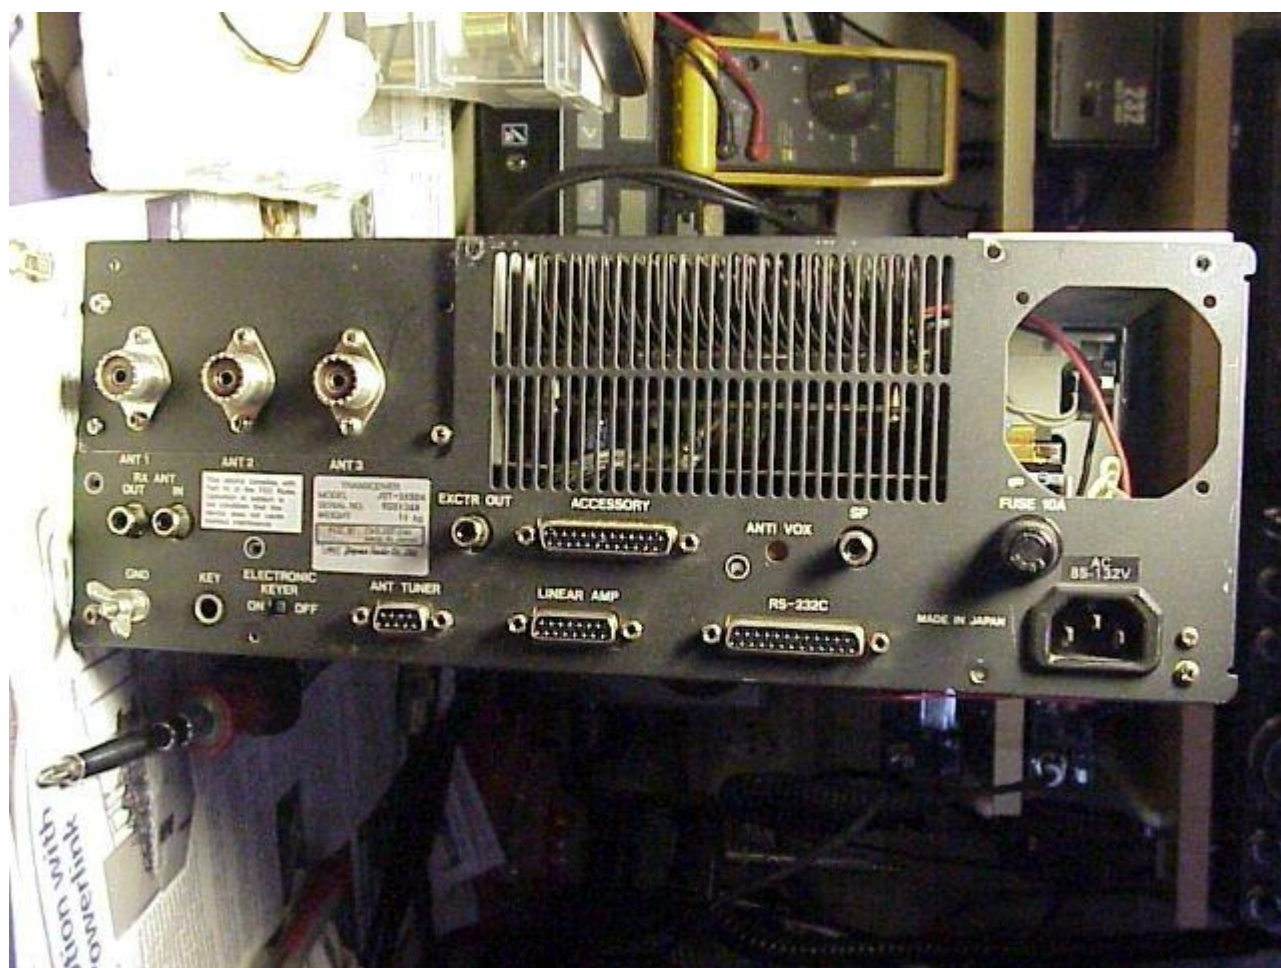
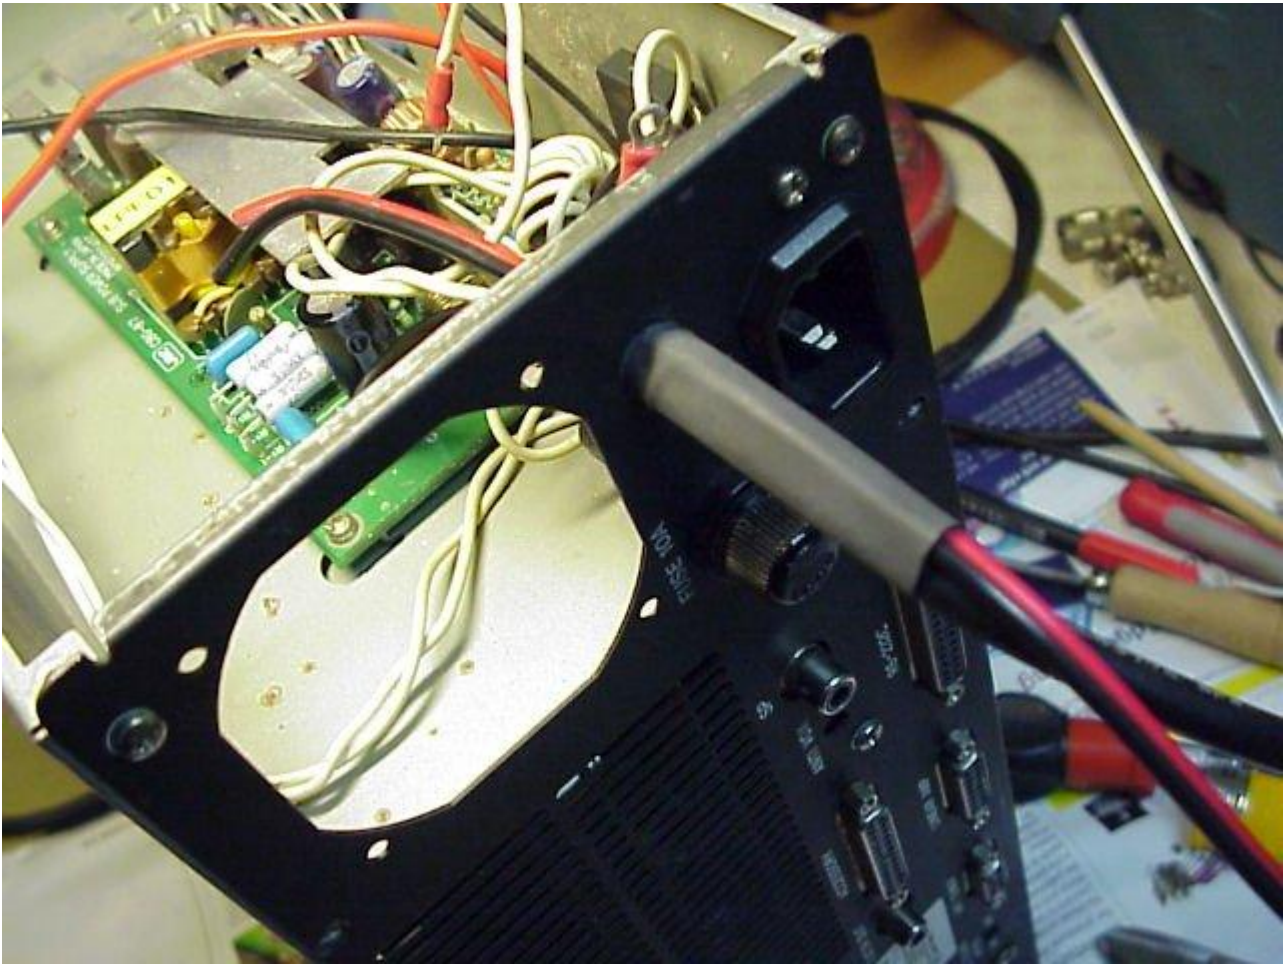
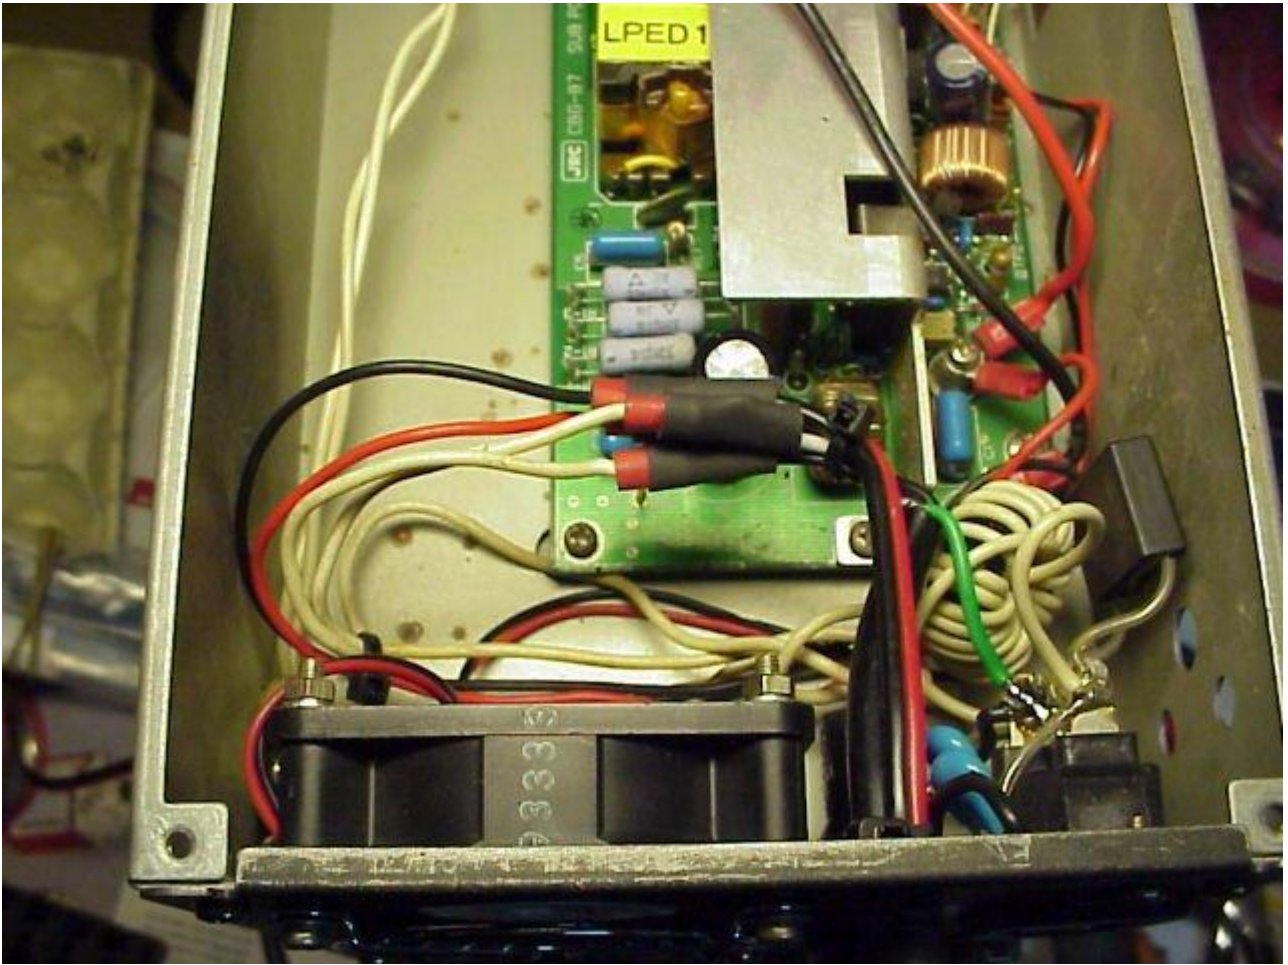
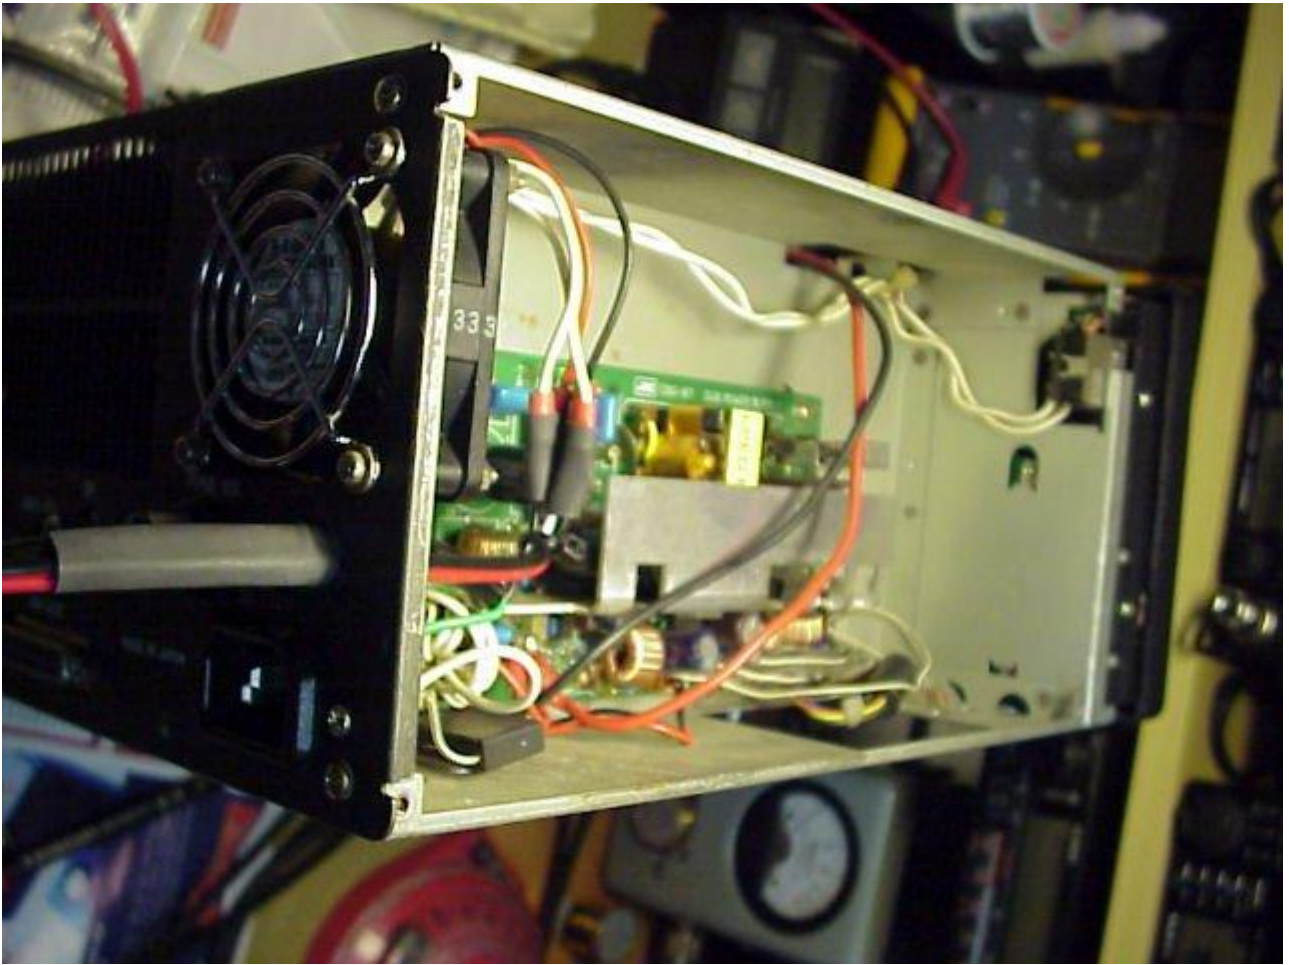
Once there I thought about repairing the internal power supply... well, I will probably attempt it in the future. But, knowing that it is the weakest link in the rig and that the external power supply I use is about three times more powerful (so it is in no way stressed), I decided to keep it this way by now. But I needed to do some work to have a FT-1000MP Mark-V-like external power supply. And best way I devised was to use the rig power switch to control the external power supply. So I would need a 4 wire cable: 2 for the VAC from the rig switch to the PS and 2 for the 48VDC from the PS to the rig. I needed to drill a 10mm diameter hole in the back of the rig for the cable, but I found this was a minor problem, as it could be later plugged with a cover, if needed. Here you have some pictures of this process:
