M1 ABRAMS

MAIN BATTLE TANK

1982-1992

M1 ABRAMS MAIN BATTLE TANK

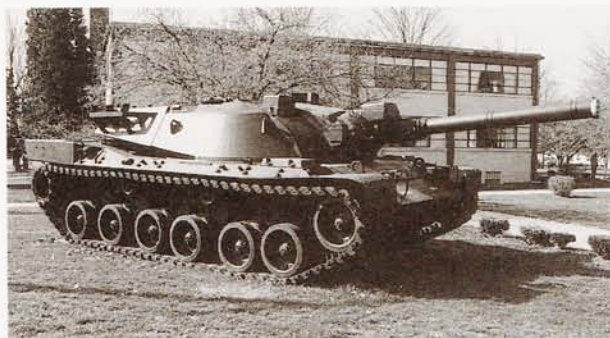
The last gasp of the failed MBT-70 programme was the XM803. This tank was intended to be a low-cost,

austere version of the overly sophisticated MBT-70. It too was cancelled in favour of a new tank. (Author)

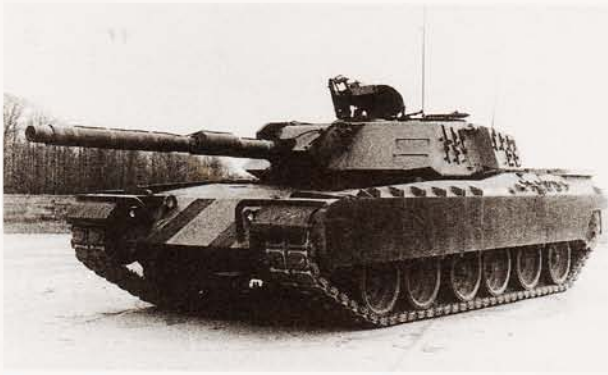
The XM1 development programme was a competitive effort between General Motors and Chrysler. Seen here is the General Motors validation phase tank. (US Army)

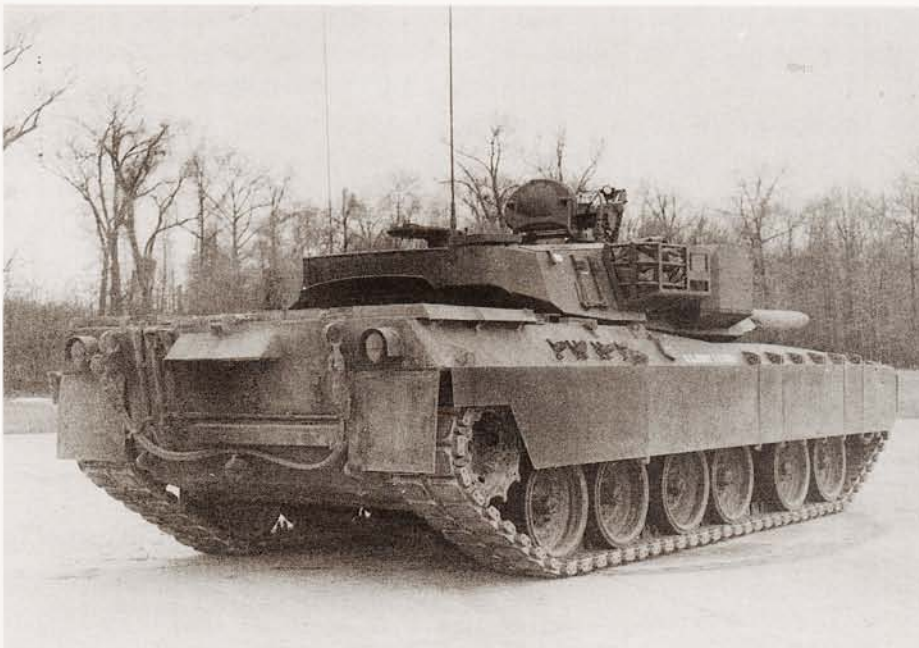
A rear view of the General Motors XM1. This vehicle had far less prominent exhaust venting at the rear than the Chrysler XM1 since it used the AVCR-1360 diesel engine. (US Army)

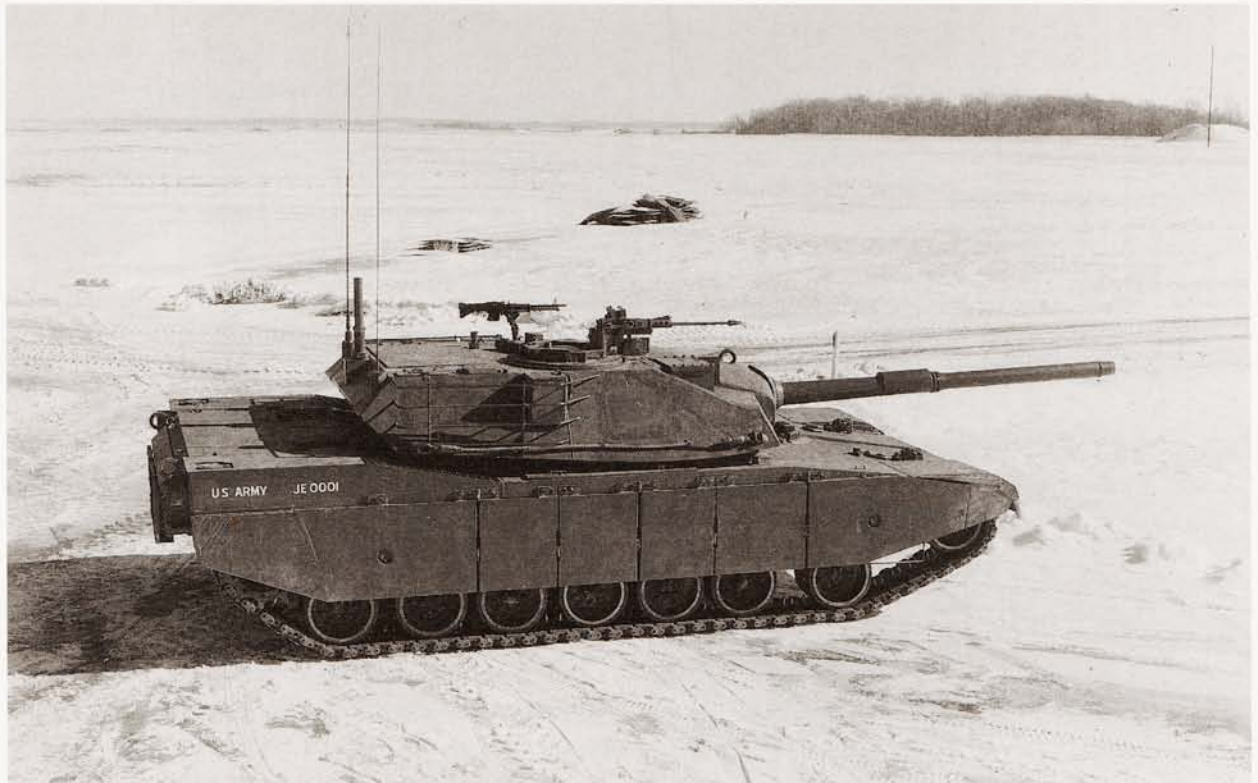
The Chrysler XM1 validation phase tank is seen here during the trials. This was the second turret

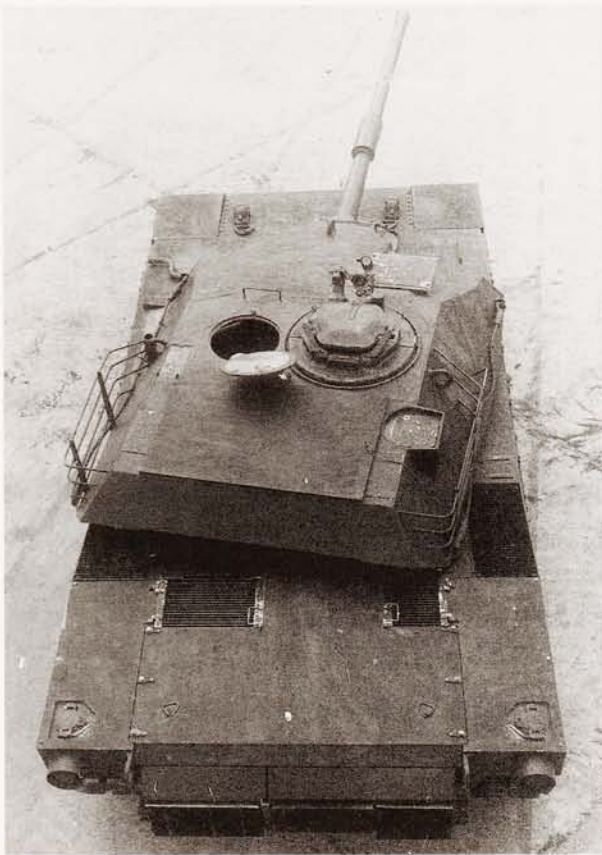
An overhead view of the Chrysler XM1 validation phase tank. There were many changes to the turret

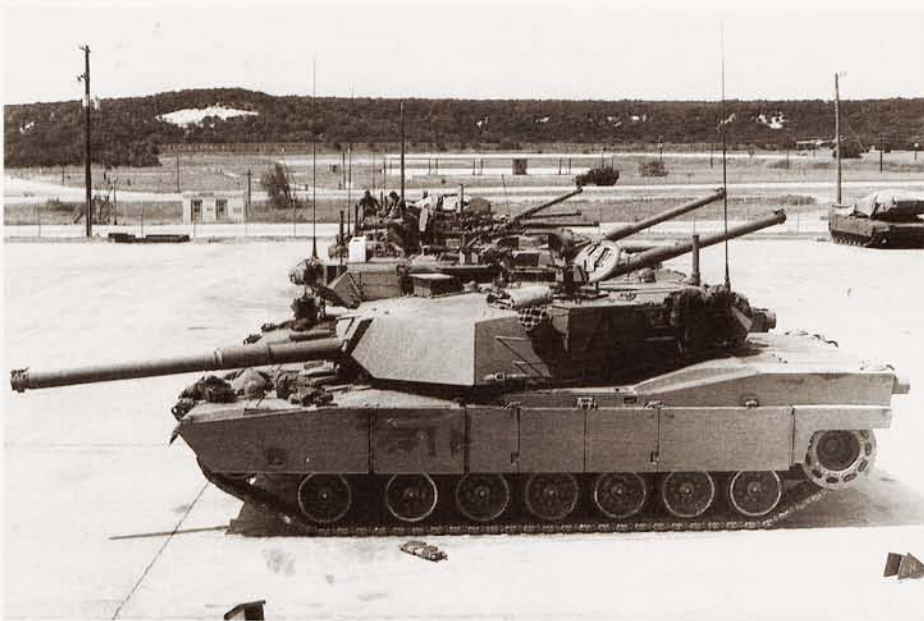
The 2nd Armored Division was the first unit to re-equip with the M1 in 1982-83. One modification developed at Ft Hood was to cut back the rear skirt to prevent mud from building up in the drive sprocket. This was later adopted at the factory. The markings on the hull side identify this vehicle as belonging to the 'Hounds of Hell' 3-67 Armor. (Author)

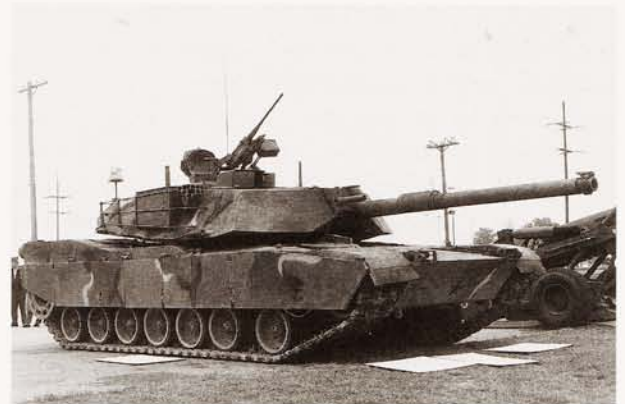
One of the initial low-rate-initial-production M1 Abrams tanks at Aberdeen Proving Ground shortly after their introduction into service. The XM1 FSED tanks can be distinguished by a more complicated ammunition feed on the

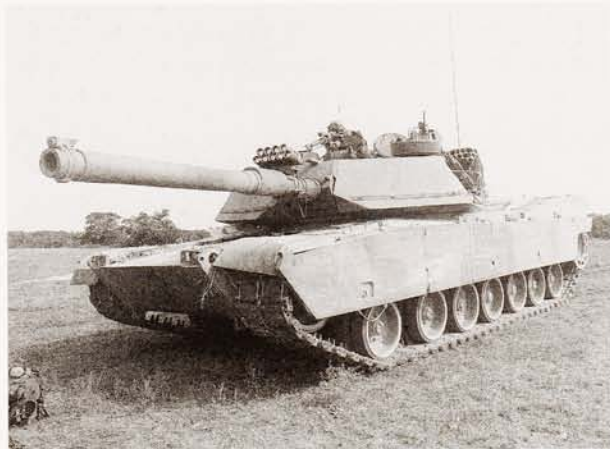
The introduction of the M1 Abrams coincided with the introduction of the MILES laser simulation equipment. The canvas webbing at the base of the turret contains small laser sensors which sense whether the tank has

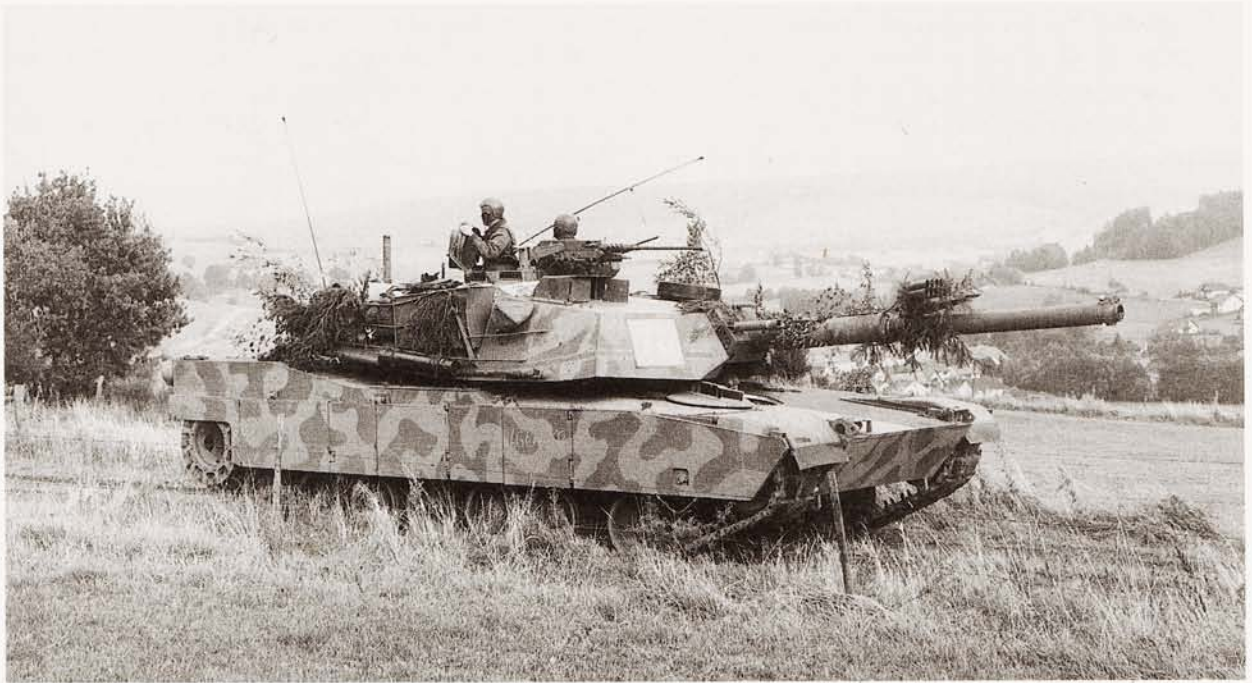
An M1 of 1-11 Armored Cavalry Regiment during Reforger-'83 in Germany. At the time, the unit was commanded by one of Creighton Abrams' sons, Col. John Abrams. During

the war-games, the unit used improvised camouflage of mud smeared over the usual green camouflage colour, sometimes in elaborate patterns as seen here. (Pierre Touzin)

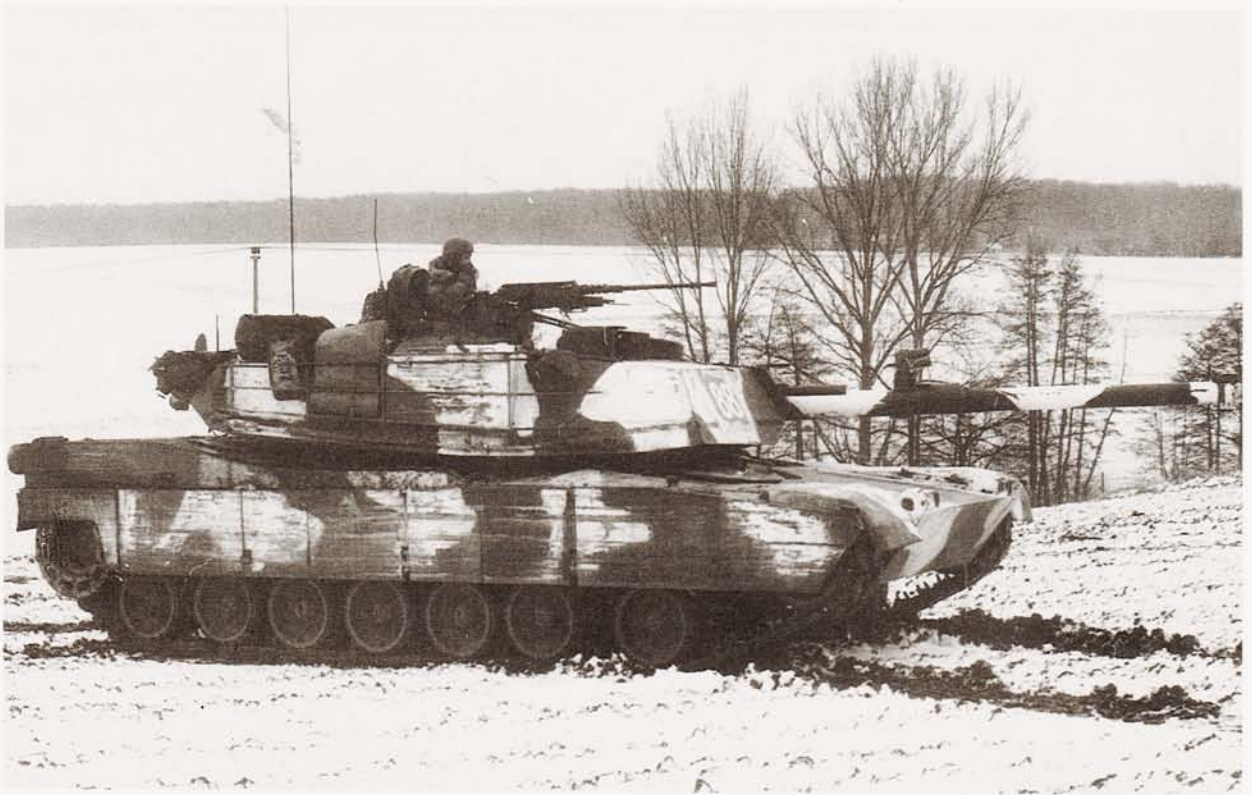
The Reforger exercises in Germany were held in the autumn or early winter. This M1 Abrams has a temporary winter camouflage pattern applied. The mast behind

the radio antenna is a mounting for the 'whoopie light' used with the MILES simulator to indicate that a vehicle has been disabled. (Pierre Touzin)

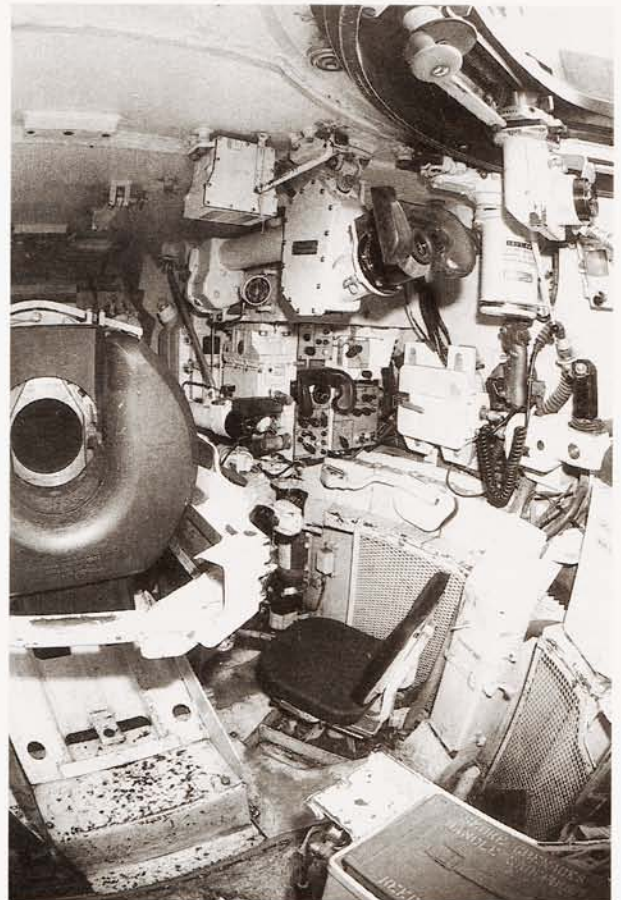
Inside the turret of an M1 Abrams. To the right is the commander's station with his fire controls evident. To the left is the breech of the

M68A1 105 mm gun. (Author)

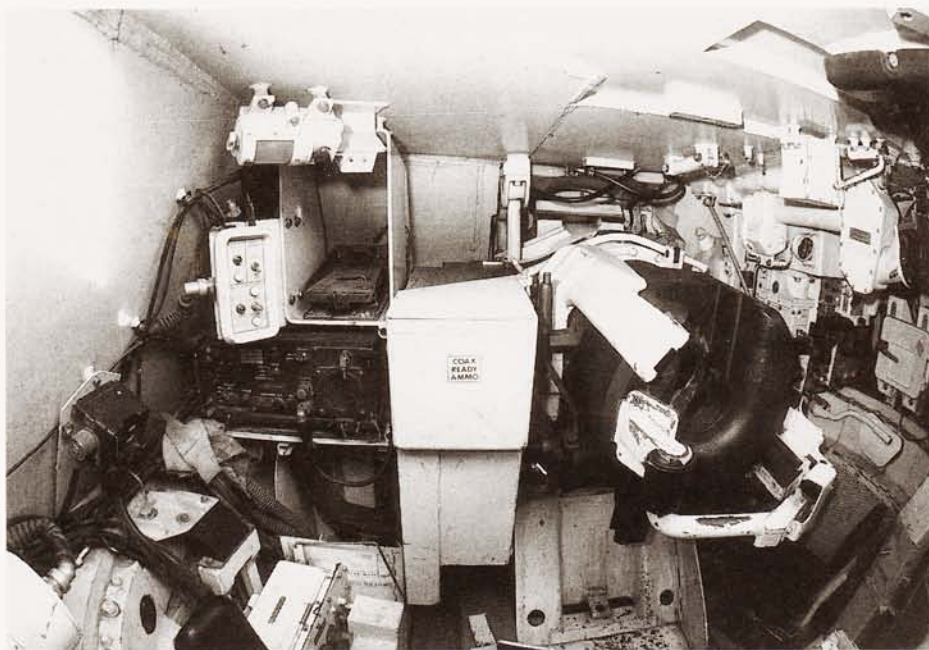
An interior view of the M1 looking forward in the loader's station showing the vehicle radio to the lower left and the gun breech to the right. (Author)

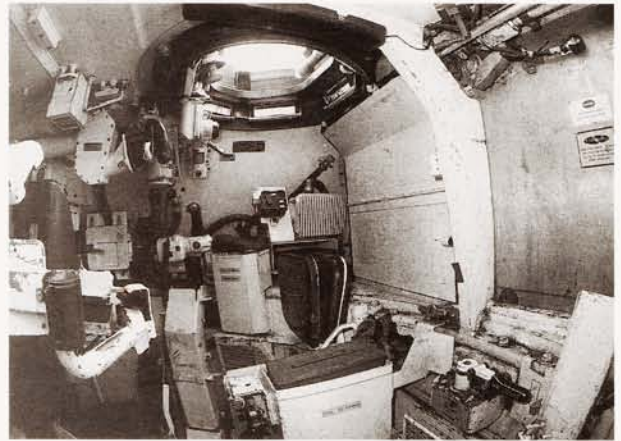
An interior view of the M1 looking from the loader's station in the left side of the turret over towards the commander's station. To the right are the blast doors for the ammunition. To the left is the gun breech. (Author)

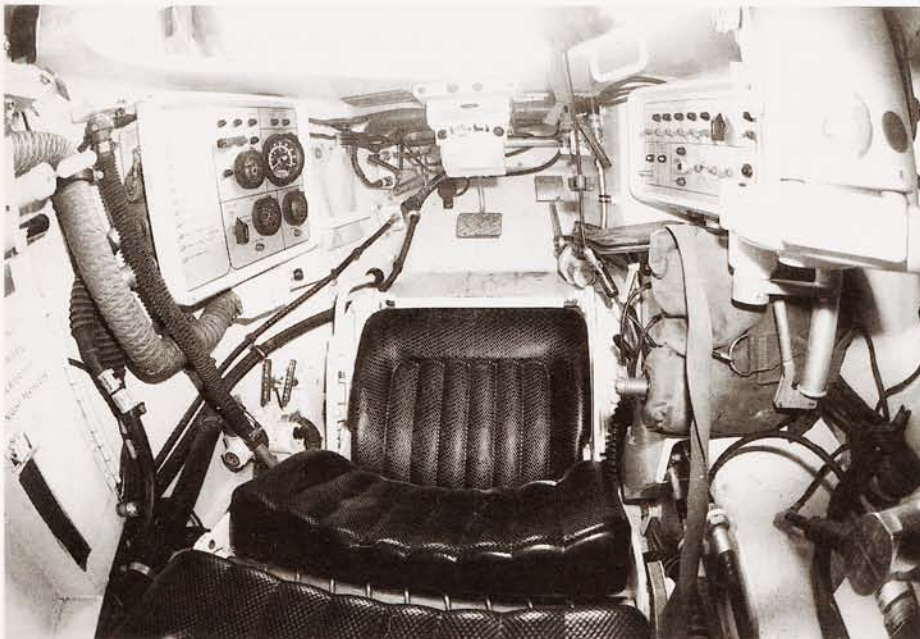
A view of the driver's station in the M1. The driver sits in an almost prone position when the tank is buttoned up. His main control is a set of hand-controls reminiscent of those on a snow-mobile or motorcycle. (Author)

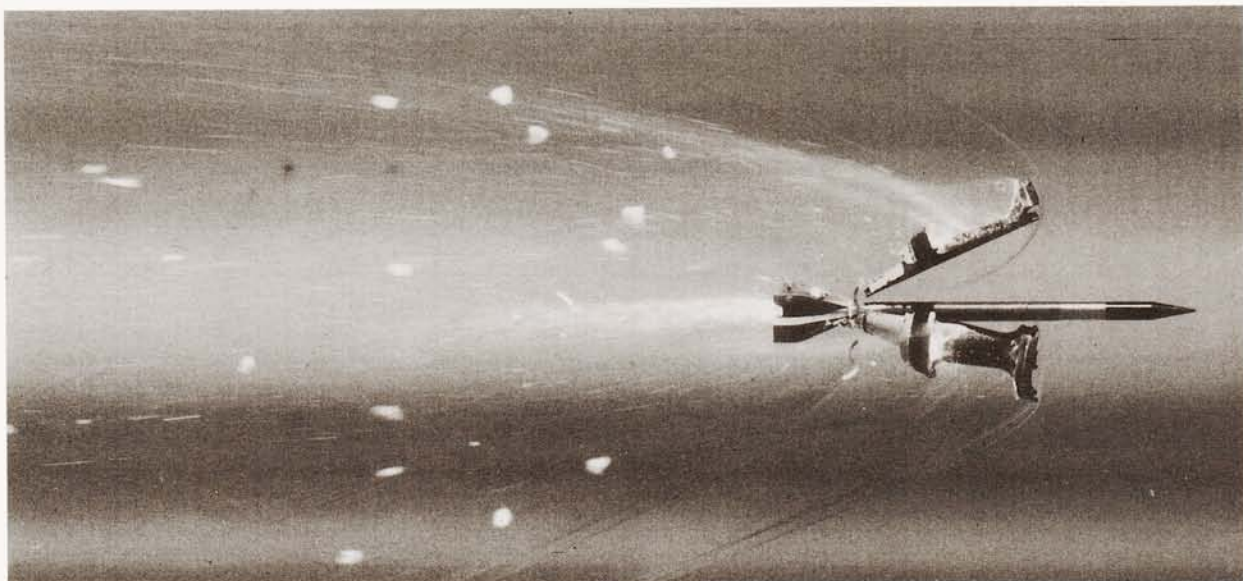
The sharp end of the M1 Abrams' weapon system is the armour-piercing fin-stabilised discarding-sabot (APFSDS) kinetic energy penetrator, more commonly

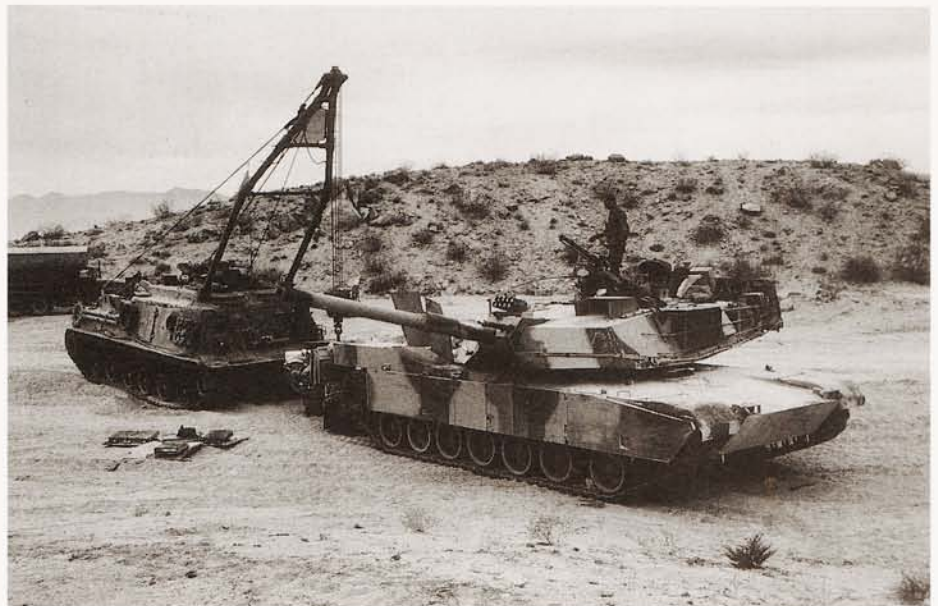
An IPMI undergoes repairs by an M88 recovery vehicle at the National Training Center at Ft Irwin, California. Most US tankers feel that the realistic war-games at NTC were the prime reason for the outstanding performance by US armour units during Desert Storm. (Author)

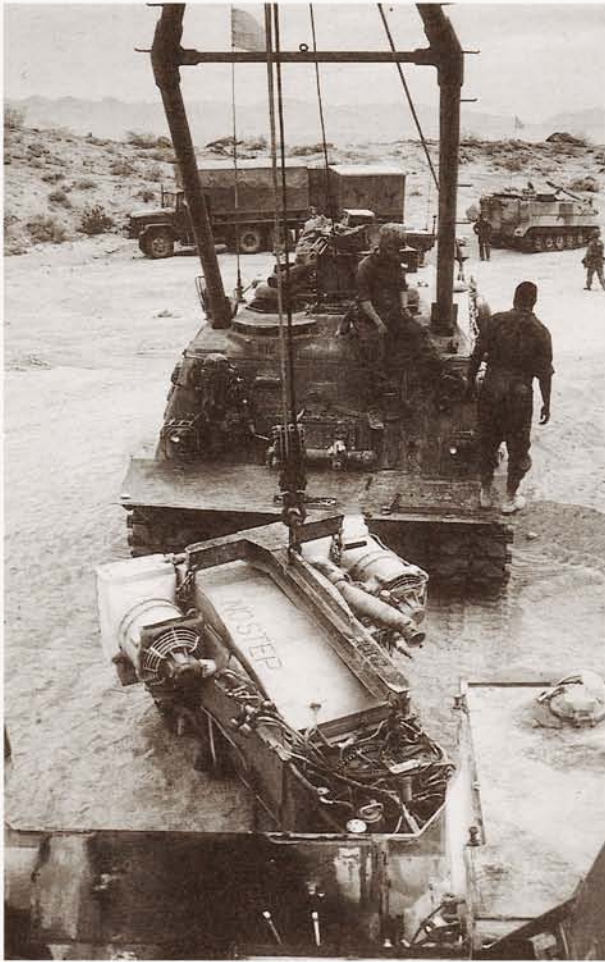
An AGT-1500 gas turbine powerpack is pulled from an IPM1 Abrams at NTC by an M88 recovery vehicle. Although the turbine has

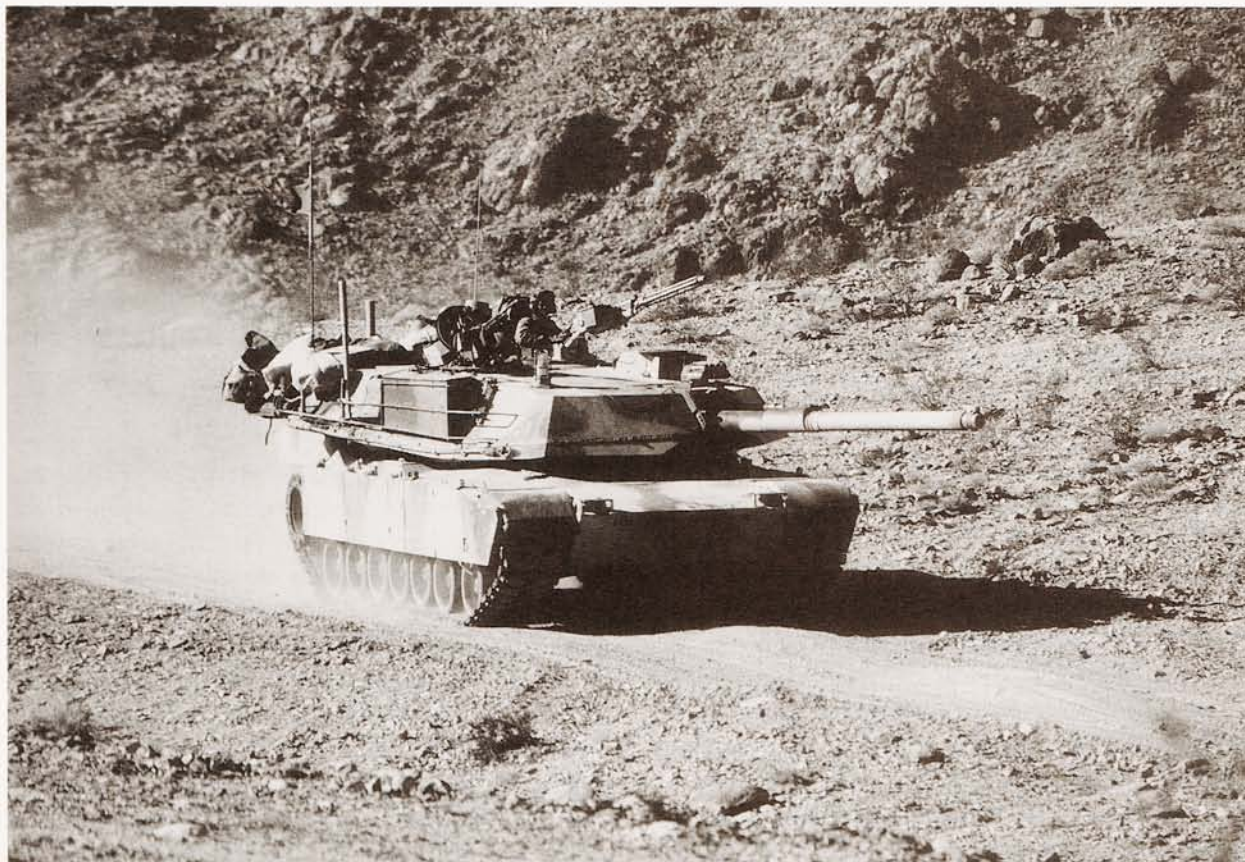
An M1 Abrams at Ft Sill, Oklahoma in 1991. This vehicle might be mistaken for an IPMI due to the rear storage basket and the absence of the retainer ring on the drive sprocket. In fact, since the late 1980s, many M1s have been retrofitted with the storage rack due to general disgruntlement

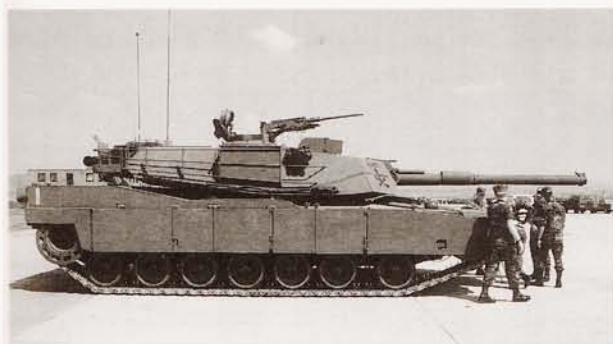
Another example of a modernised M1 Abrams with the rear turret basket, this time Ballbuster, the command tank of B Troop, 1-11 ACR at Fulda, Germany in 1988. The spacing between the front tow cable attachment and the turret armour joint on the right turret side is

different than on the left, and more difficult to gauge without reference to other distinguishing features of the IPMI, such as the front gun mantlet. This vehicle is unusual in that it is painted in overall olive drab for a change of command ceremony, not the usual forest green. (Stephen Sewell)

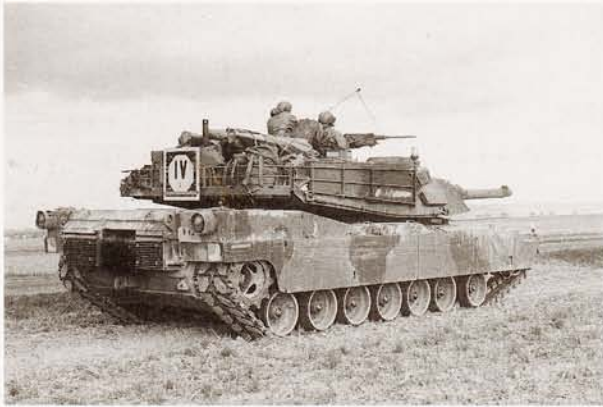
A rear view of an M1A1 of 4th Platoon, B Troop, 1-11 ACR. Since the early 1980s, US tank units have adopted the practice of mounting metal plates at the turret rear with geometric symbols to indicate unit affiliation. This is to make it easier for unit commanders to visually identify tanks in their unit. (Pierre Touzin)

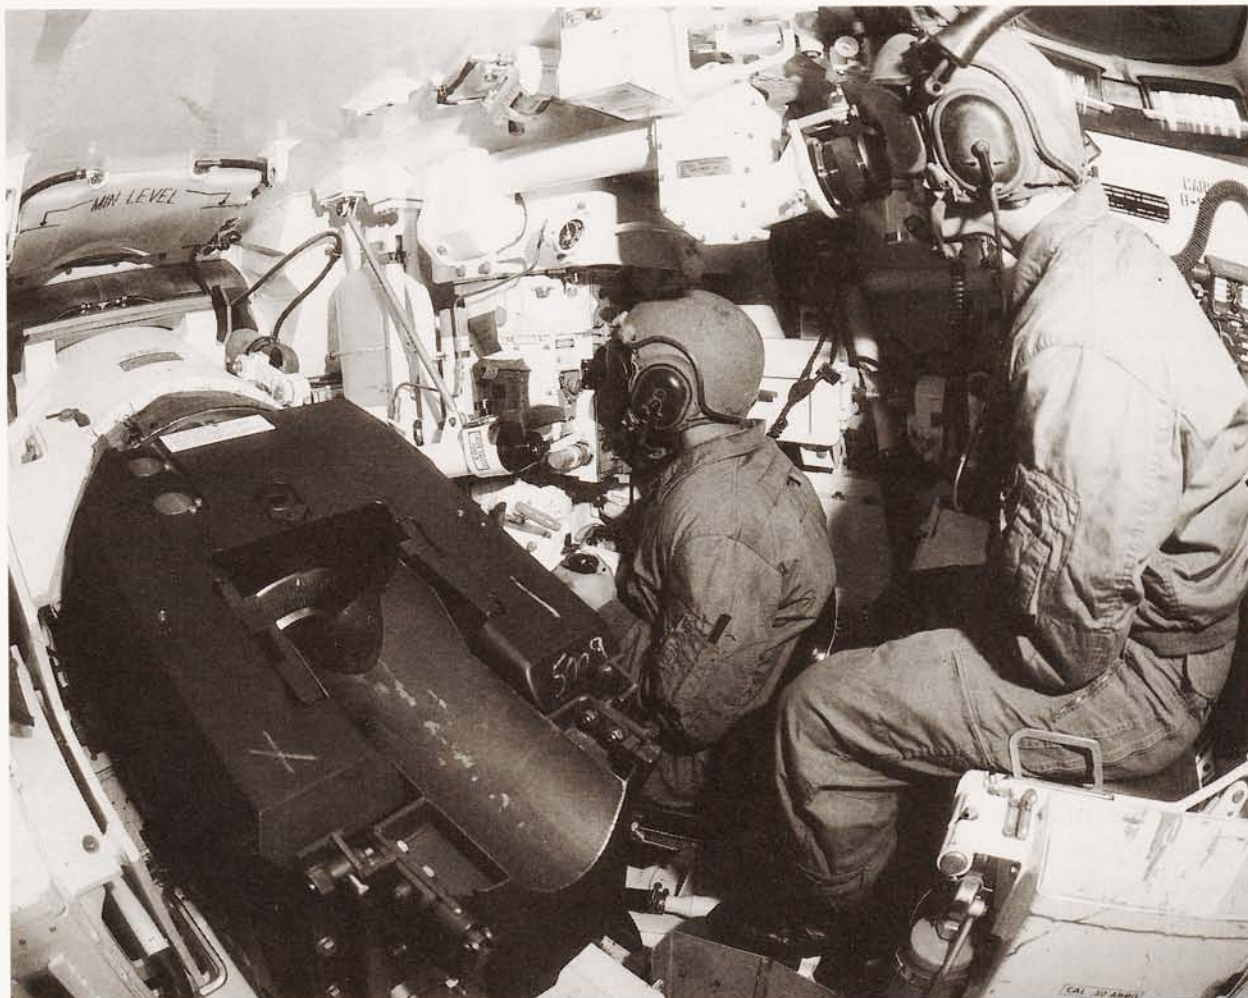
An interior view of the M1A1 tank looking from the loader's station towards the gunner and tank commander. The interior

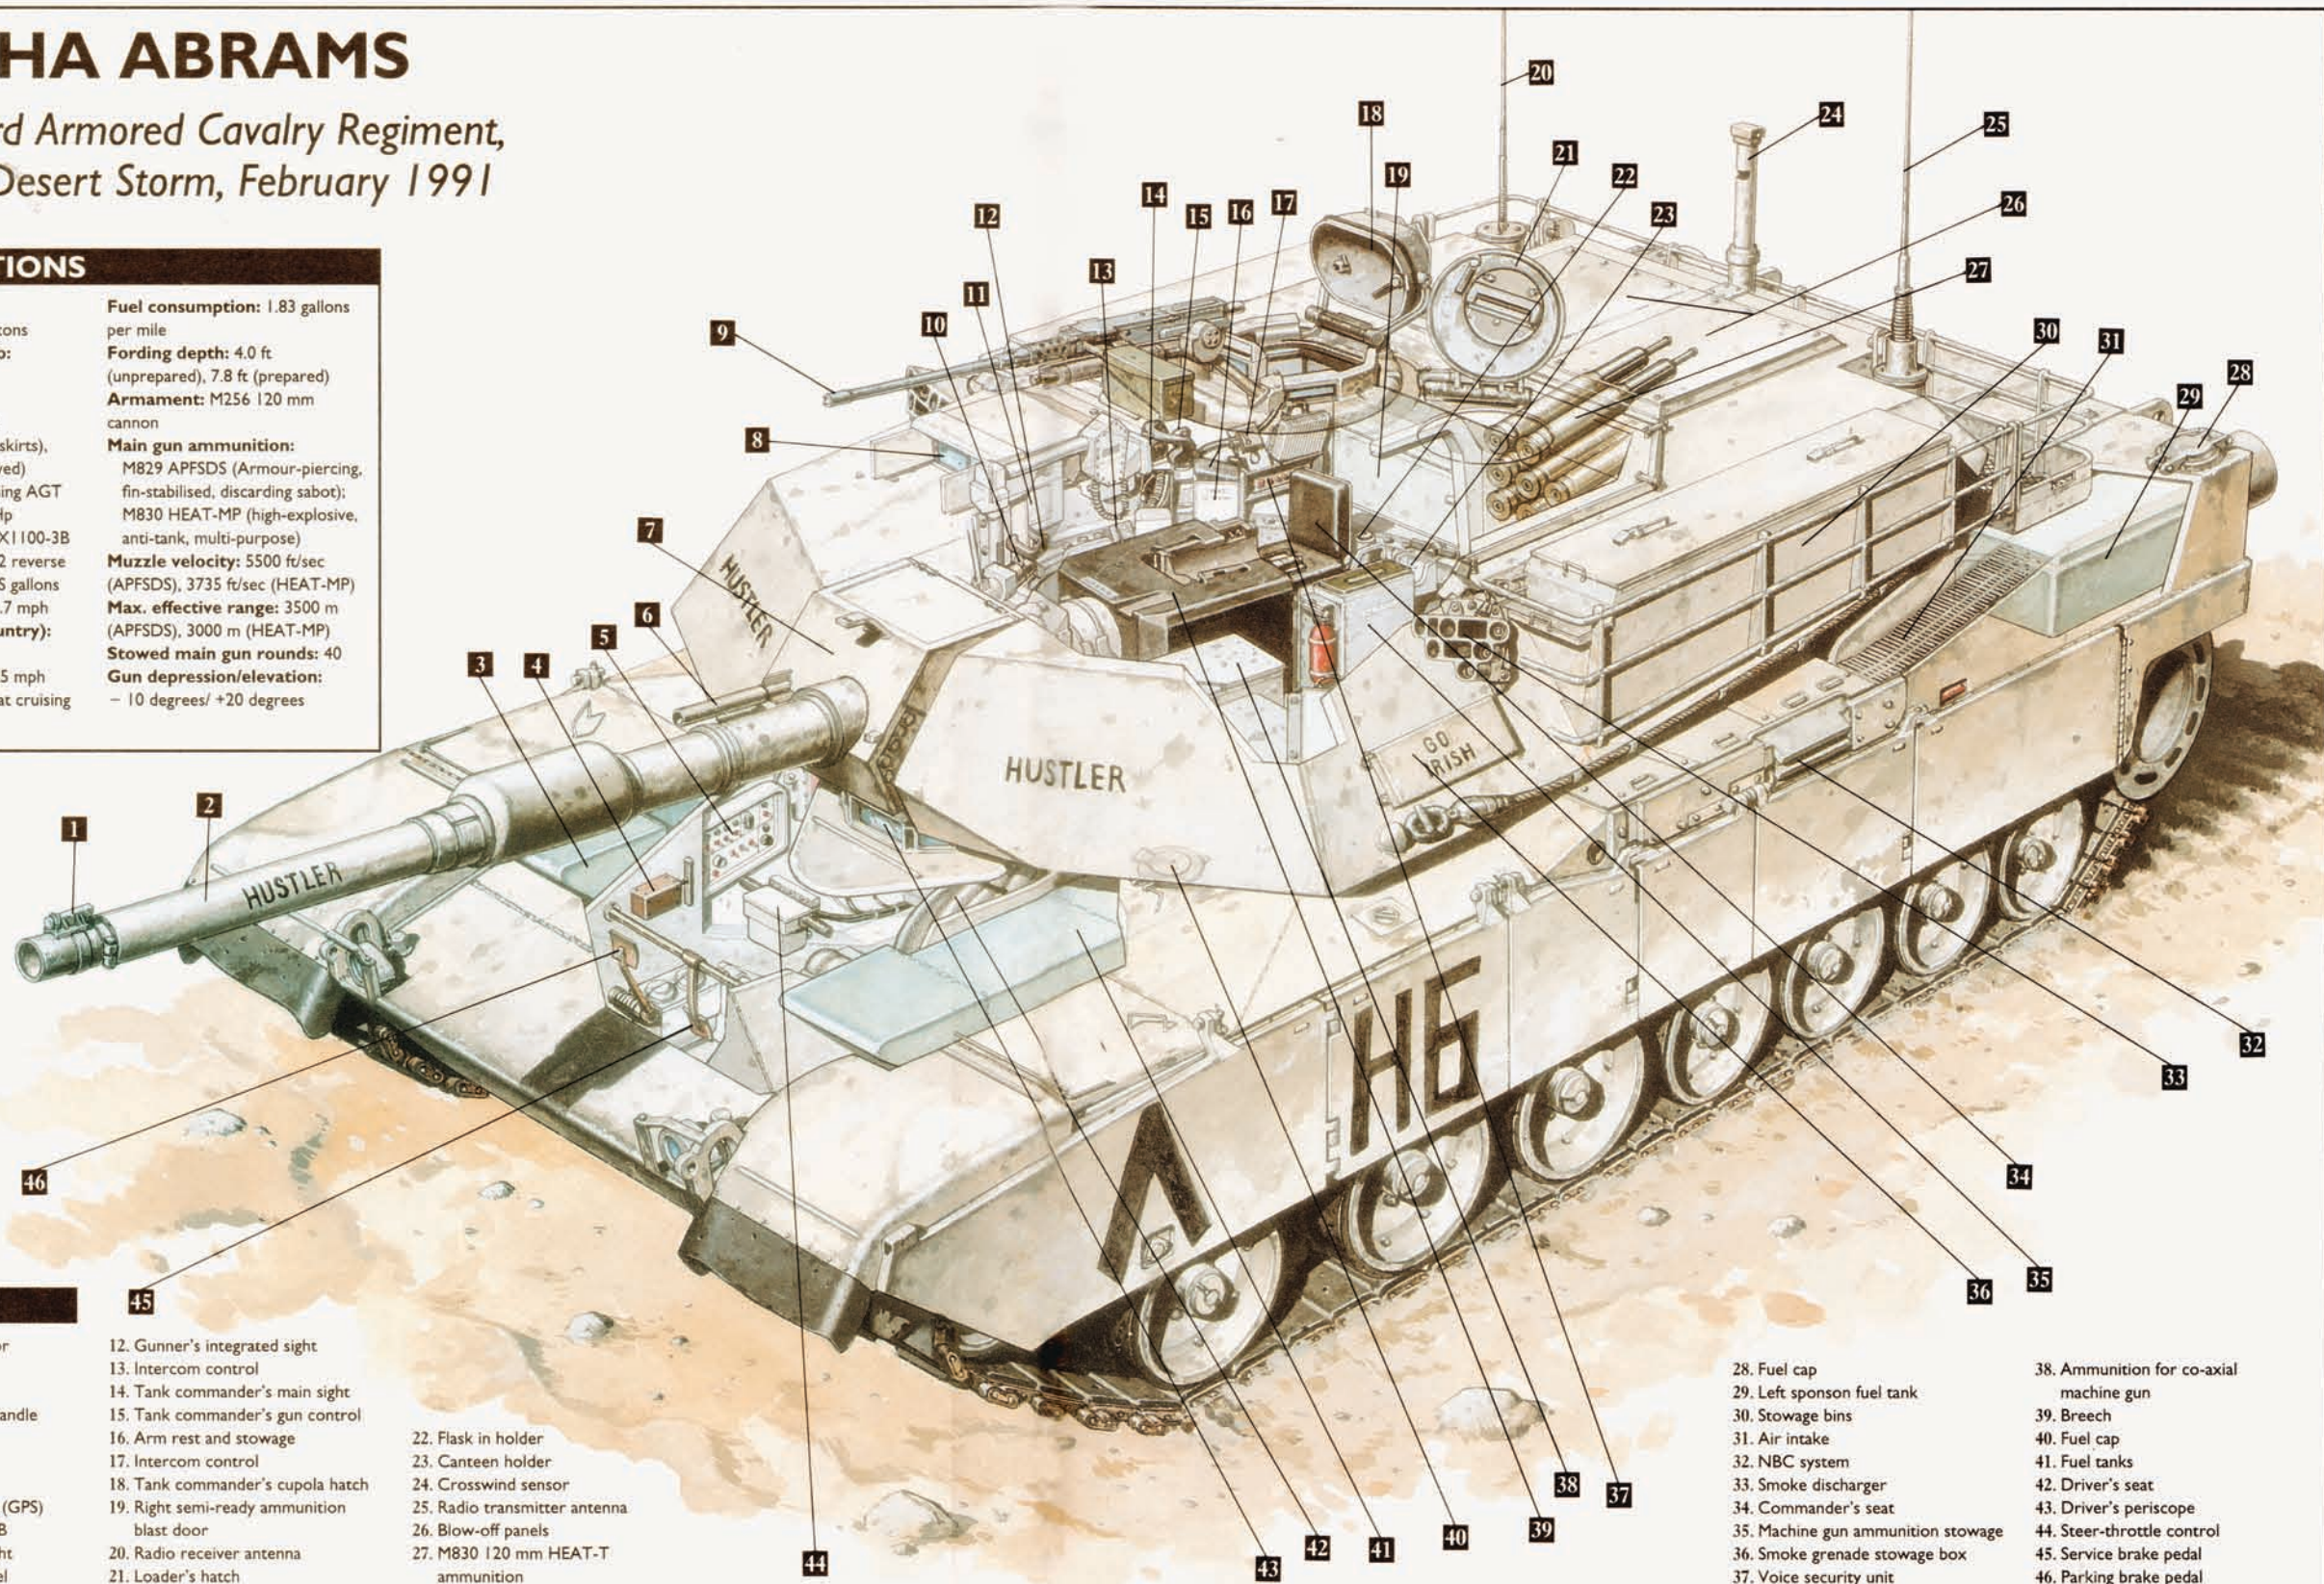
M1A1HA ABRAMS

D Ce schéma illustre le plan de l'intérieur du M1A1 Abrams. Les intérieurs du M1, IPM1, et M1A1 sont essentiellement semblables bien qu'on incorporait des améliorations diverses au cours de la production. Le poste du conducteur au devant du char est indépendant, et le conducteur est quasiment prostré lorsque l'écoutille est fermée. Cette position a été adoptée pour réduire la hauteur de la caisse, et donc la hauteur générale du véhicule. On contrôle ceci à l'aide d'un joug visible sur l'illustration. On trouve les cellules à carburant de chaque côté du conducteur. La tourelle est occupée par l'équipage, les armes et les contôles de feu. Bien que le M1A1 soit visiblement plus grand à l'extérieur que le modèle plus ancien M60A1, l'intérieur du M1A1 est plus petit à cause de la place qu'occupe l'équipement de blindage. Le commandant s'assied sous l'écoutille principale droite, avec devant lui une mitrailleuse M2 .50 cal télécommandée. Devant lui se trouve l'artilleur et le chargeur est posté à gauche de la brèche. Les munitions principales du canon sont situées à l'arrière de la tourelle derrière les portières spéciales anti-explosion. La cellule principale de courant du véhicule, le moteur turbine à gaz AGT-1500cv, est située à l'arrière de la caisse. Le moteur et la transmission sont intégrés pour permettre leur remplacement facile sur le champ de bataille.

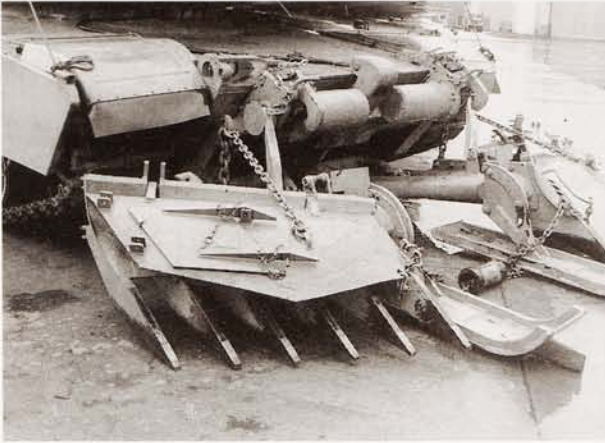
The most common element of the Battalion Counter-mine Set (BCS) is the mine plough. This system is

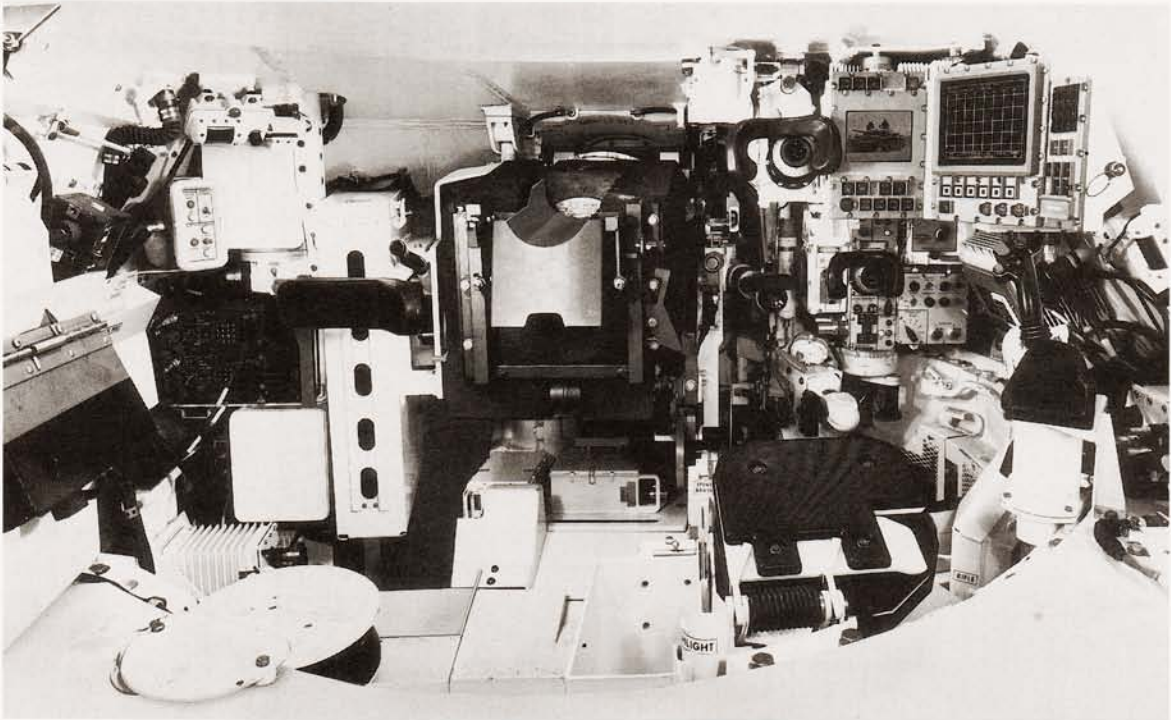
An interior view of the M1A2 Abrams. One of the most significant differences is in the area of the commander's station which

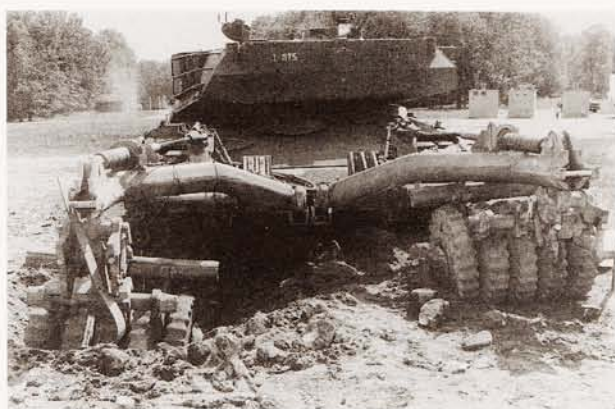
The BCS also includes a mine roller, patterned after Soviet systems. This photo was taken during tests at

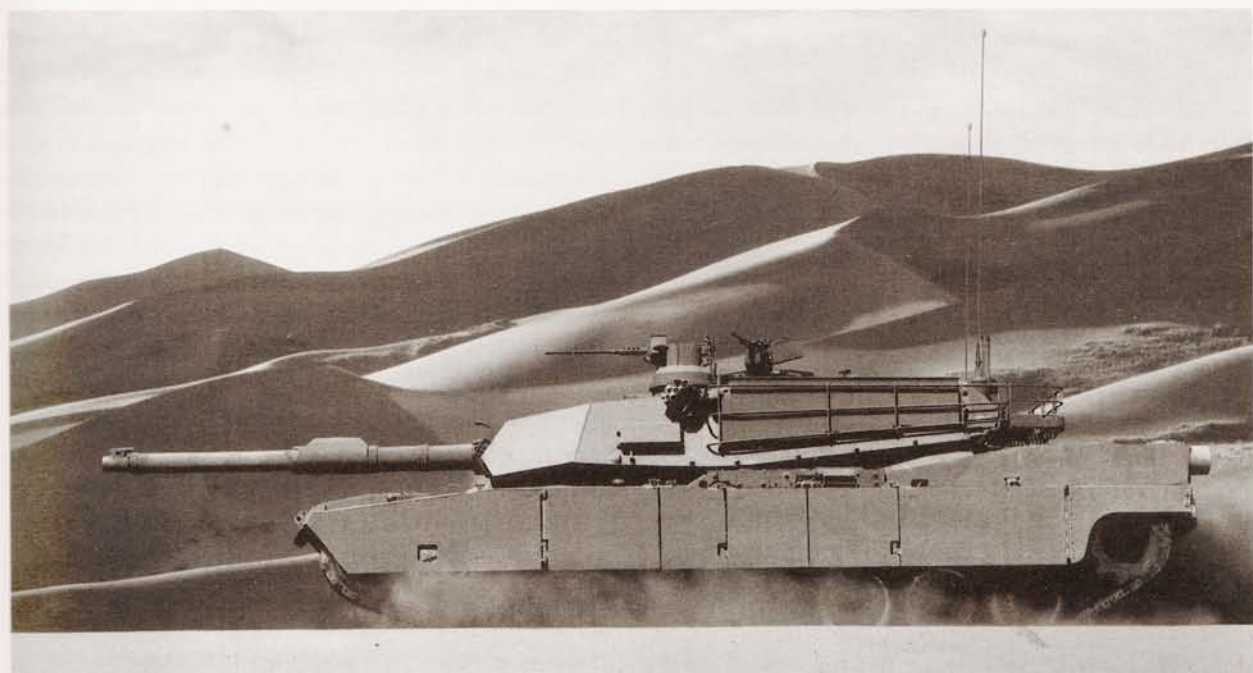
A side view of the M1A2 Abrams. This version is most easily distinguished by

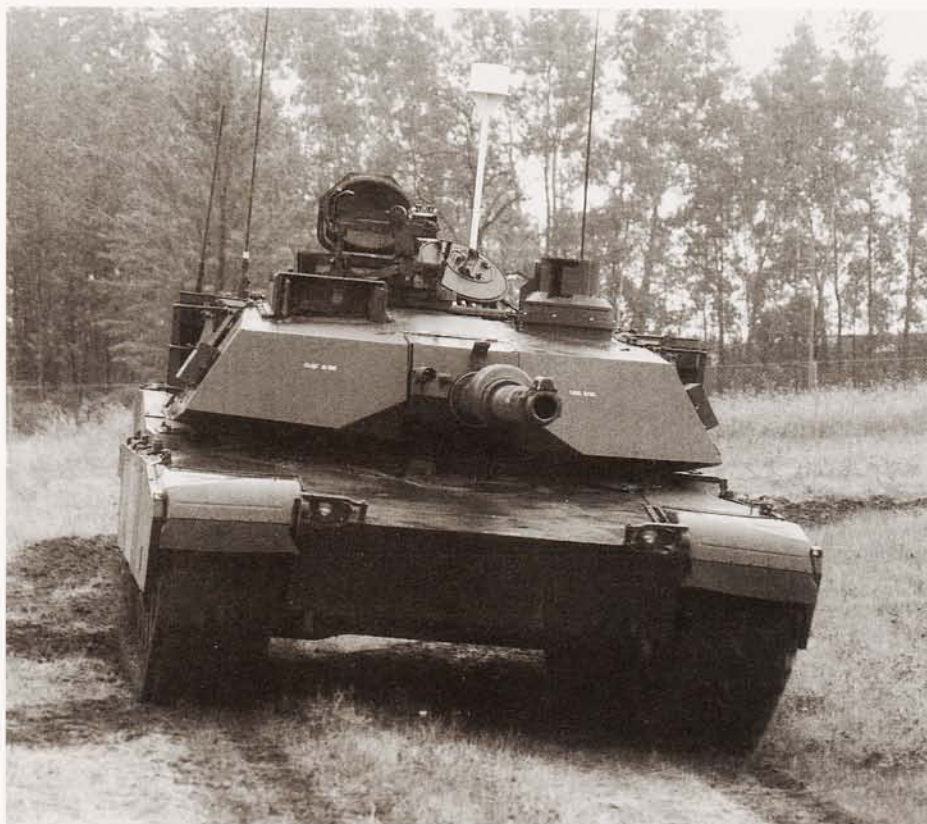
A frontal view of the M1A2 Abrams during trials. In this view, two of the key external changes: the ICWS cupola and CITV sensor can be seen. (GDLS)

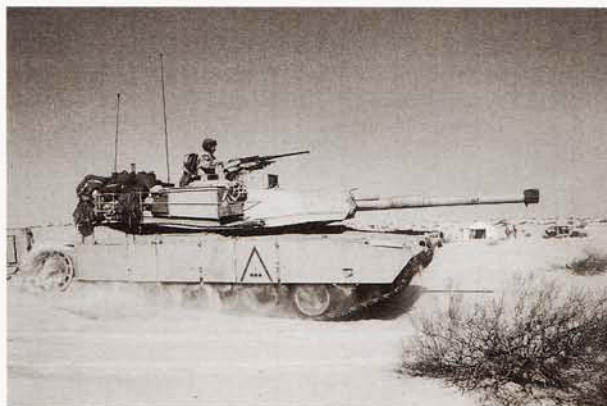
An IPM1 of the 24th Infantry Division during Desert Shield. This division was the first heavy division into Saudi Arabia and was

still equipped with the older M1 and IPM1 tanks. This particular tank is fitted with the external APU at the rear. (US Army)

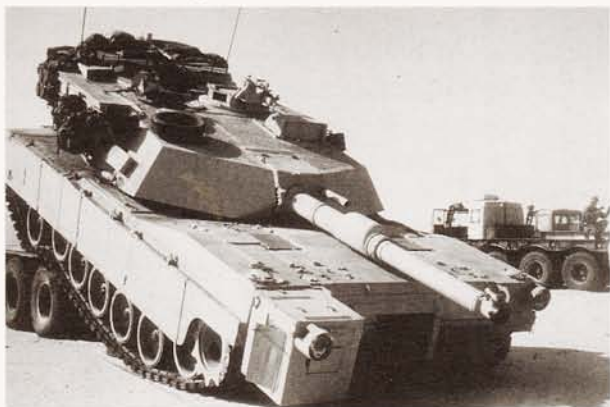
An M1A1 Abrams being off-loaded during the roll-over programme before Desert Storm. This vehicle shows several interesting details

including the external APU and the additional access doors on the engine deck roof, characteristic of the M1A1. (US Army)

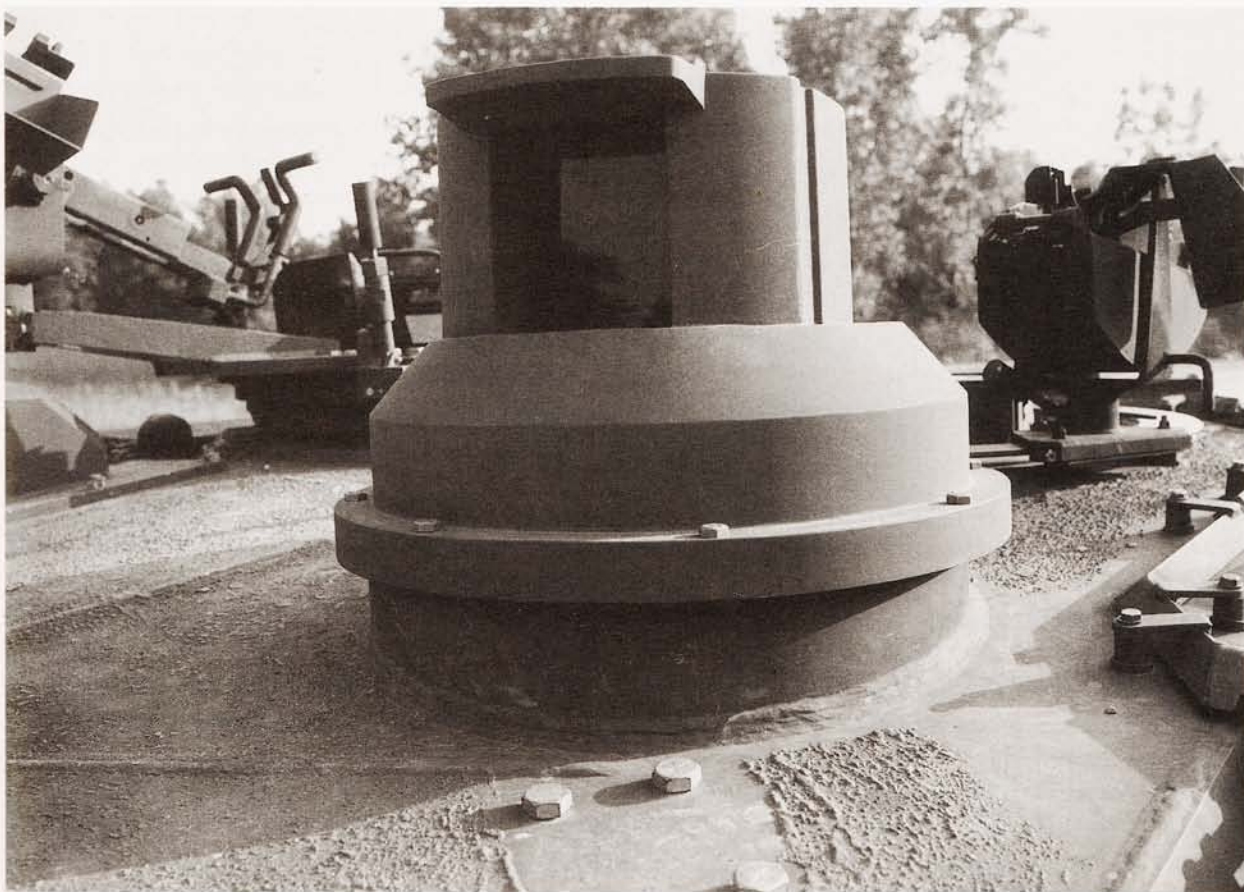
The CITV Commander's Independent Thermal Viewer on the M1A2 gives

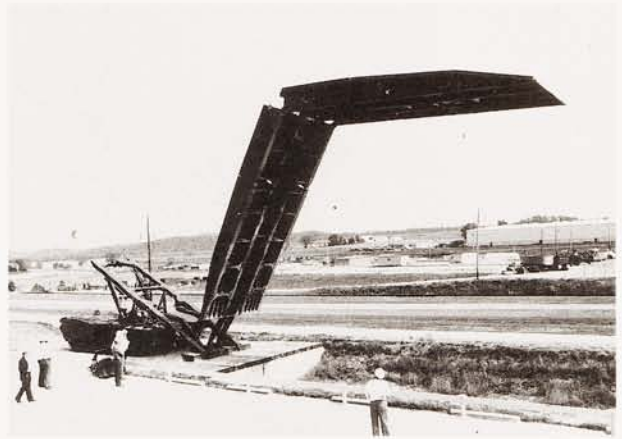
The first version of the Heavy Assault Bridge on the M1 chassis, developed by BMY, entered tests in 1984 as is seen here. The army later decided a

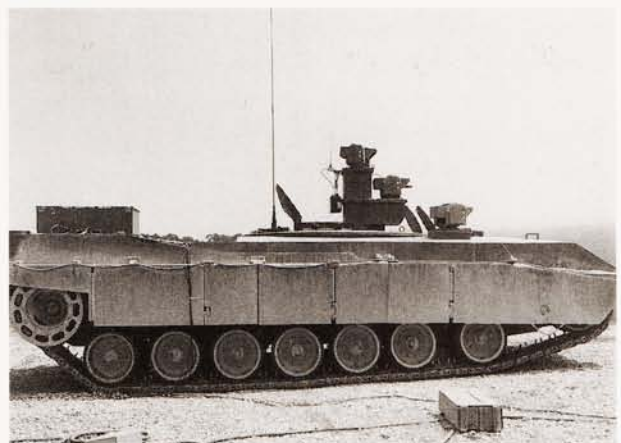
One of the odder M1 variants was the SRV surrogate research vehicle. This vehicle tested new tank vision devices in
