M1 ABRAMS

MAIN BATTLE TANK

1982-1992

M1 ABRAMS MAIN BATTLE TANK

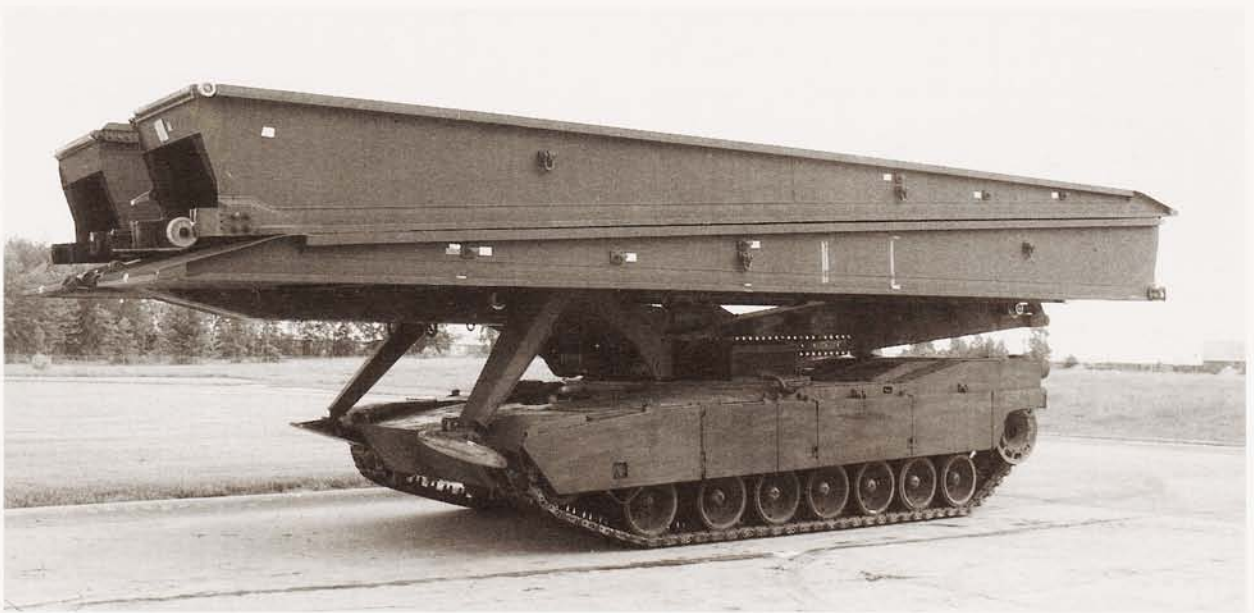
The second bridging version of the M1 Abrams developed by General
