# T-34/76

## MEDIUM TANK

### 1941-1945

# T-34/76 MEDIUM TANK

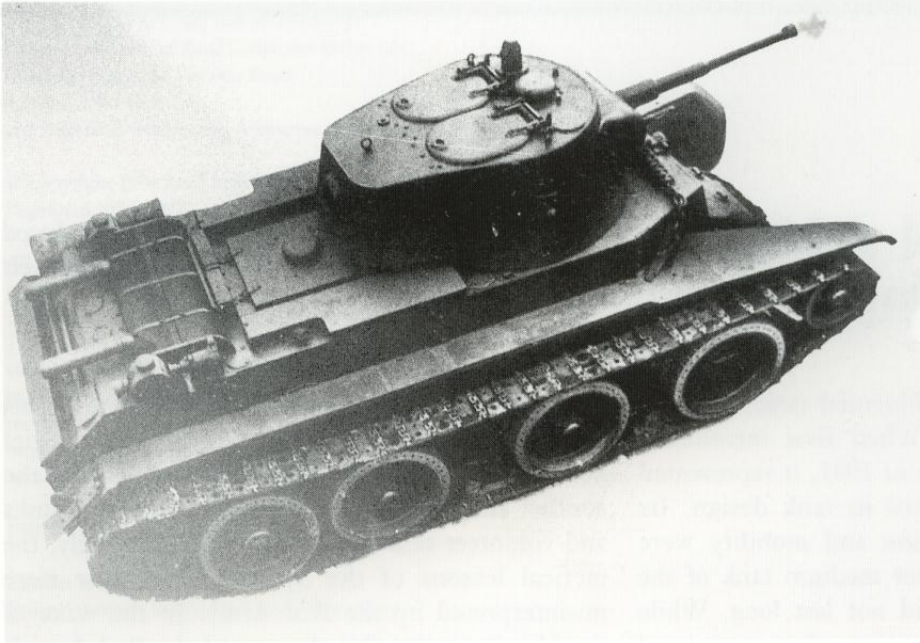
*The A-8 was the final member of the BT family produced. It was powered by the new Trashutin V-2 diesel engine. It was called the BT-7M in Red Army service, though it is sometimes called BT-8 due to its experimental designator.*

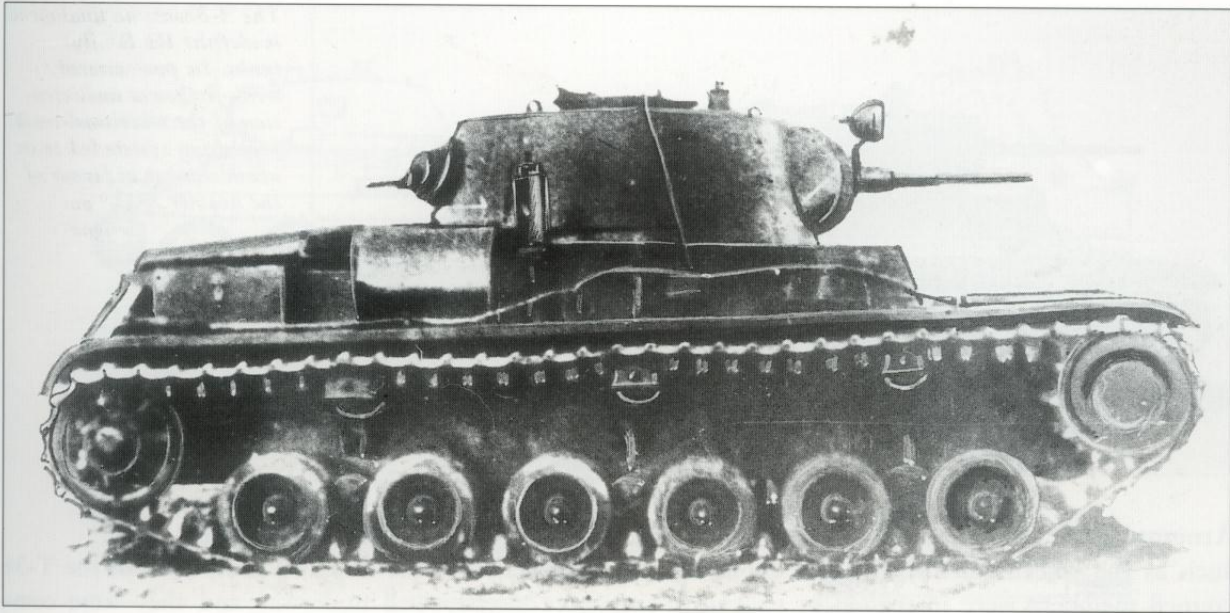
*The T-46-5, also known as the Izdeliye 111, was the first Soviet tank with 'shell-proof' armour. Although*

*better armoured than the BT tank, it did not prove successful enough for series production.*

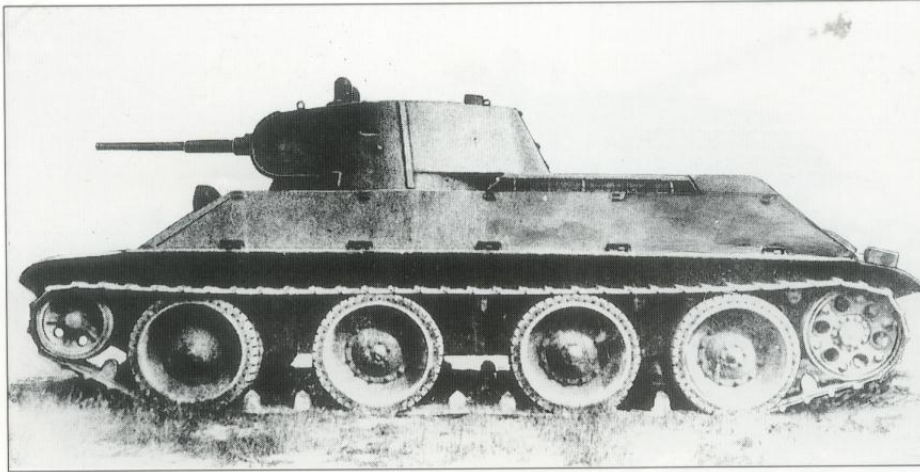
*The A-20 was an attempt to modernise the BT fast tanks. Its poor armour, weak firepower and retention of the wheel-and-track propulsion system led to its abandonment in favour of the heavier A-32.*

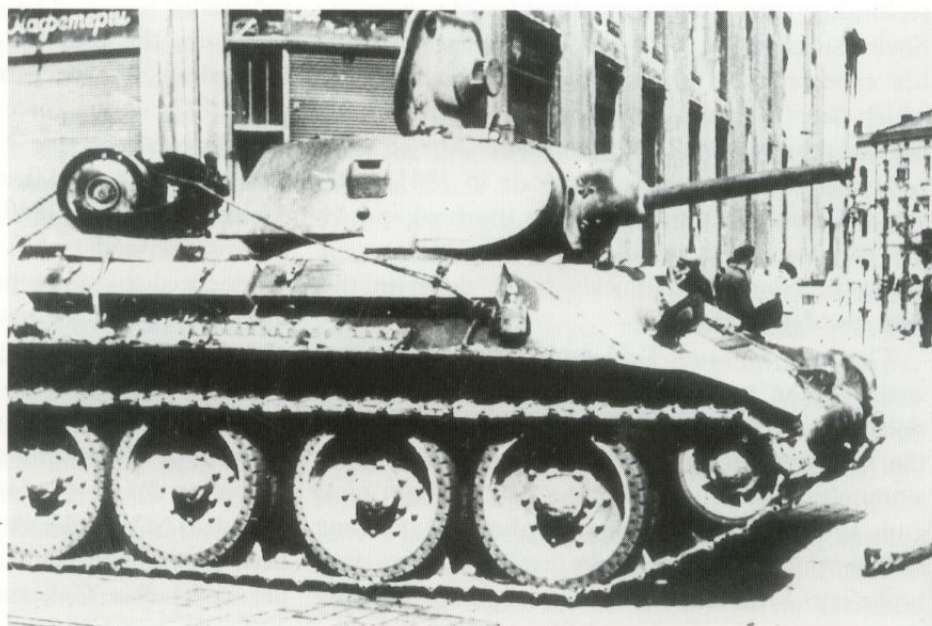
*A T-34 Model 1940 of Vlasov's 4th Mechanised Corps, abandoned on the streets of Lvov in western Ukraine in June 1941. Strapped to the back engine deck is a spare transmission, a reminder of the teething problems suffered by the new machines. (US National Archives)*

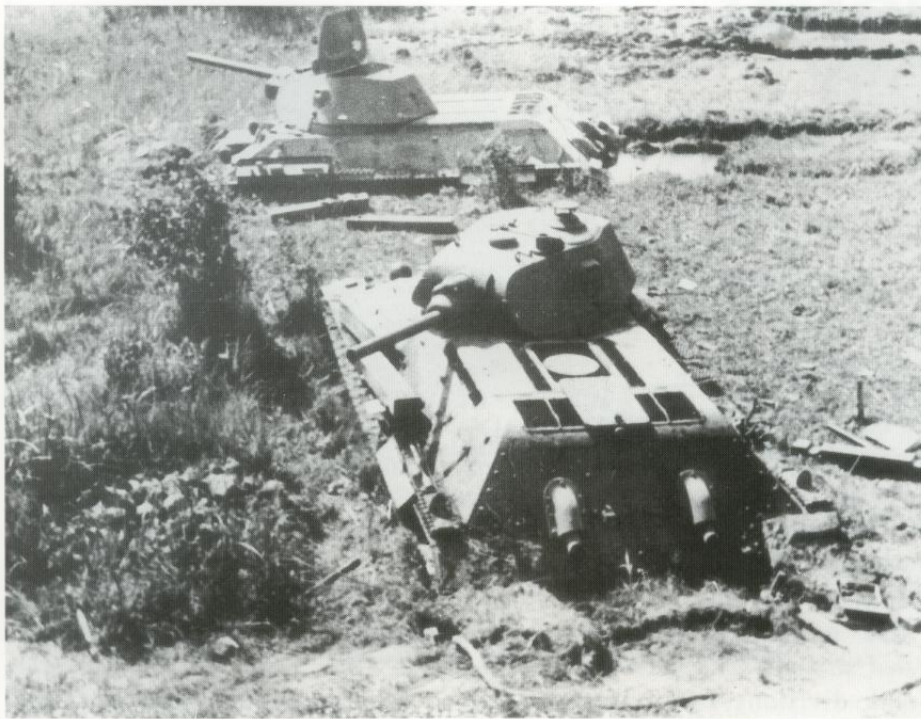
*An all too frequent fate of the T-34s during Operation 'Barbarossa' is seen here. This T-34 Model 1940 and T-34 Model 1941 in the background were lost in July 1941 when they were driven into the Toloshchin marsh near the Drut river east of Borisov in Byelorussia. (US National Archives)*

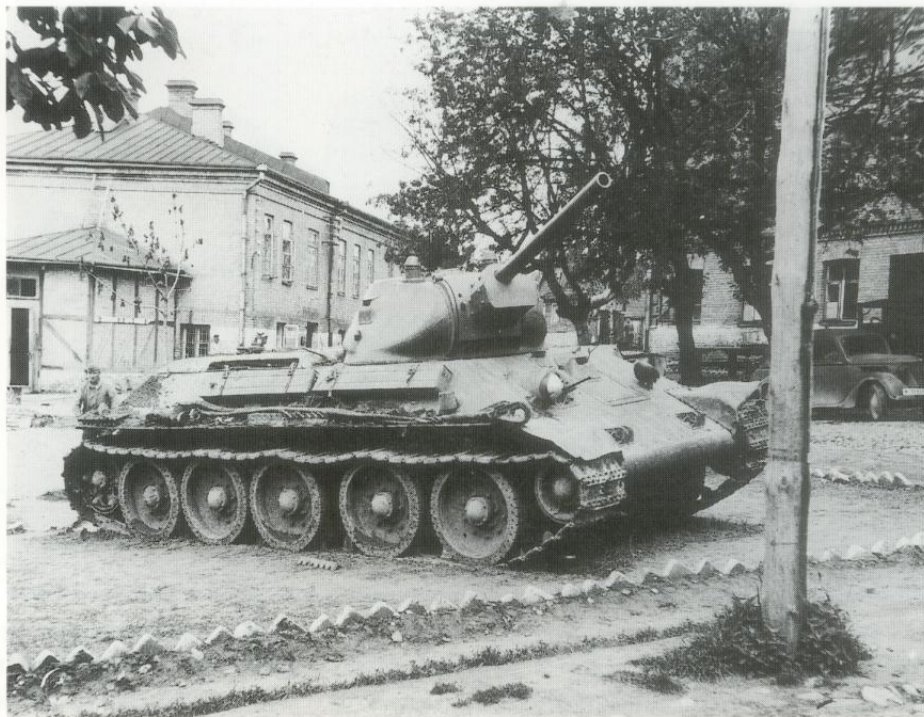
*A factory fresh T-34 Model 1941 abandoned in Ukraine in the summer of 1941. The T-34 Model 1941 was fitted with the improved F-34 76.2mm gun. This particular vehicle is fitted with one of the new cast turrets which entered production shortly before the war began. The containers on the hull side are for fuel.*

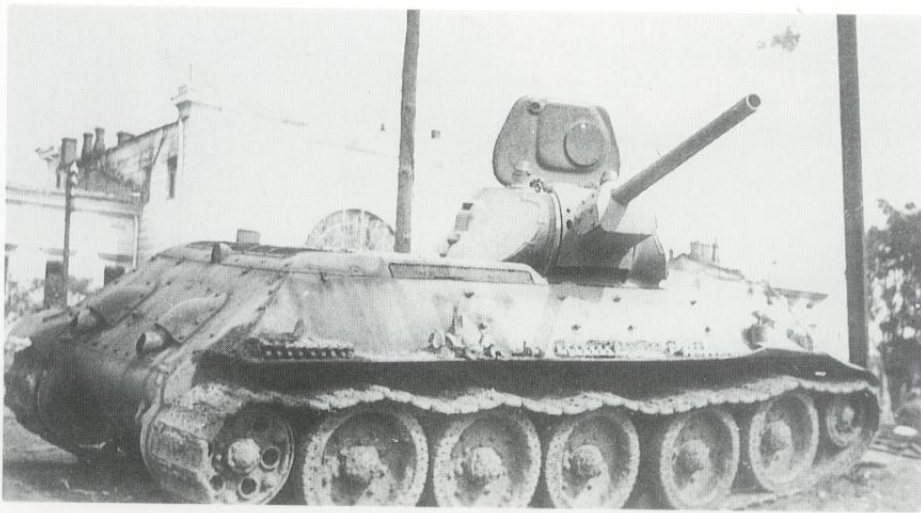
*A T-34 Model 1940 abandoned at Vinnitsa in western Ukraine following the Dubno-Brody tank battles at the end of June 1941. Small numbers of T-34s survived these battles, but many were abandoned due to breakdowns and lack of spare parts.*

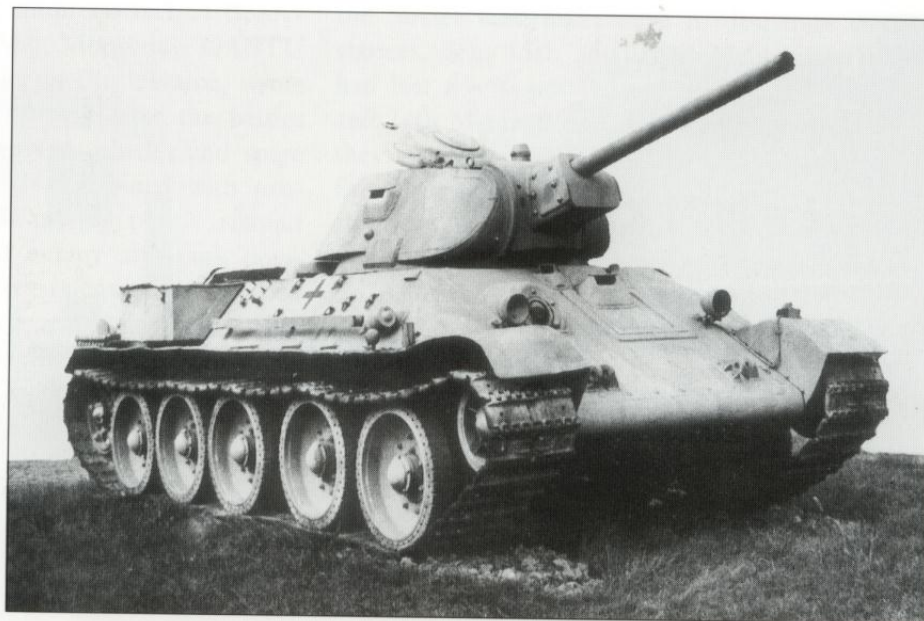
*The earliest surviving example is this T-34 Model 1941 preserved at Aberdeen Proving Ground in the United States. Captured by the Wehrmacht in 1941, it was used for training in France where it was captured by the US Army in 1944. So far as is known, no T-34 Model 1940 still exists.*

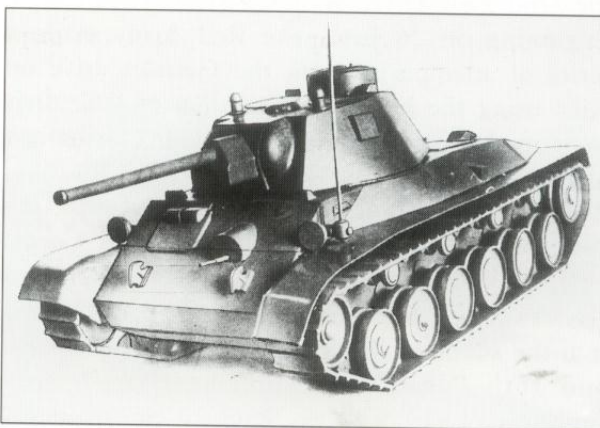
*It was planned to halt T-34 manufacture in the autumn of 1941 in favour of the T-34M. After the war broke out, the programme was abandoned over concern that it would disrupt vitally*

*needed tank production. As is evident from this model, the T-34M would have corrected one of the main shortcomings of the T-34 – its two man turret.*

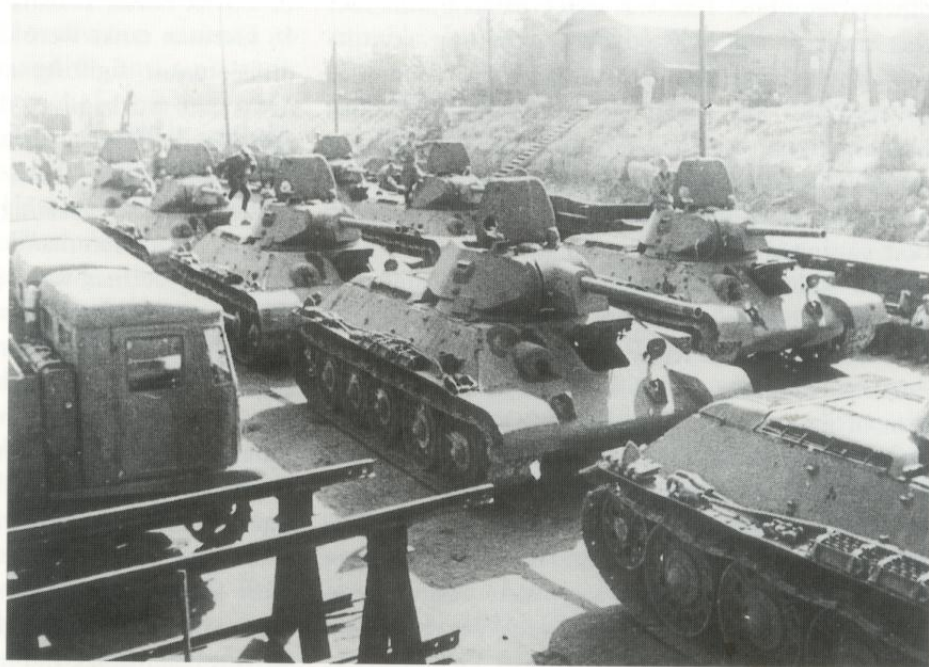
*The transfer of the Kharkov Locomotive Works to Nizhni Tagil put the burden of T-34 production on the Stalingrad Tractor Plant (STZ). Here, T-34 Model 41/42s sit in the marshalling yard outside the STZ plant while awaiting rail shipment to the front.*

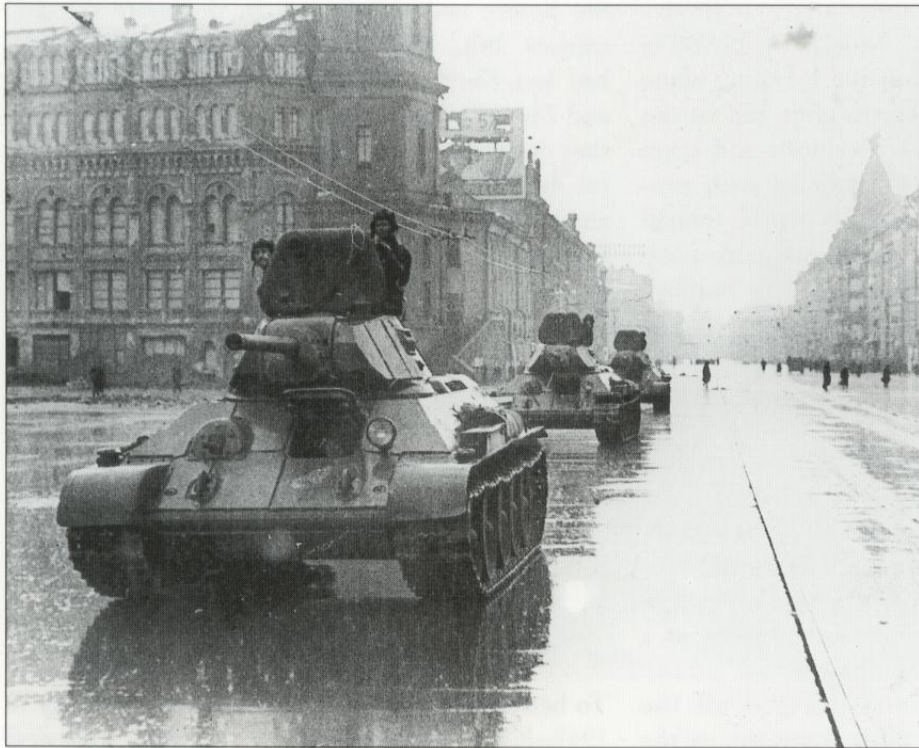
*The STZ T-34s had many small differences from those at other factories, including the use of an interlocked glacis plate. These T-34 Model 41/42 tanks were rebuilt by Zavod No 27 in Leningrad with additional armour plate to better protect them against newer German anti-tank guns. Surprisingly, these were still in service at Leningrad in June 1944. (Sovfoto)*

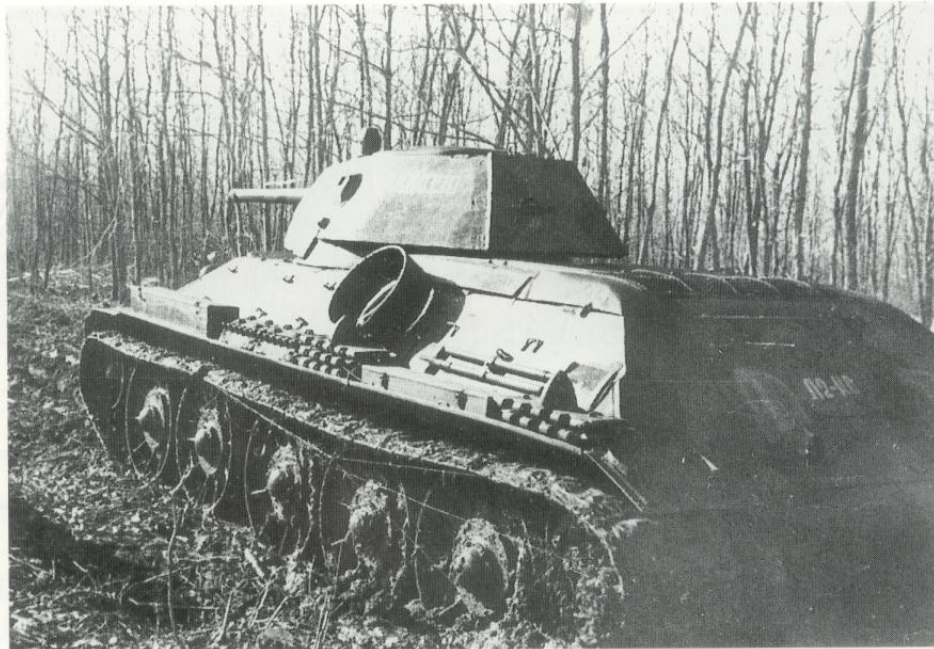
Another of the changes introduced at the Stalingrad Tractor Plant in late 1941 was this modified turret which had a simple flat plate at the rear, without the usual rounded corners, to expedite production. This particular tank is named after Ordzonikidze, a popular Bolshevik leader from the 1930s.

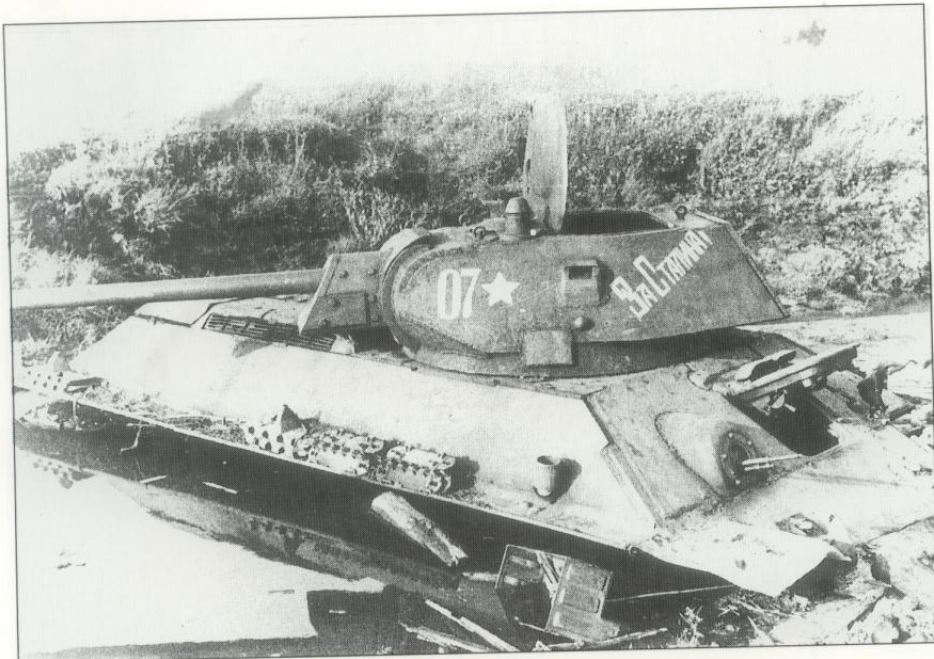
*A T-34 Model 41/42 abandoned in a river during the summer of 1942. Note the features of this interim model produced at the Stalingrad Tractor Plant: the new pattern driver's hatch, the interlocked glacis armour, the chisel-shaped gun recuperator housing, the undercut turret front and the flat turret rear plate.*

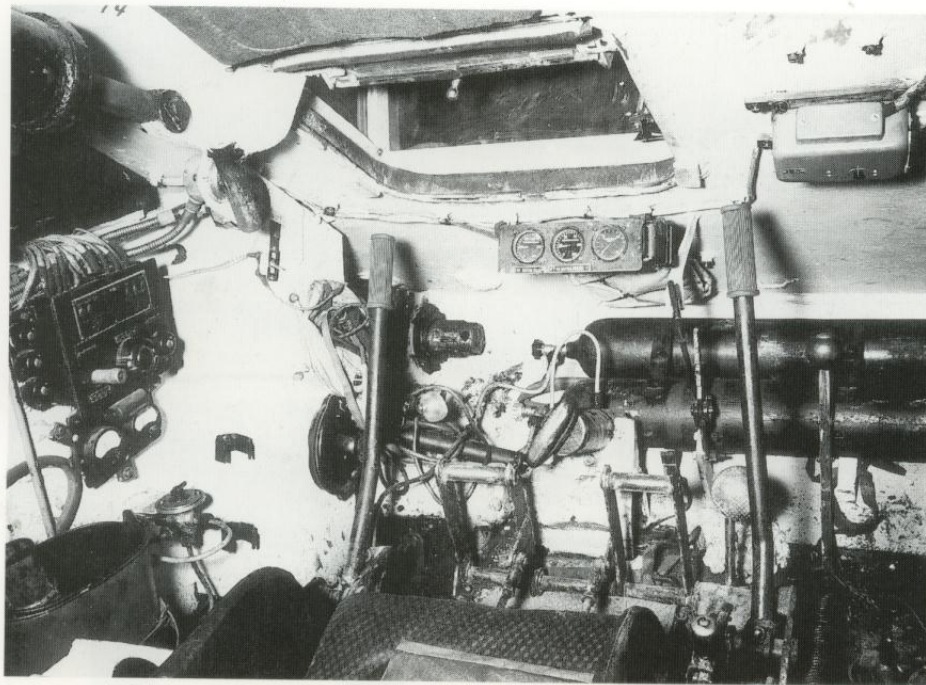
*A view inside the driver's station of the T-34 Model 1942. The T-34 had few frills, and used elementary driving controls. The two compressed air bottles in the nose are to help start the engine in cold weather.*

box were close together. T-34 drivers frequently kept a small mallet nearby to help move the controls when they jammed up. At the driver's feet was a pair of compressed air bottles. These were used to help start the diesel engine in particularly cold weather. Features such as this enabled the T-34 to operate in winter, when German tank crews found it extremely difficult to even start their tanks.

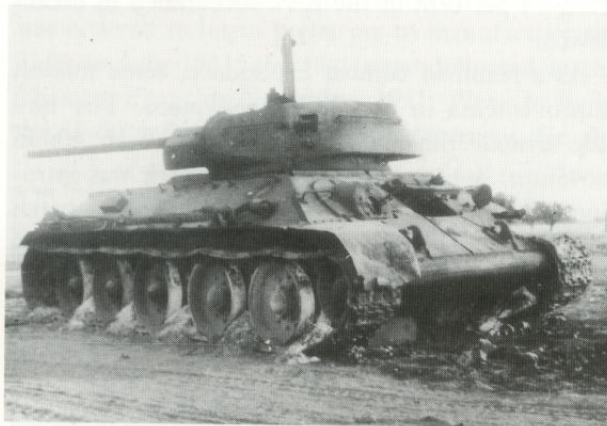
*The T-34 Model 1942 was a simplified version of the Model 1941, introducing a new pattern of tracks, new driver's hatch and many other small features. This is a T-34 Model 1942 knocked*

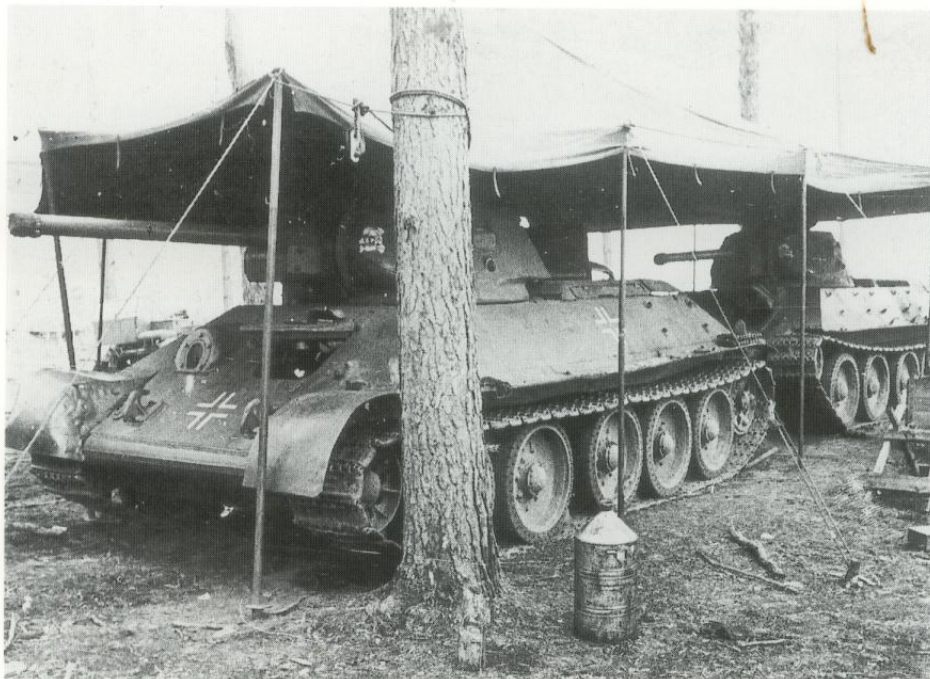
The Germans made limited  
use of the T-34 as this  
photo of two tanks of the  
3.SS-Panzer-Division  
'Totenkopf' in September  
1942 attests. The lead vehi-  
cle is a T-34 Model 1942  
with the simplified fittings,  
while the vehicle behind is  
a T-34 Model 1941.

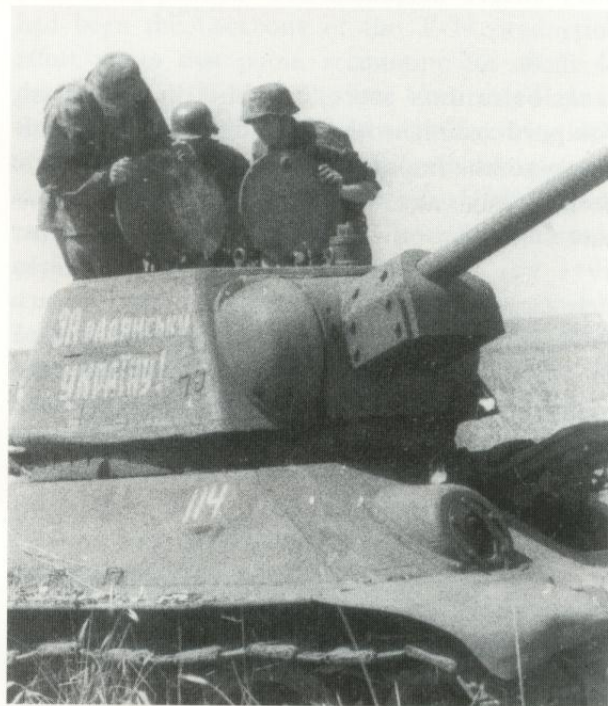
The T-34 Model 1943 introduced a new hexagonal turret and was produced in small numbers in the spring of 1942. This is a particularly early example, lacking the later armoured mantlet for the hull DT MG and

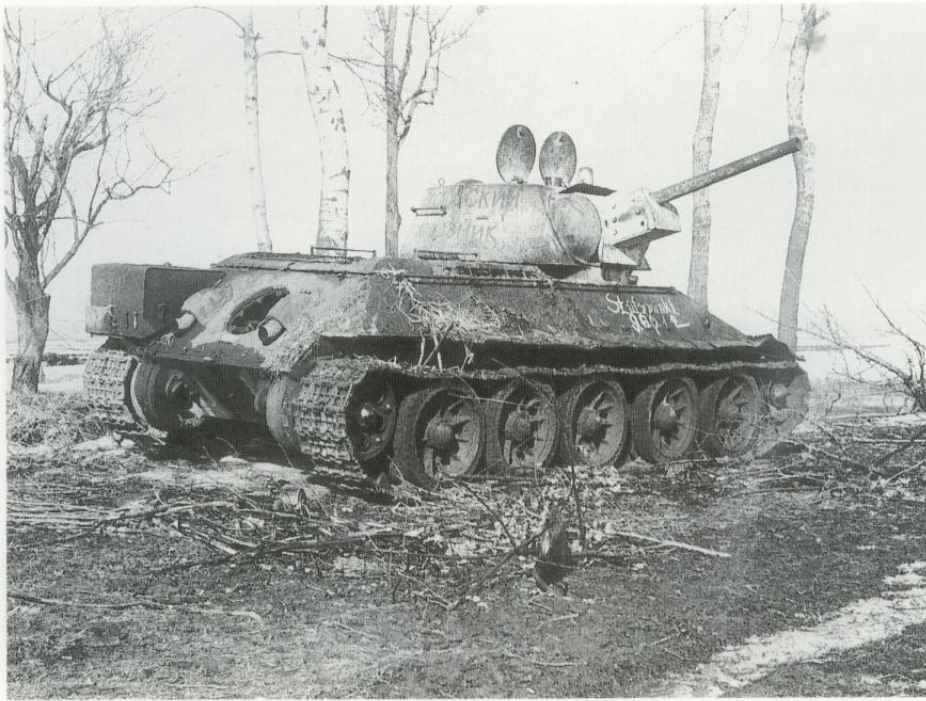
*In the autumn of 1942, T-34s began to be fitted with external 40-litre fuel containers on the hull rear. This particular T-34 Model 1943, named 'Moskovskiy Khokolznik', appears to have had its right side container knocked off in combat. (National Archives)*

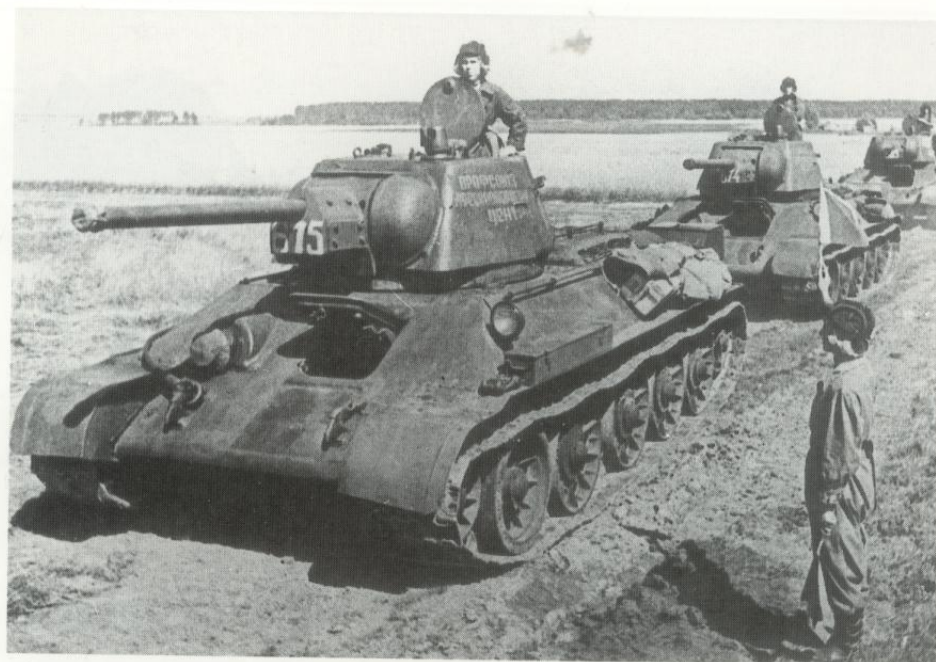
*A fine example of a typical 1943 production machine. This T-34 Model 1943 has the hexagonal turret, the hull MG mantlet, and the mid-war infantry hand-holds. The slogan on the turret side is 'From the Trade Union of the Co-Operative Centres'.*

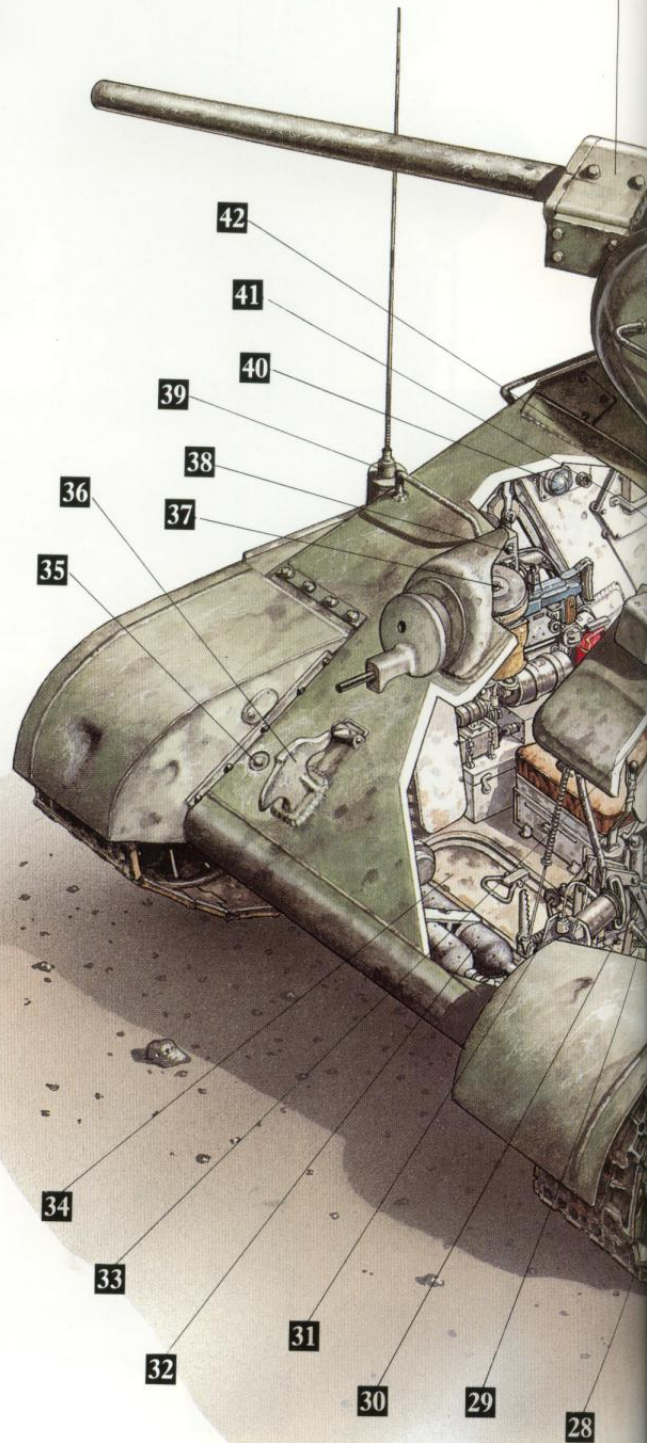
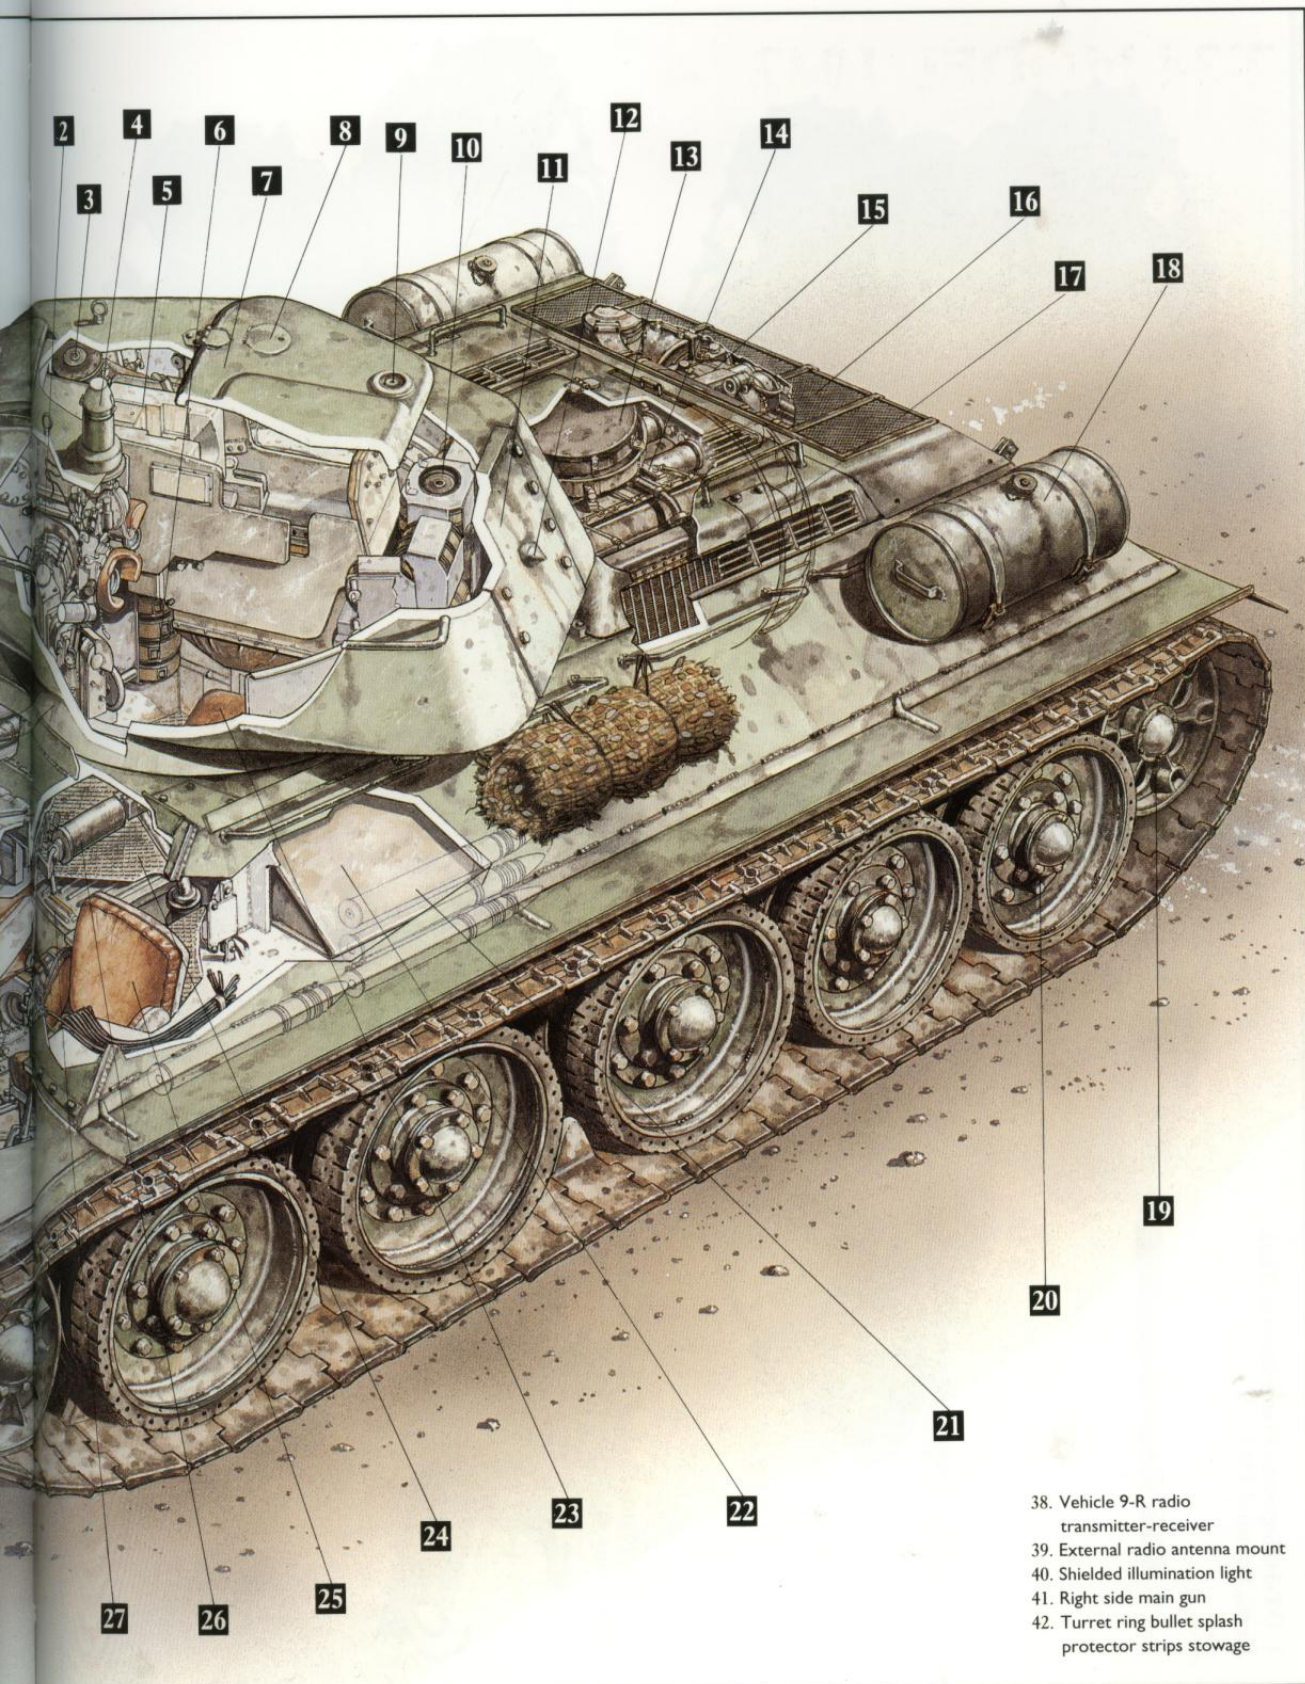
# T-34 MODEL 1942

| 20. Main road wheel | |

- 38. Vehicle 9-R radio transmitter-receiver
- 39. External radio antenna mount
- 40. Shielded illumination light
- 41. Right side main gun
- 42. Turret ring bullet splash protector strips stowage

**D** L'intérieur du T-34 était relativement simple à cause de l'absence d'une nacelle de tourelle. Le compartiment de combat était complètement ouvert entre l'avant de la caisse et la zone de la tourelle. A l'avant de la coque le chauffeur/mécanicien était assis à gauche et le MG/opérateur radio à droite. A part neuf cartouches se trouvant sur les côtés de la coque, les munitions de 76,2mm étaient stockées dans des caisses métalliques sur le sol de la coque. L'intérieur de la tourelle était peint en blanc brillant et certains éléments étaient laissés en acier brut. Le compartiment du moteur possédait trois éléments principaux : le diesel V-2 flanqué de radiateurs, un ventilateur circulaire et la boîte à vitesses et le système de freinage.

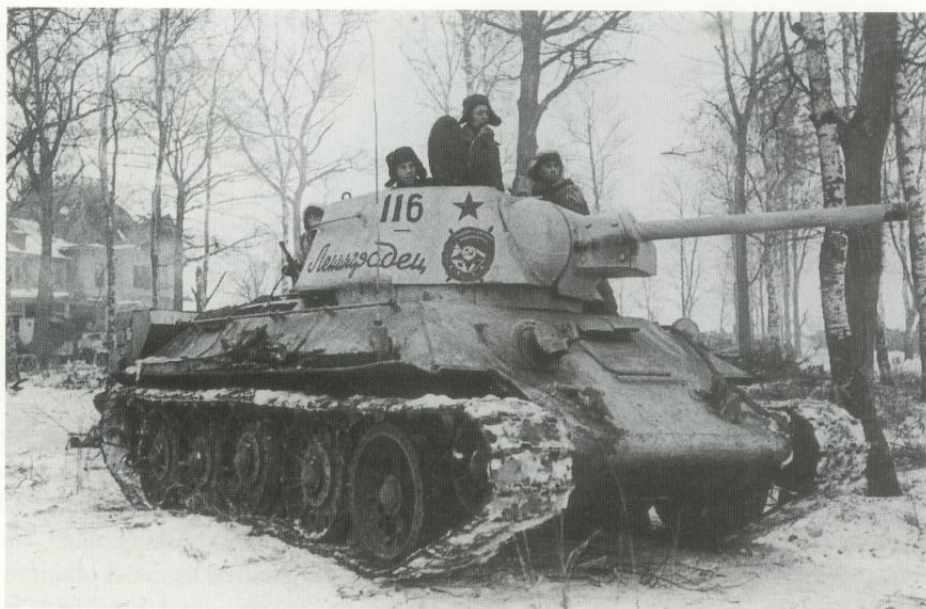
Another T-34 Model 1943 from the 30th Gds. Tank Bde. near Krasnoye Selo during the battles to relieve the siege of Leningrad. This tank has the later style 40-litre fuel cells on the rear. Besides its name 'Leningradets', the tank is also decorated with the Order of the Red Banner. (Sovfoto)

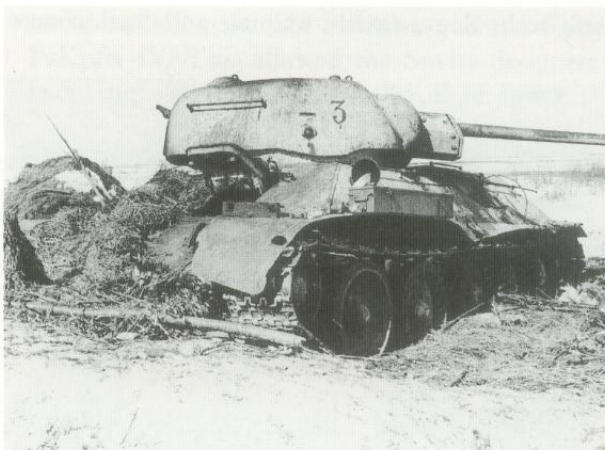
*There was considerable variation in the turrets of the T-34 Model 1943s due to the large number of factories involved in their manufacture. The Uralmash Plant in Sverdlovsk used a special forge to manufacture turrets*

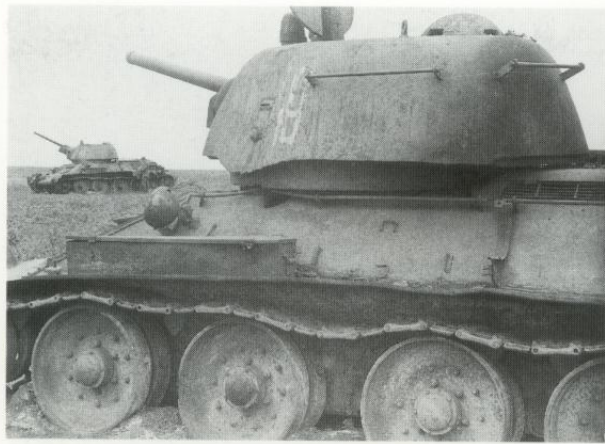
*A good example of the Uralmash turret on a T-34 Model 1943 knocked out during the summer of 1943.*

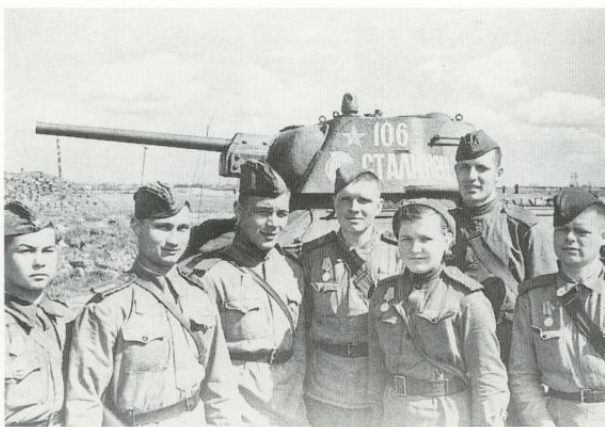
*The T-34 Model 1943 was the most common variant in service in the pivotal battles in the Kursk-Orel bulge in July 1943. This tank, named 'Stalinets', served with the 30th Guards Tank*

*Brigade. It was credited with eight tank kills when this photo was taken in the autumn of 1942. The female NCO is probably a medic; women tank drivers did not become common until 1943.*

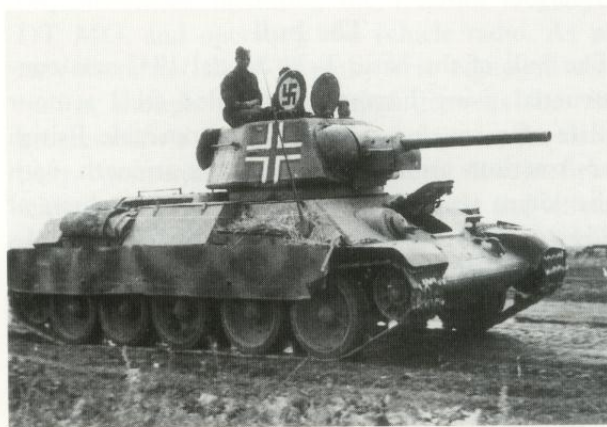
T-34 tanks were employed in small numbers by the Wehrmacht on the Eastern Front. This T-34 Model 1943 served in Romania in 1944. Visible modifications

include a German radio aerial, side skirts, note driving light and new stowage bins. (US National Archives)

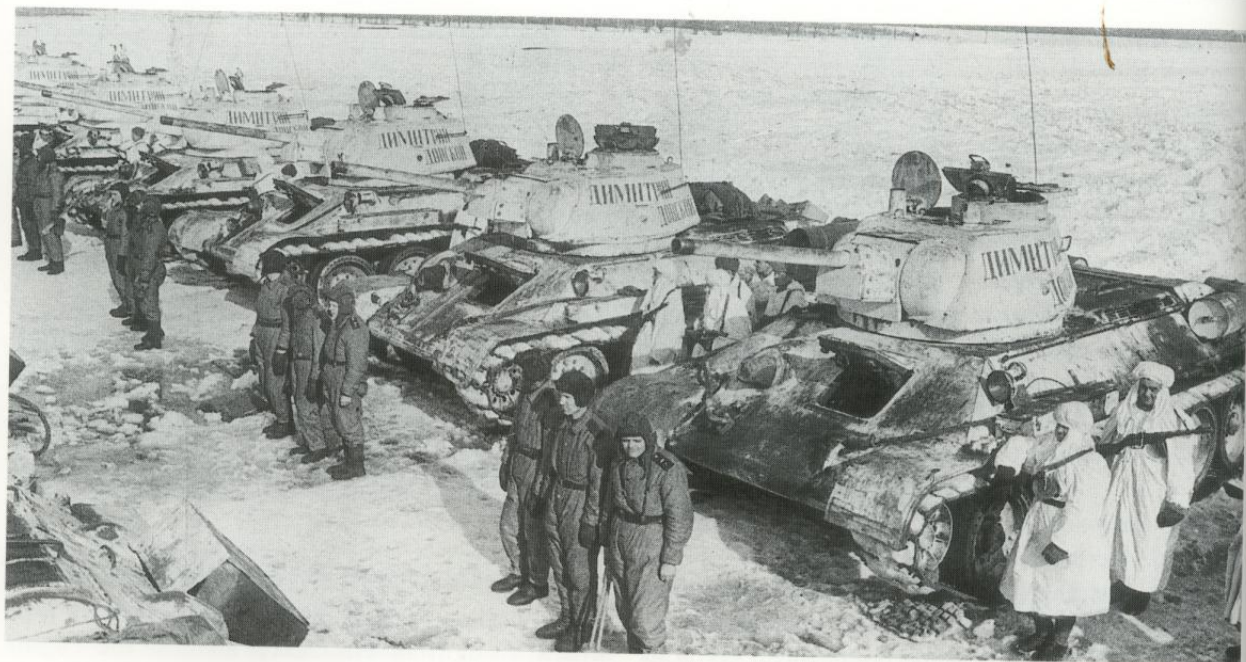
*The OT-34 flamethrower tank resembled the normal version, but had a flamegun in place of the hull MG. The other distinctive feature is the location of the radio aerial pot at the rear of the*

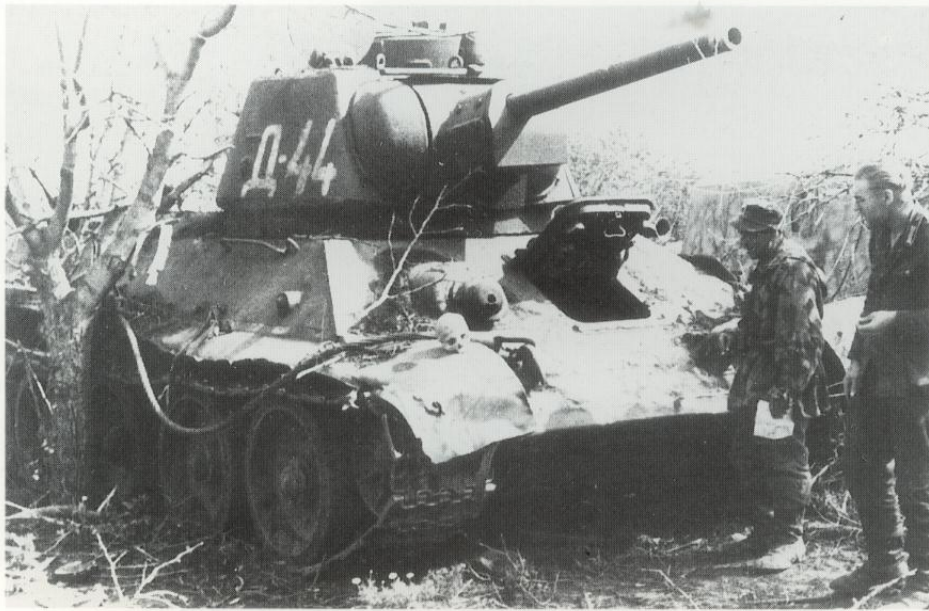
*An OT-34 flamethrower tank knocked out in 1944. Aside from the flamethrower head fitted on the hull front in place of the usual defensive MG, this version had the right hull radio socket plugged since the radio was moved into the turret rear. This is a late production tank, probably from 1944, with the angled hull front and late pattern hand-holds.*

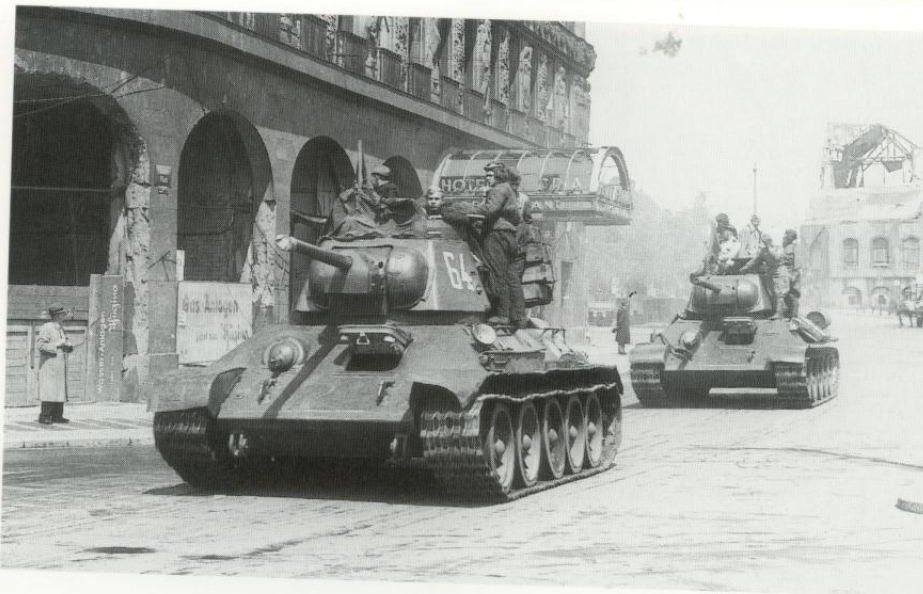
*Although T-34 Model 1943 production ended in 1944 with the advent of the T-34/85, examples of the type remained in service until the end of the war and for some time afterwards. Here a pair of late production vehicles drive through Leipzig, Germany, in July 1945. In 1943, the T-34 Model 1943 was modified by the addition of a commander's cupola and the substitution of cylindrical fuel tanks for the earlier 40-litre containers. (US Army)*

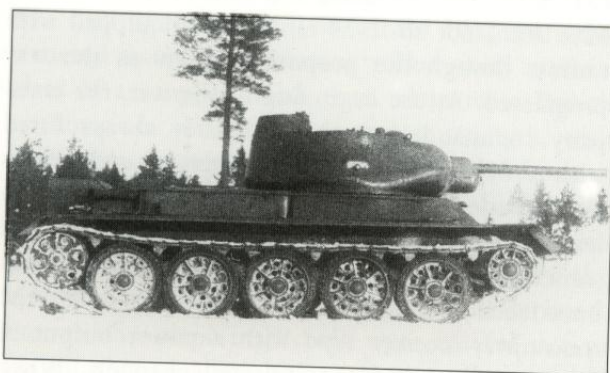
*A second attempt to replace the T-34 was undertaken in 1942, under the designation T-43. Although closely resembling the T-34, it used torsion bar suspension,*

March 1943. The T-43 prototypes underwent extensive road tests at Kubinka where it became evident that the heavier armour significantly decreased mobility in comparison with the T-34. No serious thought was given to series production of the T-43 as the upcoming summer campaign required all resources to be directed towards maximum production. The summer battles in the Kursk-Orel salient, followed by the Soviet counter-offensive, made it clear that the main failing of the T-34 was its gun, not its armour. As a result, a crash programme was begun to arm the T-34 with a new 85mm gun. (The full story of this variant, the T-34/85, will be covered in a subsequent New Vanguard.) As a result, the T-43 was dropped.

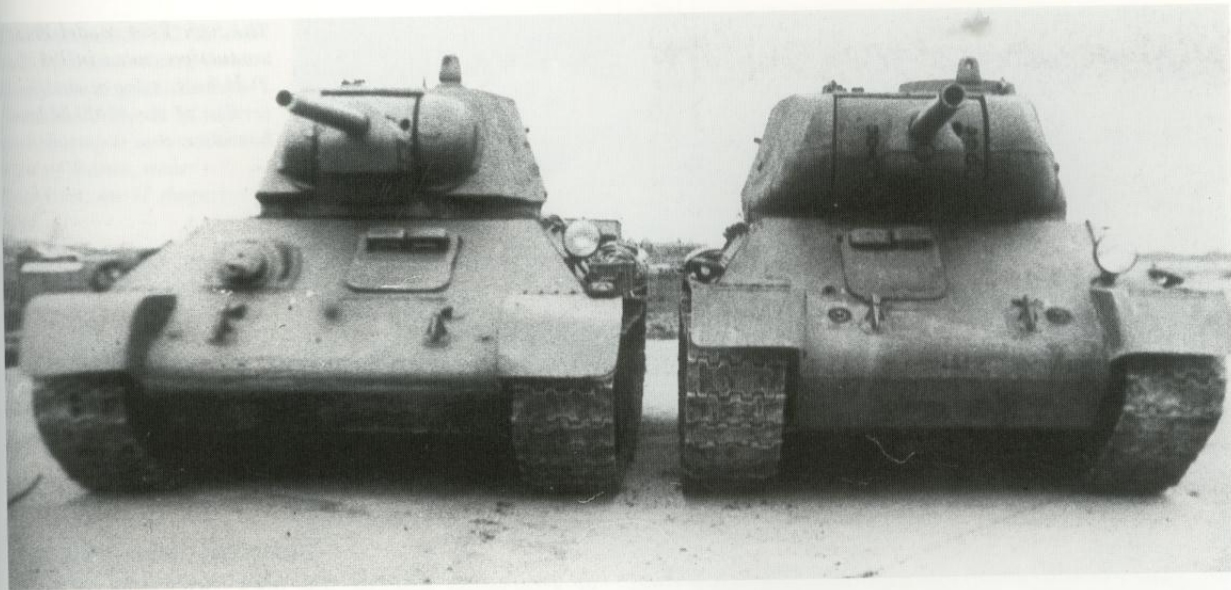
*A comparison of the T-34 Model 1943 and the T-43. The larger size of the T-43 turret allowed a third crewman to be carried, a feature*

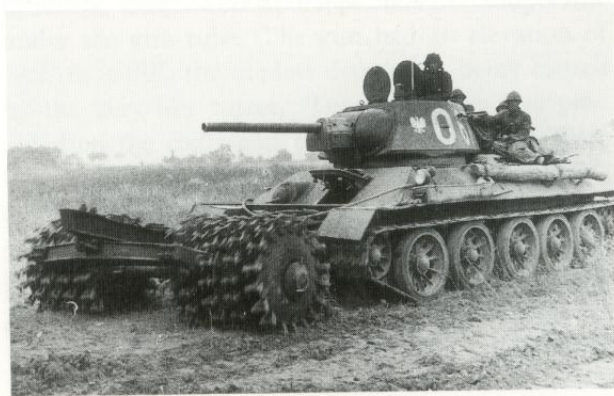
*The PT-34 was a mine-roller tank fitted with the PT-3 mine tawl. This particular tawl, a T-34 Model*

sets of mine rollers. At the same time, additional units were being trained and organised at Tula. Some experiments were conducted using Lend-Lease tanks as well, including Shermans and Churchills. In combat, not all the PT-3 rollers were used at the same time. A portion of the T-34s in the unit would be left without them to provide fire support. The rollers could generally withstand five to ten detonations of anti-tank mines, after which they would have to be replaced. The 166th OITP continued to see extensive use including the offensive operations during the Dnepr river crossing and liberation of Kiev in the autumn of 1943.

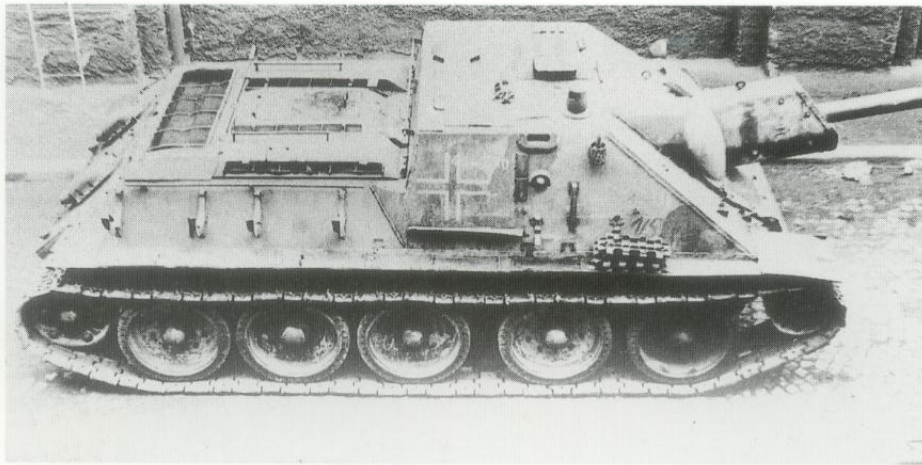
*The SU-122 was a medium assault gun mounted on the T-34 hull, using a modified version of the M-30 122mm howitzer.*

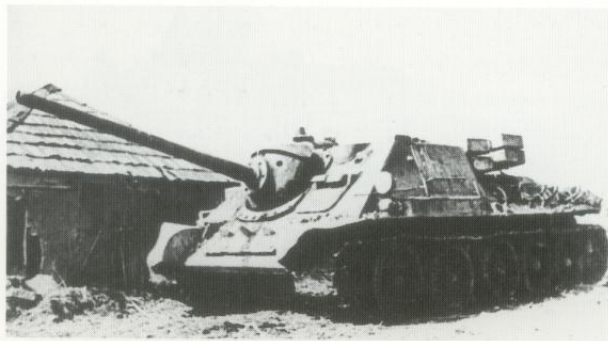
*The SU-85 tank destroyer was the most successful variant of the T-34. Entering service in 1943, it was one of the few Soviet*

The capture of a damaged German Tiger I heavy tank in the Leningrad area in January 1943 came as a rude shock to the Red Army. The new tank was so thickly armoured that it could not be knocked out by the F-34 and ZIS-5 guns mounted on the T-34 and KV. As a result, a crash programme was begun to develop a tank destroyer suitable for combating the Tiger. Trials against the captured Tiger indicated that the only existing guns capable of penetrating it were the 85mm anti-aircraft gun and the 122mm A-19 corps gun. The design bureau under Gen. F.F. Petrov was assigned the mission of developing an armoured vehicle gun based around the ammunition used in the standard 85mm anti-aircraft gun. The resulting weapon, designated D-5S-85, was experimentally mounted on an SU-122 chassis by L. Gorlitskiy's team at Uralmash. Although the 85mm gun proved effective, the SU-122 gun mounting was not ideal as it lacked an adequate direct fire telescopic sight. A new ball mount with a TSh-15 telescopic sight was developed, and the superstructure was redesigned. The new configuration allowed 49 rounds to be carried, and the SU-85 was ready for production in August 1943. The SU-85 was deployed in two different organisations. The separate self-propelled battalions were equipped with 12 vehicles, and assigned to army and front level commands for specialised missions. In addition, larger regiments were formed in the same fashion as the SU-122. These medium self-propelled regiments had four batteries, totalling 16 SU-85 and one T-34 command tank. The regiments were first deployed in mechanised corps to provide them with additional anti-tank firepower. In 1944, some SU-85 regiments were also attached to special anti-tank artillery brigades.
