# T-34/76

## MEDIUM TANK

### 1941-1945

# T-34/76 MEDIUM TANK

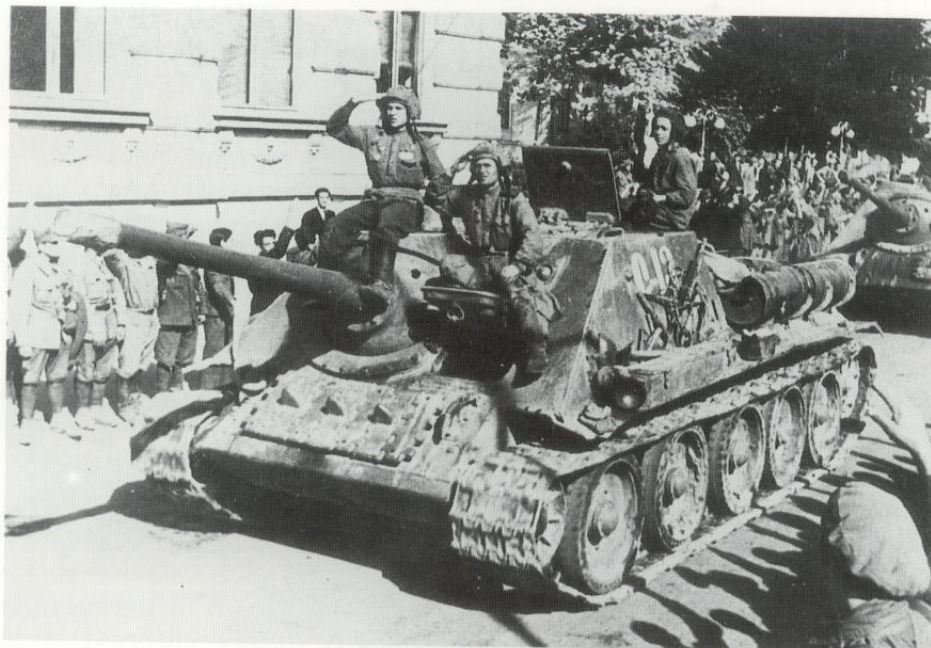
On 20 August 1944, the 2nd and 3rd Ukrainian Fronts launched an offensive into Romania. Here, a SU-85 tank destroyer enters the town of Bacau, near Bucharest, on 31 August 1944.

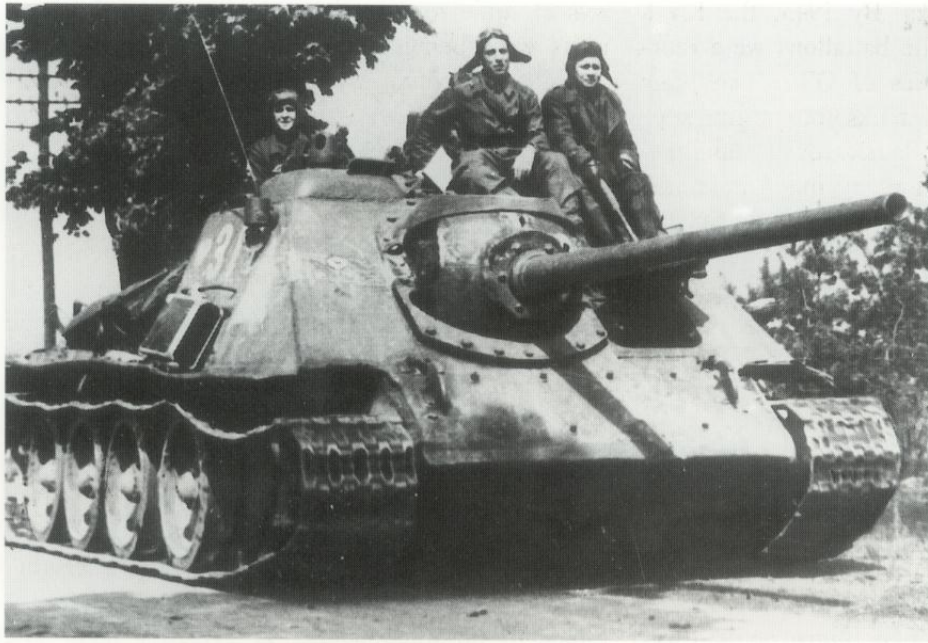
*The 13th Self-propelled Artillery Regiment of the Polish LWP took part in the Berlin campaign in April-May 1945. Notice that the vehicle has lost its front roadwheel, presumably to a land-mine.*

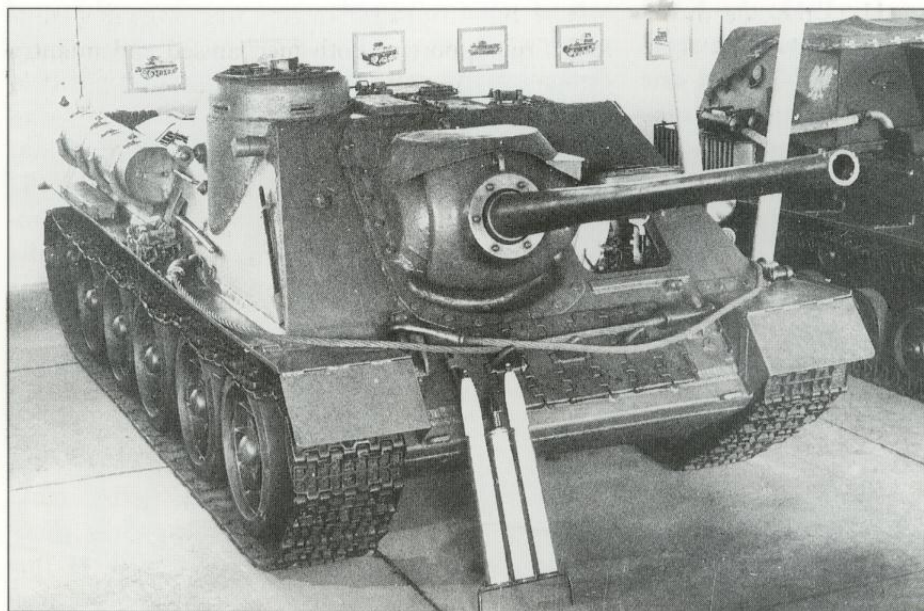
*The final production batch of SU-85 used the new superstructure developed for the SU-100. This was characterised by a new commander's cupola on the right side of the hull. (Janusz Magnuski)*

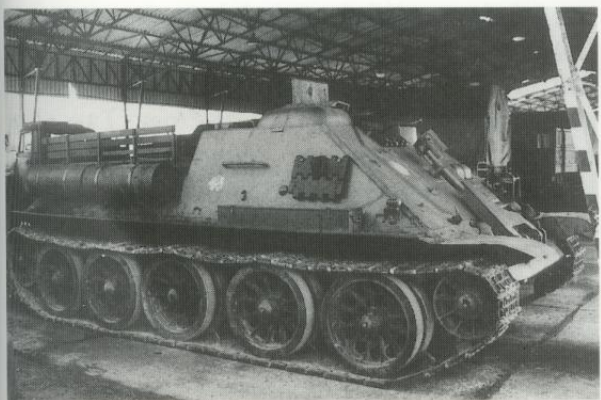
One of the last T-34 derivatives, an East German SU-85-T recovery vehicle still being used in 1990. Like most of the recovery vehicles based on the T-34 and

tures. A small number of T-34s were also converted to heavy duty cranes (SPK-5) in 1955. The SU-85-T conversions mostly took place at depot level and were not as extensive. Generally, the gun assembly and internal stowage racks were removed and the vehicles used mainly for towing or light repair. A few SU-85/Ts remained in use by the East German NVA army as late as 1990.
