The Restoration of a ‘Parts Set’ Eddystone S.940: Part 1 - Cleanup, Mechanical /Electronic Repairs and ‘Jump Starting’ – by Gerry O’Hara, G8GUH

The Eddystone ‘Stop Gap’ That More Than Made The Grade

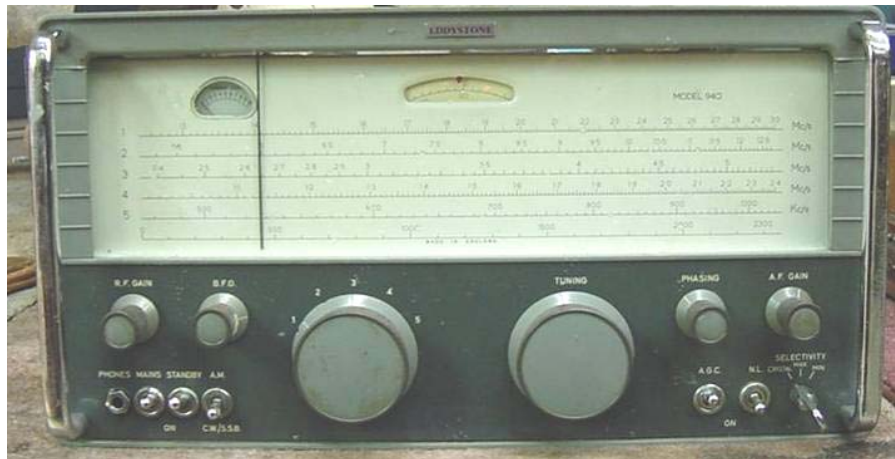
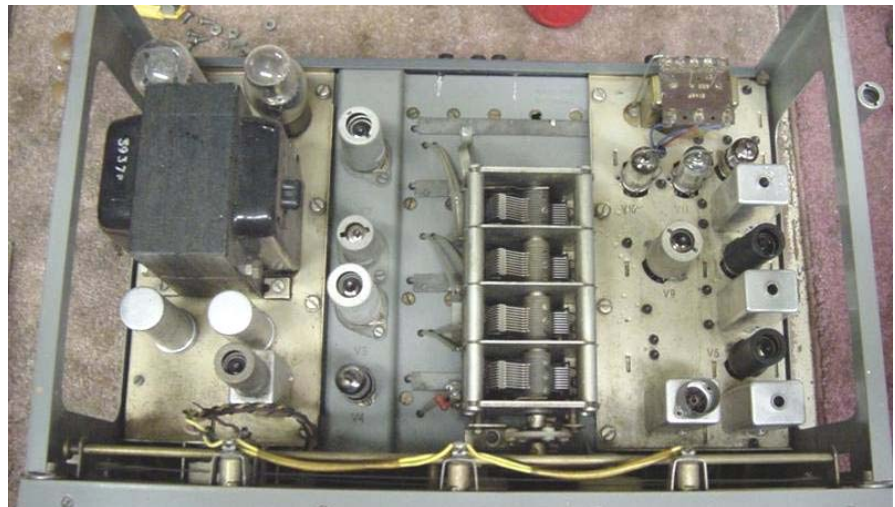
Before the mains transformer was donated to Pat’s S.750 and the BFO and dial lamp holder were removed

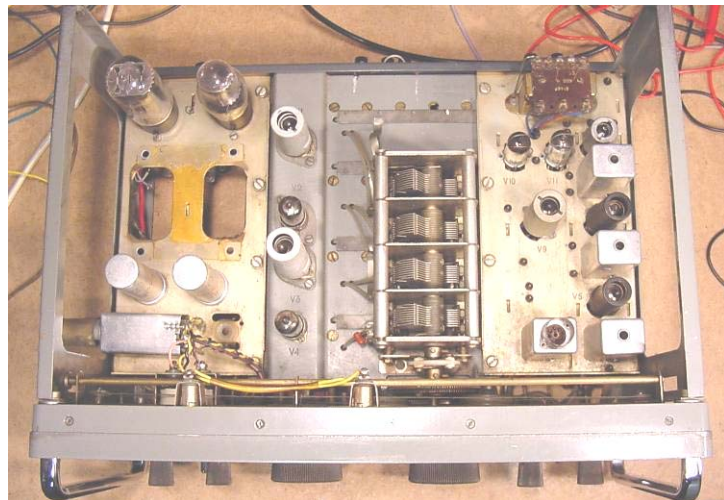
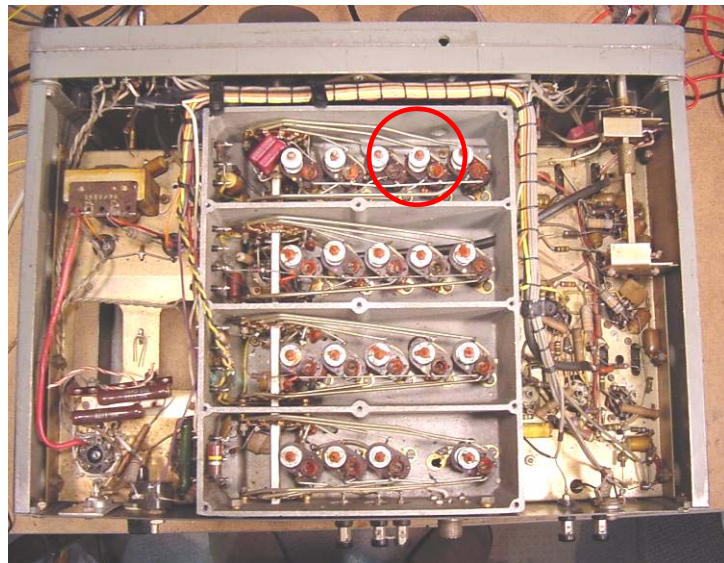
The S.940 on arrival at the G8GUH shack – spot the differences to the photos above...

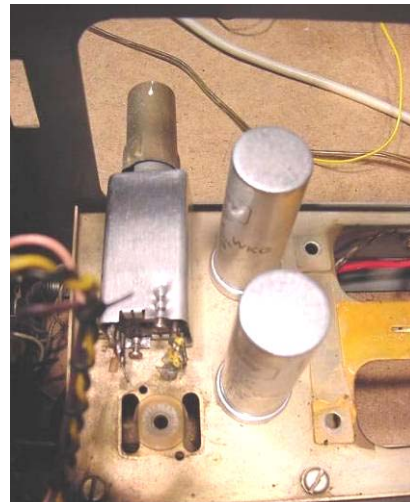
BFO unit on arrival – all present and correct but a bit detached (like me?)

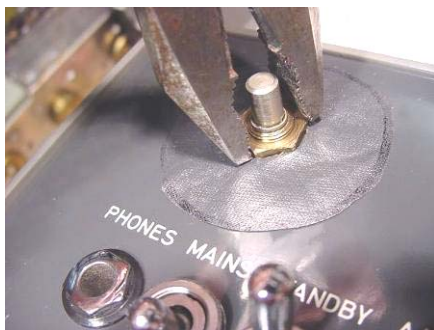
Removing the controls – note the oversized scratch guard

- Carefully removed all the retaining nuts from the controls using a Teflon scratch guard (see photo below) and prized the fingerplate away from the front panel casting. It was fixed at the centre using double-sided tape, the residues of which were carefully scraped away. Removed the small screws holding the BFO and crystal phasing controls in place.

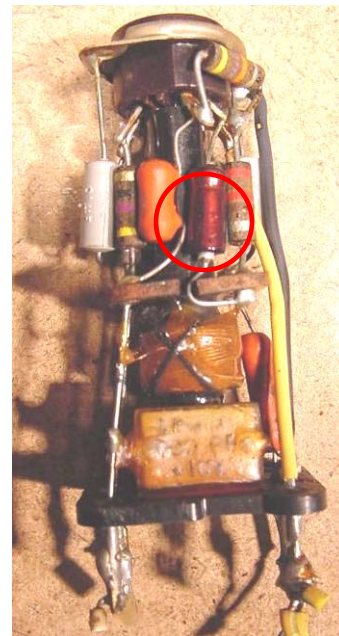
Inside the BFO unit – note C100 (10uf electrolytic) lurks in here (circled)

First I removed the can from the BFO unit and did some cursory component and pin-out checks before refitting it to the chassis and re-wiring into the circuit. While I had the opportunity I checked C72 (metallised paper heater decoupler) and found it to be leaky – replaced it (blue capacitor in photo, left).

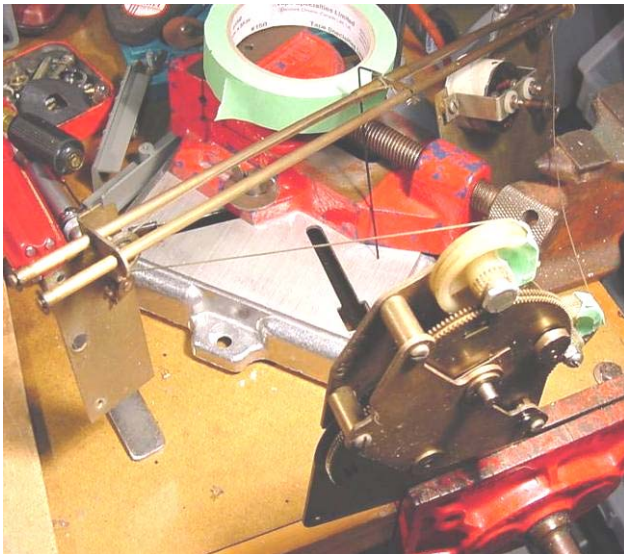
Gearbox in my bench vice for cleaning (note dial cord still attached and threaded through idler and jockey pulleys)

- I removed the round logging scale (vernier) dial plate from the gearbox front spindle (photo right) and placed the gearbox into a smooth-jawed bench vice and then painstakingly cleaned each tooth on each gear and pinion using isopropyl alcohol, a darning needle and Q-tips. I used lighter fluid to remove the more stubborn ‘gum’ and clean out the bearings. I found

that the gears were now freely-turning and I decided not to dismantle the gearbox totally, but to apply a light coating of high-quality light machine oil (not 3-in-One!) to each of the bearings and a smearing of molybdenum (‘moly’) grease to the parts of the brass gears that did not mesh with the plastic spool pulleys. I tried it out – much smoother now. The friction drive plate was cleaned using lighter fluid to remove any stray oil or grease, as was its mating surface on the tuning spindle.

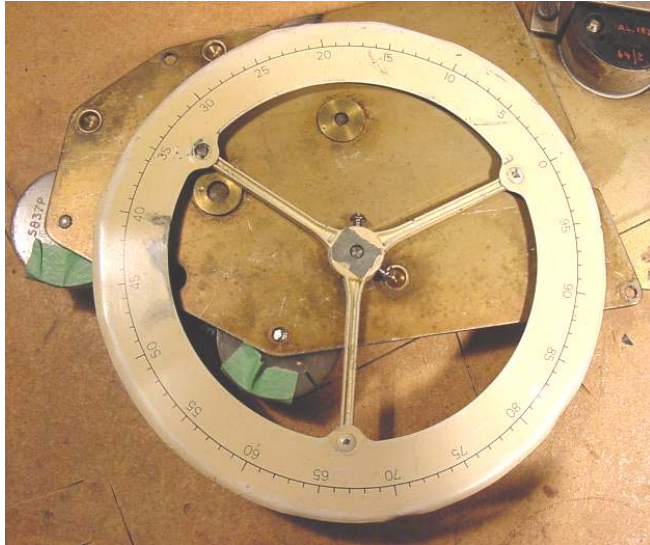
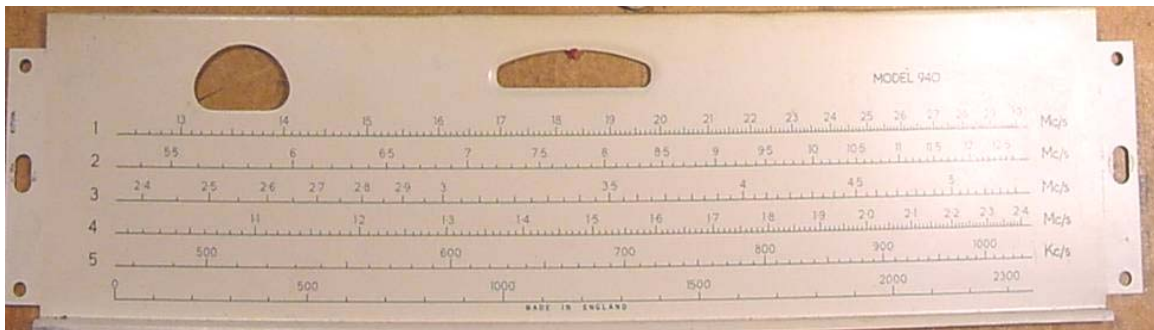
Vernier scale and main dial plate – the former looking a bit sad before cleaning...

- Cleaned the dial glass, dial plate and vernier dial using warm soapy water and cotton wool – these have very delicate markings (so be very gentle) – see photo above. The round vernier scale is constructed from a thin aluminium pressing attached to an alloy casting bushing and spokes. The metal pressing was very distorted and a considerable amount of care was exercised in trying to reproduce its original form (careful bending between fingers and checking by placing on a flat surface many times until it was deemed ok). Luckily most of the catching had been between the rear of the vernier dial and the front gearbox plate, thus preserving the vernier scale markings intact.

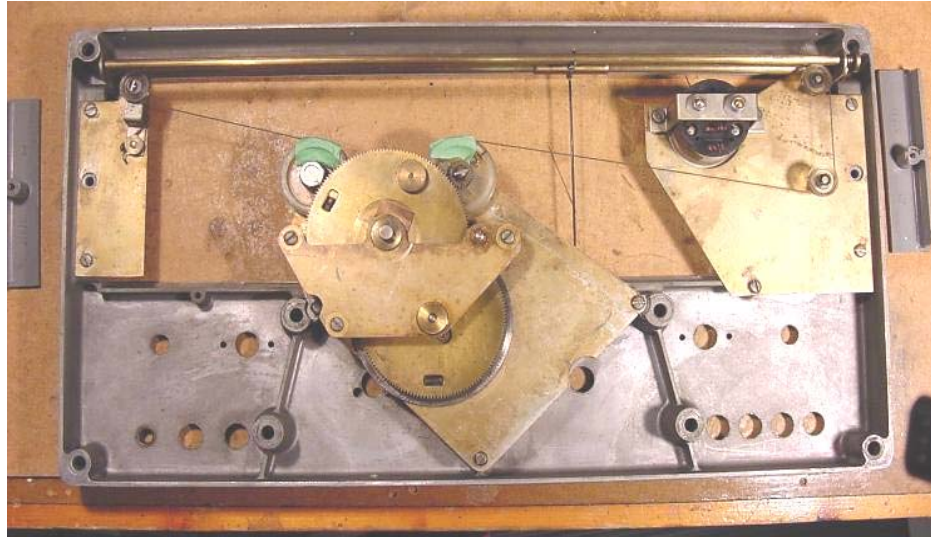
Front panel and dial drive mechanism after cleaning and re-assembly

- Cleaned-up all the remaining drive components (idler pulleys, guide rails etc) and re-assembled the drive mechanism to the front panel casting, simply reversing the disassembly order.

- Applied a little moly grease to the guide rails.

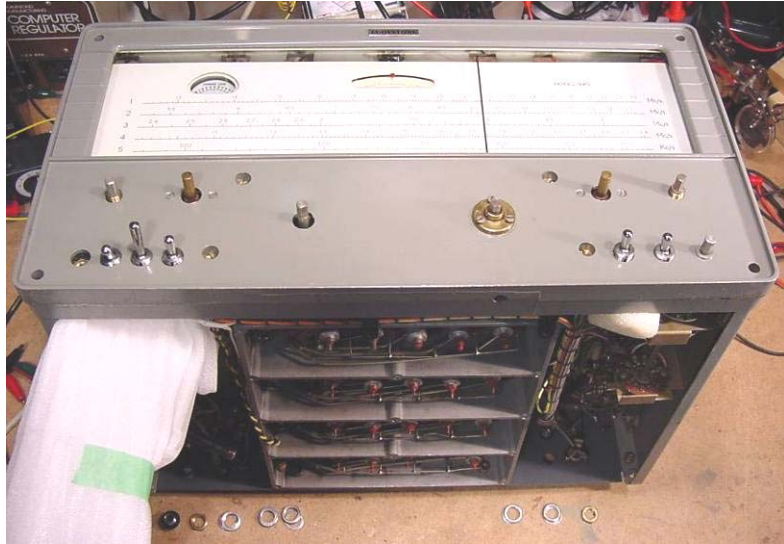
- Then I re-attached the front panel to the chassis. This is easier said than done, as getting all the switches and other controls into the correct holes at the same time takes some doing! A tip to help with this (that I meant to mention in the S.750 article) is to temporarily stuff the space beneath the switches and other controls with some packing material (see photo right) – this simple expedient holds all

the controls in place while you fit the retaining nuts (saves a lot of time and cursing).

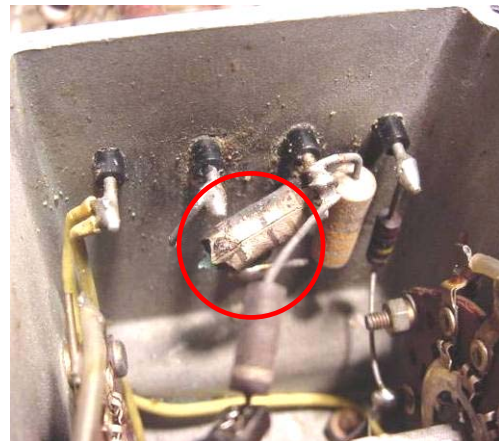
- Next up was investigation of the cause of a disintegrated resistor (R9, 3.3kohm) – see photo below – feeding HT to the cascode RF stage (V1). I suspected a component(s) further down

the voltage divider chain of resistors, possibly a short circuit capacitor (C13, C14 or C15 were suspect). C15, a 400vw 0.047uf polyester, hidden twixt the end plates of L6 was found to be ok. C14 however, a 200vw 0.1uf plate ceramic, tested short-circuit (very unusual in my experience for a ceramic capacitor to do this). Some resistance measurements during dismantling confirmed that R7 was ok, but R5, R6 and R8 were out of tolerance (R5 way high at almost infinity, R6 low at 12kohm and R8 short-circuit: this could explain why C14 failed (excess voltage).

Burned-out R9 (not) feeding HT to V1

Replacement of some of these components is easier said than done (though see Lighthouse issue 78, page 42 by Graham Wormald for some tips) as they are buried in the deepest recesses of the coil box, beneath the band change switch shaft and a divider cast into the box (see annotated photos below). I temporarily removed components above the valve base to

clear some room, but decided to leave the band change switch shaft in place, use a pencil soldering iron and to do some pre-assembly of the new parts (apparently some of these components were pre-mounted on the valve bases and then dropped in through the top of the casting as the first step in assembly at the Bath Tub, with all the remaining components then being added around them from beneath). I used over-rated (1w) resistors for the two 100kohm units (R5 and R6) for stability and longevity. Graham suggests that R5 and R6 can be connected to the 'cold' ends of L6 (terminals nearest the valve socket), but I did it the hard way and replaced them in their original locations. I used a Mylar replacement for the shorted-out C14 and a polyester replacement for C13 (the original C13 component was low leakage but also very low capacitance).

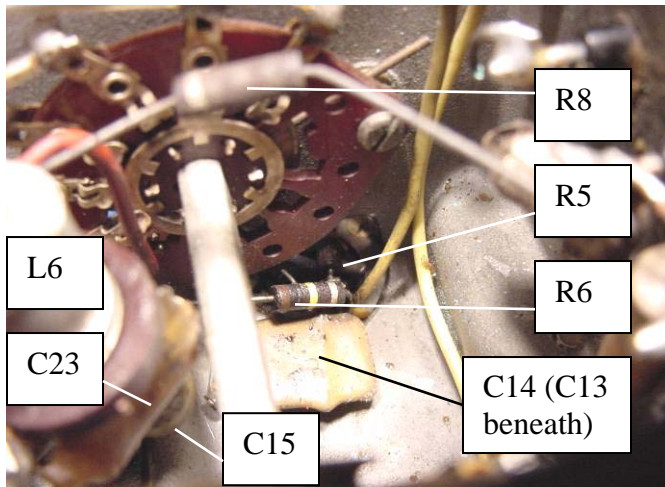
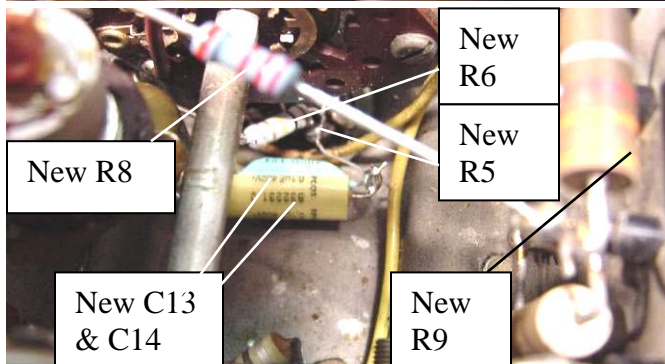
V1 valve base showing original component locations above and new components below

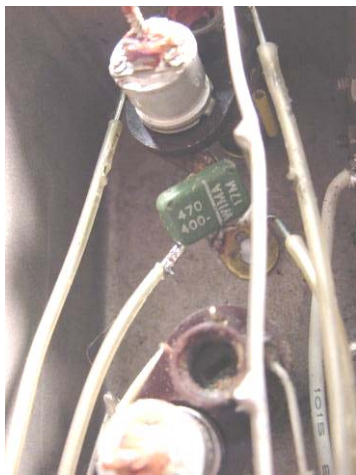
Temporary bridging cap in Band 4 aerial circuit

- As noted, the set was a bit ‘deaf’ on all bands at this point, with only signals from known local very strong stations producing movement on the S-meter, so I decided to do a full re-alignment – this would be needed anyway due to the non-standard crystal filter frequency. Before I started, I ‘bodged’ the RF coupling to V1 on Band 4 by temporarily installing a 470pf capacitor between the wires hanging in the aerial input section of the coil box where the L4/C4 combo had been removed. Closer inspection of the IF transformer and coilpack dust cores (‘slugs’) and ‘beehive’ concentric trimmers showed signs that they had been played around with as most of the red wax seals were broken (where unbroken, the wax actually looked to have been

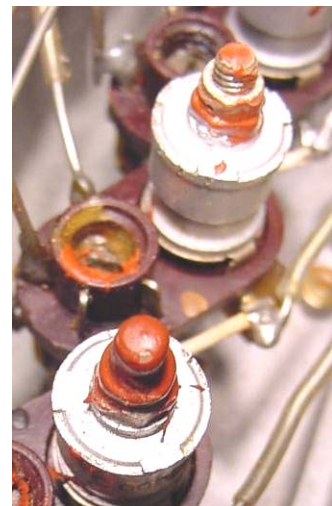
Hardened red sealing wax on the concentric trimmers and coil slugs

- During adjustment of the iron dust cores (for low-frequency settings), I first scraped off the hardened red wax covering the ends of the cores sufficient to allow the core to be turned. Fortunately all the cores were found to be in reasonable shape despite a 'twiddler' having 'had a go' at some time(s) in the past. Adjustment of the 'beehives' (high-frequency settings) was straightforward. Only two iterations of adjustments on each range produced good scale linearity.

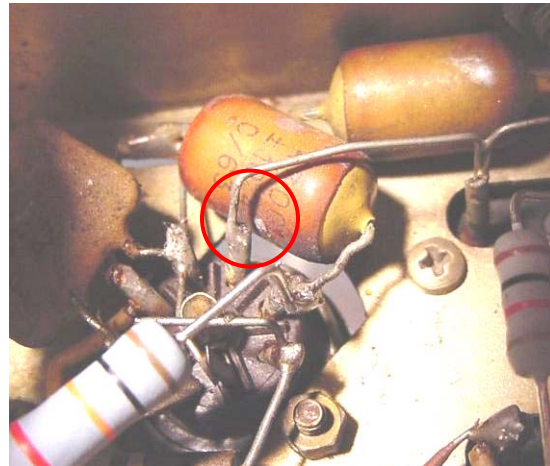
- Still only around -2.5v of AGC voltage measured on the VTVM on a strong signal that hard-stopped the S-meter. I checked around V7a again: the cathode was right on the desired 45v. I changed-out the 6AL5: no difference. I disconnected C88 (a 50pf tubular ceramic) that applies IF from the anode of V6 to V7a anode – it was ok (63pf and no leakage). Re-checked R41 and R42: both ok. Staring at the component layout in disbelief, I noticed that the (bare) lead of C88 was pushed hard against the case of C82, a 0.047uf polyester bypass capacitor on the screen of V6, and the plastic film coating the capacitor sleeve had been breached at that point (light dot circled in photo right). I separated the two and the AGC voltage jumped to over -5v, indicating that although it was not forming a low-resistance short (as there was still correct voltage on the anode of V6), there had been sufficient coupling between the lead of C88 and the C82 sleeve to affect the AGC voltage – a strange fault indeed...

Lead from T4 secondary/C88 where it was pressed hard against the case of C82 (note small 'bare' spot' where it had been resting)

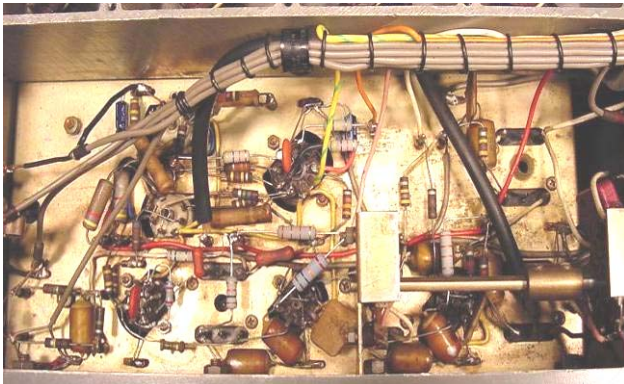
The IF/AF chassis during component replacement (annotated photo at the end of the article, Page 24)

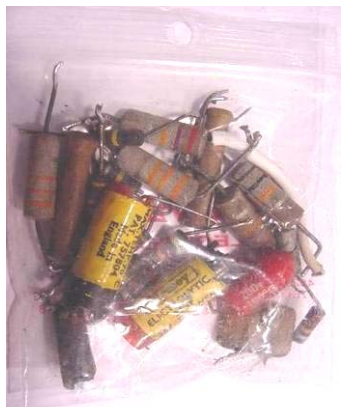
Bag of duff parts removed from my S.940... any offers?

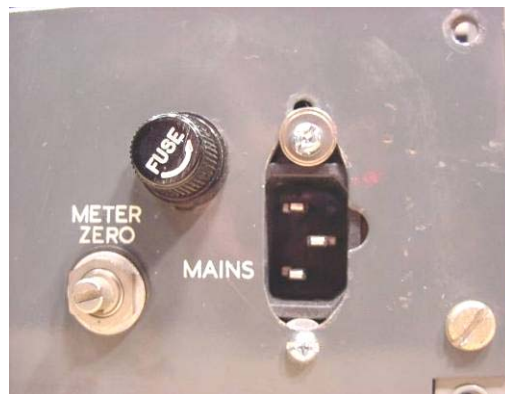
‘Euro-connector’ mains connector now fitted (not much use at present!)

- Checked the general electrical safety of the psu unit – someone had replaced the original ‘kettle connector’ with a horrid and flimsy-looking two pin chassis-mounted plug screwed to a piece of aluminium. I decided to replace this with the Euro-connector conversion as described in my S.830/4 and S.770R articles. This done, I proceeded to check for poor connections, heat damaged wires, poor insulation etc. as well as trace the loose wires left hanging when Pat had removed the mains transformer.

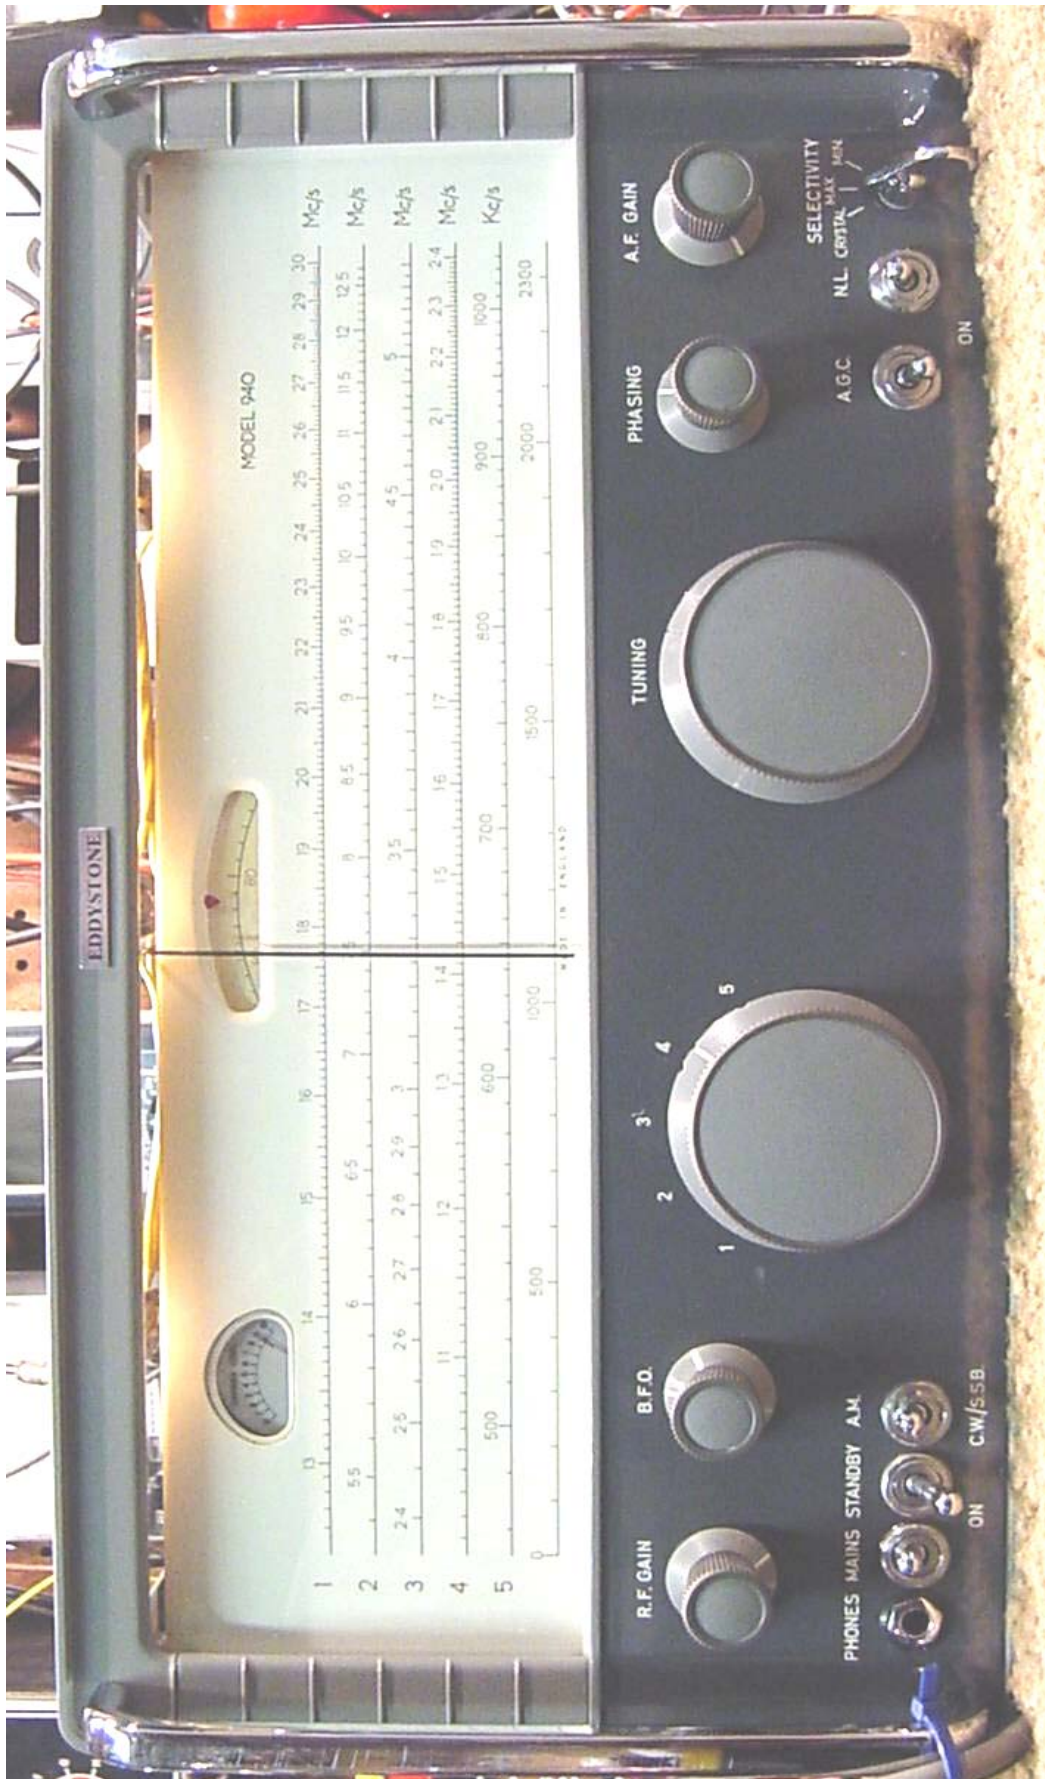
The S.940 looks pretty good from the front – I would say as good as my S.830/4 anyway. Here it is pulling in ‘Coast to Coast AM’ on 1410kHz @ 5-9+.

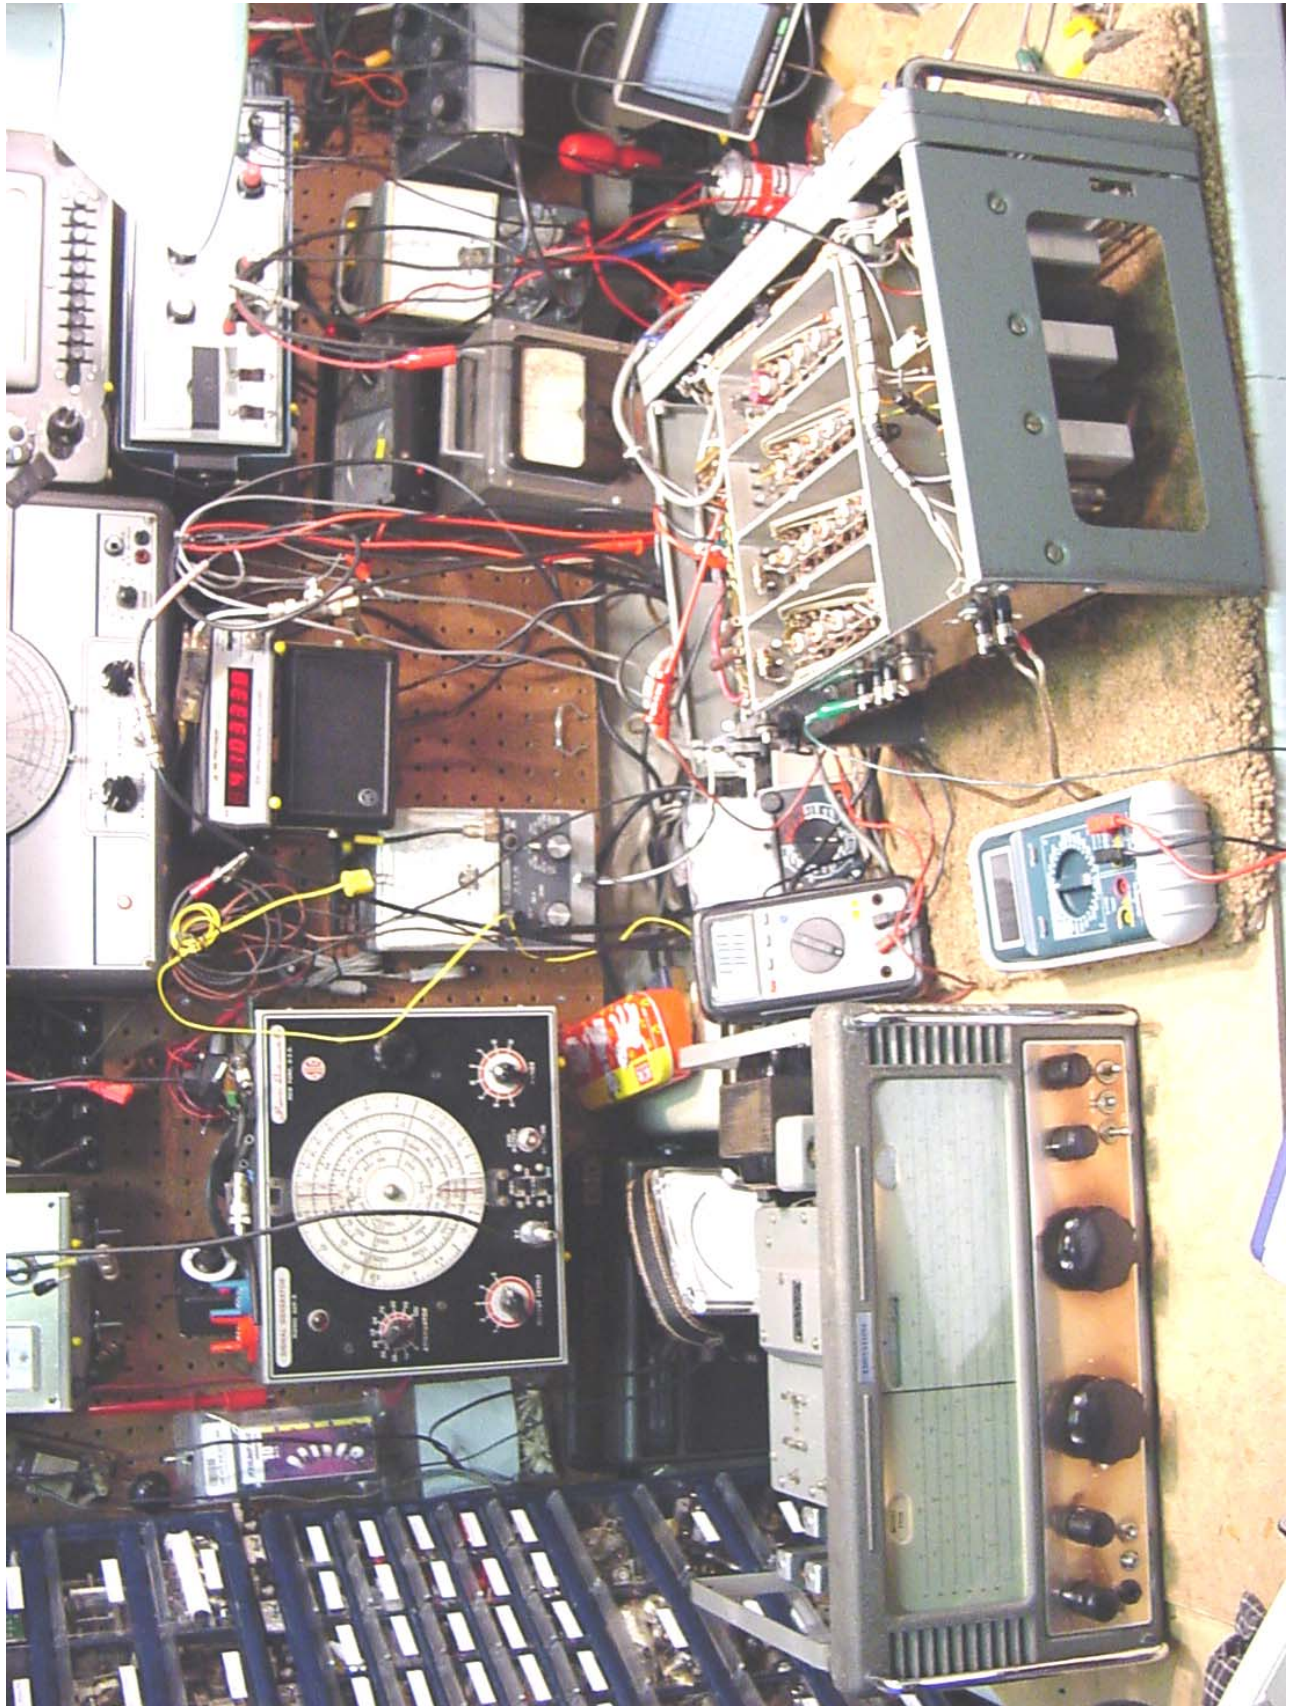
The temporary 'jump start' arrangement of powering the S.940 using the S.770R power supply – it feels strange switching one receiver on and the other one actually powering-up...

- Drastic action was needed – so I decided to use another Eddystone as a temporary power supply – my S.770R was handy and has a similar power supply circuit and the same model of power transformer. I unplugged the octal plug from the rear of the S.770R

(this disconnects all the 6.3v heater circuits except for its noise limiter valve, V10 - this being fed from a separate secondary winding, so V10 was removed). I then installed a thick ground jumper between the two receiver chassis and jumpers from the S.770R's rectifier (5Z4) cathode (HT) to the input of the HT choke in the S.940 (also disconnecting the S.770R's choke) and from the 6.3v heater transformer winding in the S.770R to the heater supply bus in the S.940. All these temporary leads were soldered in place, insulated where needed and securely held with cable ties. I installed the stabilizer valve (OD3/VR150) in the S.940 and temporarily disconnected the S-meter as it would be really imbalanced with no valve (V6) in place and could therefore possibly be damaged, plugged the S.770R into my variac and....

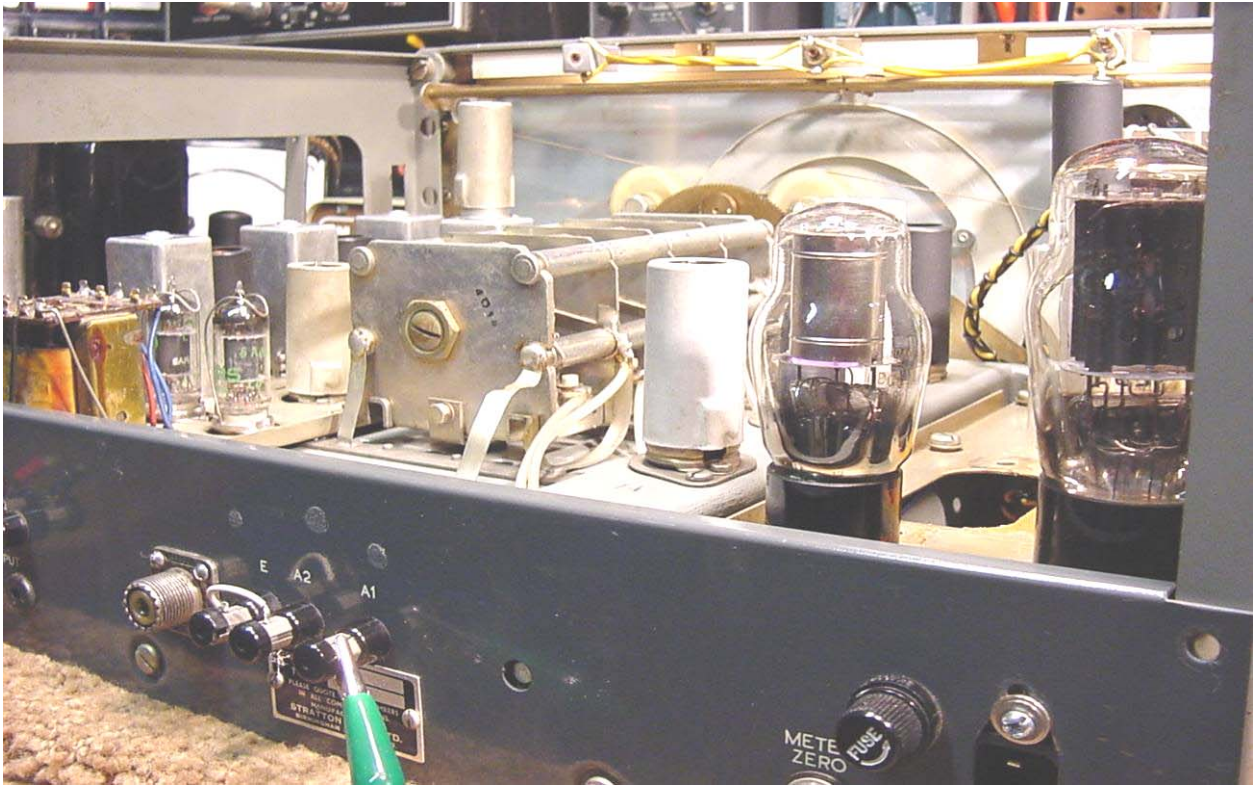
A nice shiny new 5Z4G fitted and not an electron to rectify...

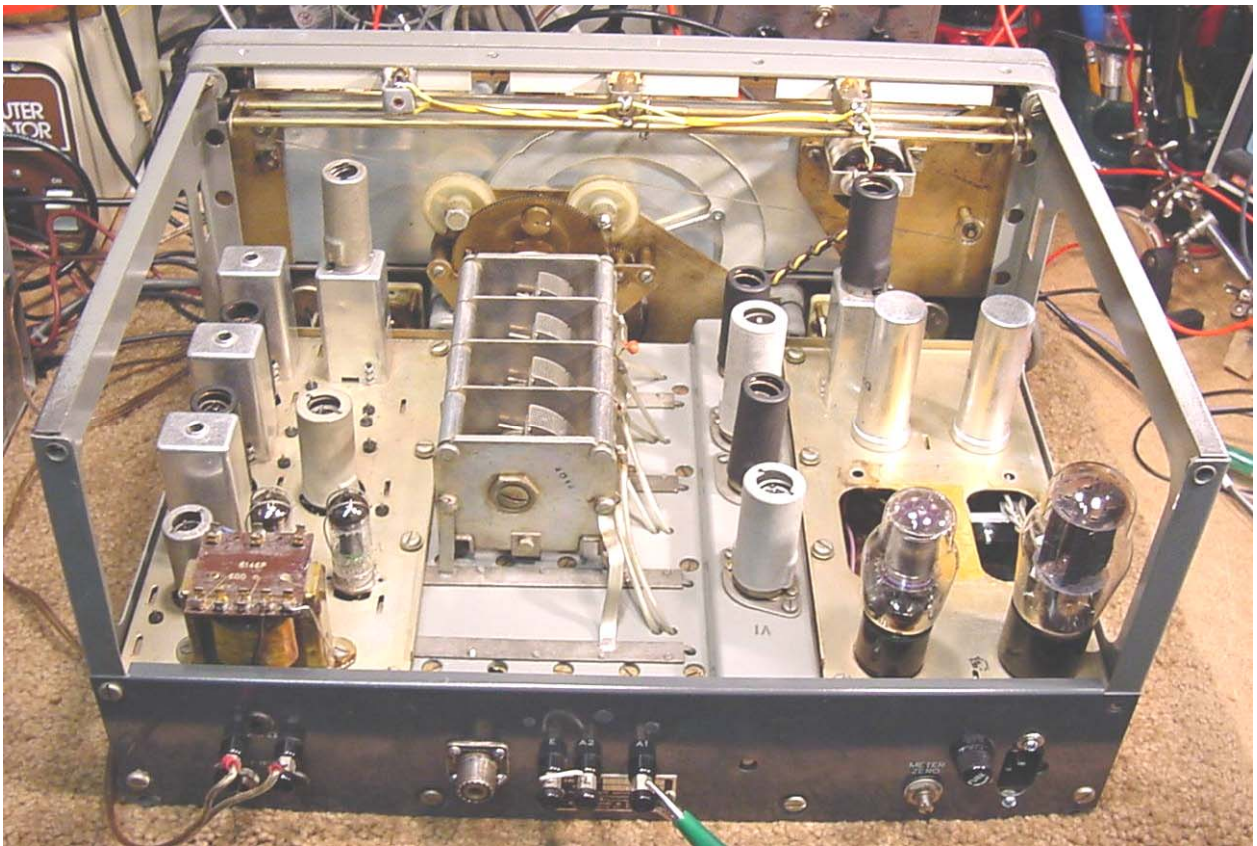
The S.940 isn't bad inside either – "...look mum, I'm working good without a transformer..." (there surely must be less painful ways to lose a few pounds?)

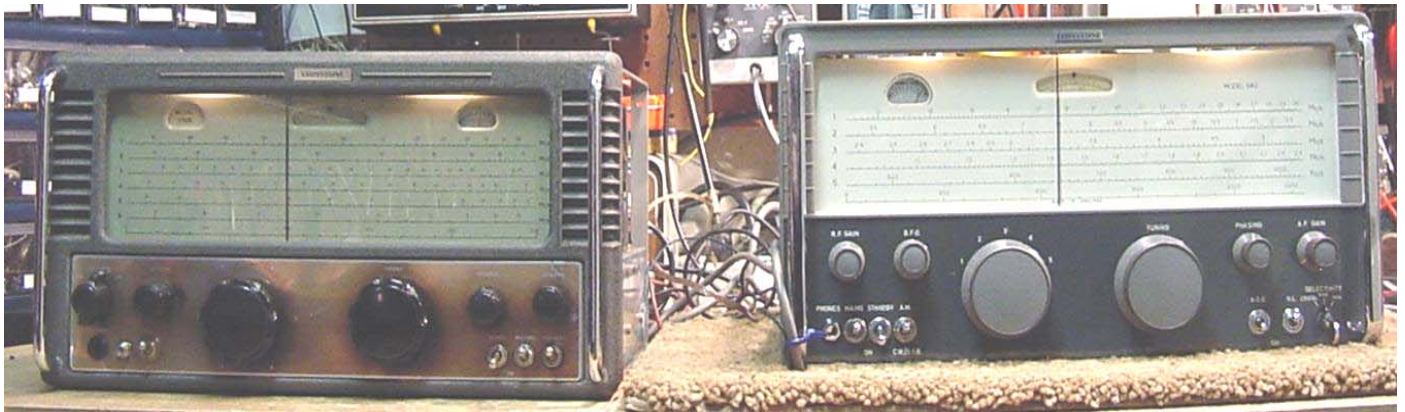
The S.940 on 'soak test' powered by the S.770R

I left the set on 'soak' test for a few hours and tuned around the bands – pretty impressive! I re-checked all the key voltages as listed in the manual following some prolonged use of the set and they were all found to be within tolerance when the HT1 line was adjusted to the specified 240v using the variac. I noted that the set was now drawing around 95mA on standby, 105mA when a strong signal was applied and up to 115mA under no signal conditions (a little more when set to Bands 1 through 3). Also, with 120v AC applied directly to the S.770R supply, the HT1 line was at 255v and the current draw was 125mA with a strong signal applied. I figured that although the current draw still seemed high, it could conceivably be normal, especially as all the key voltages checked out ok. Once the 'real' power supply is fitted and working in the S.940 I will re-visit this issue (note: the S940 power supply has two 140ohm resistors fitted to the mains transformer HT secondary, feeding

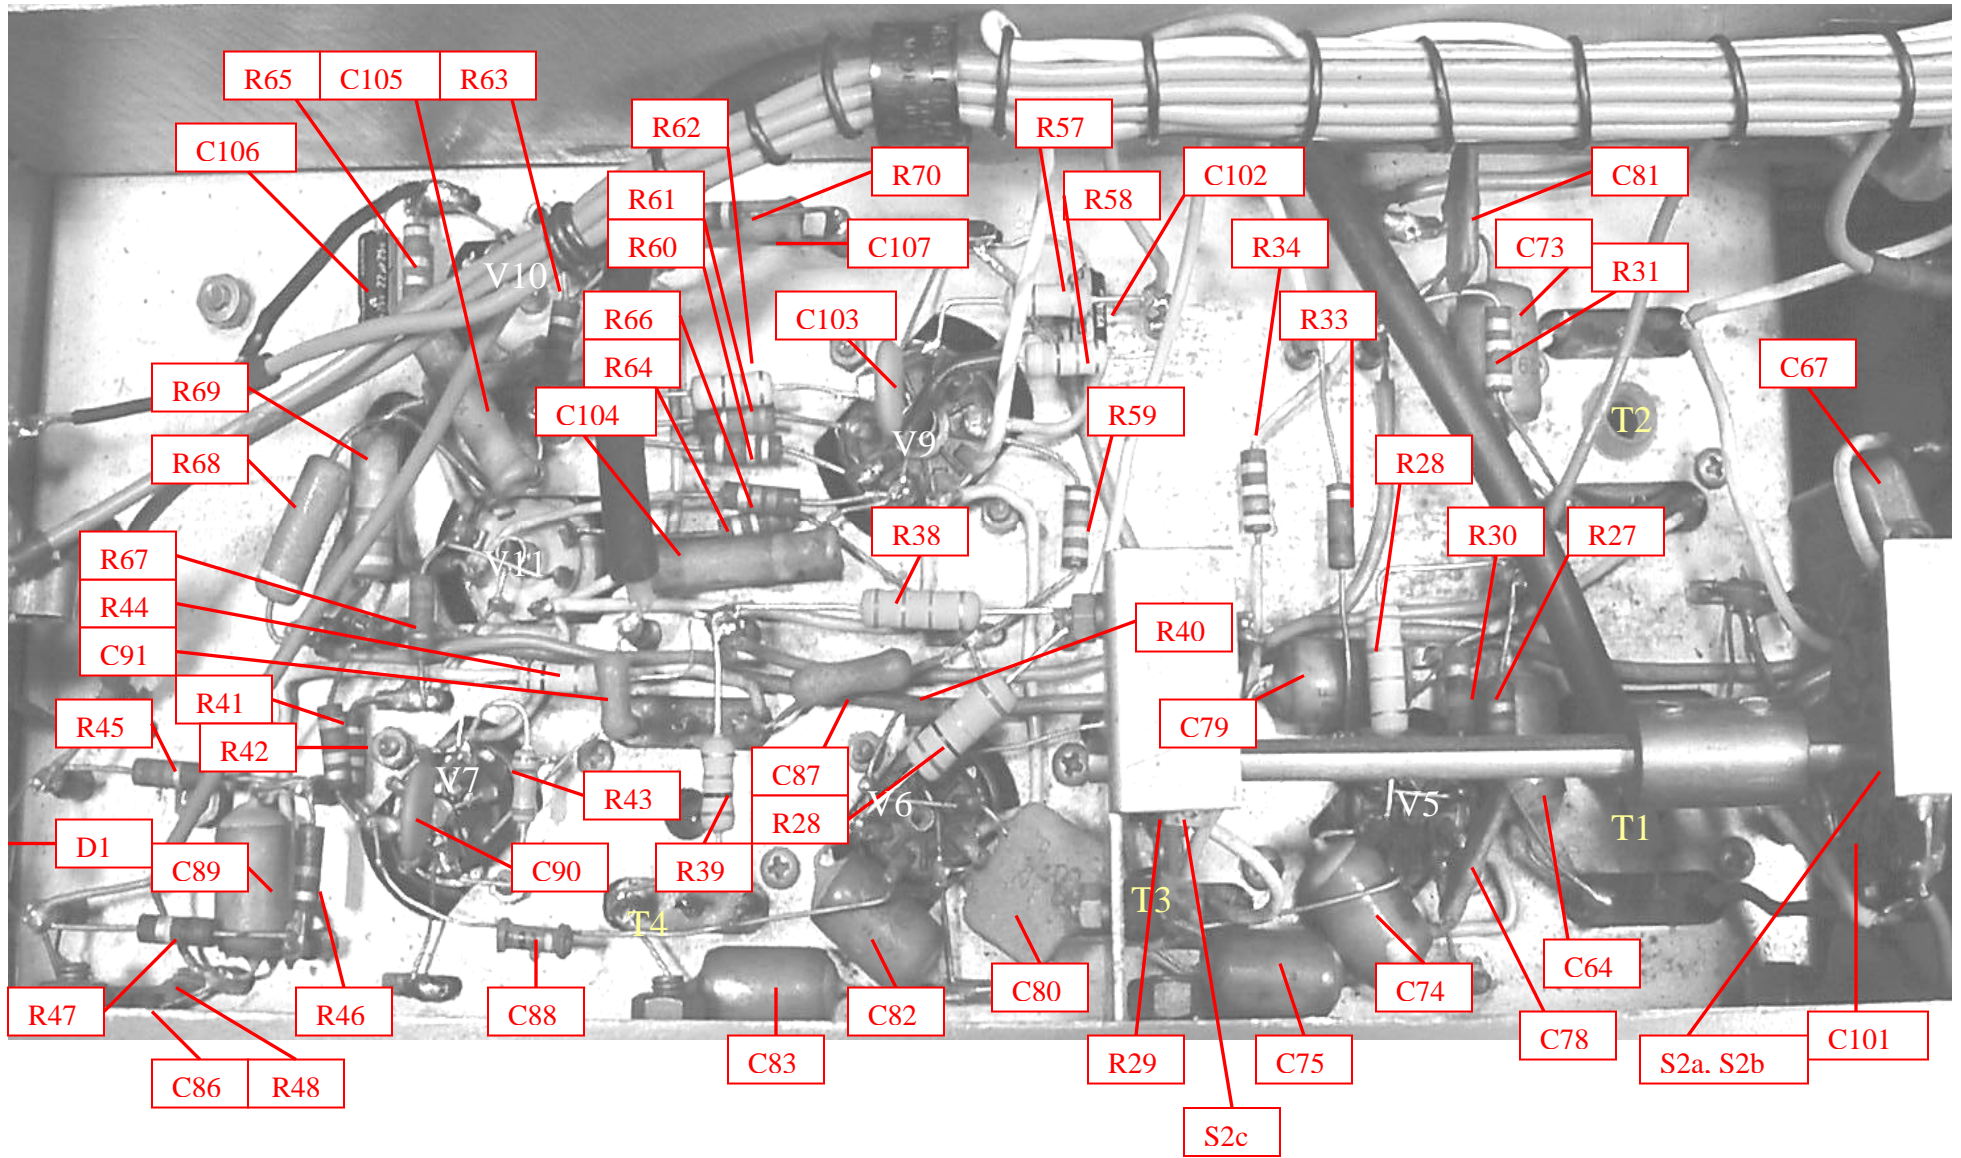
S.940 IF/AF sub-chassis with components identified

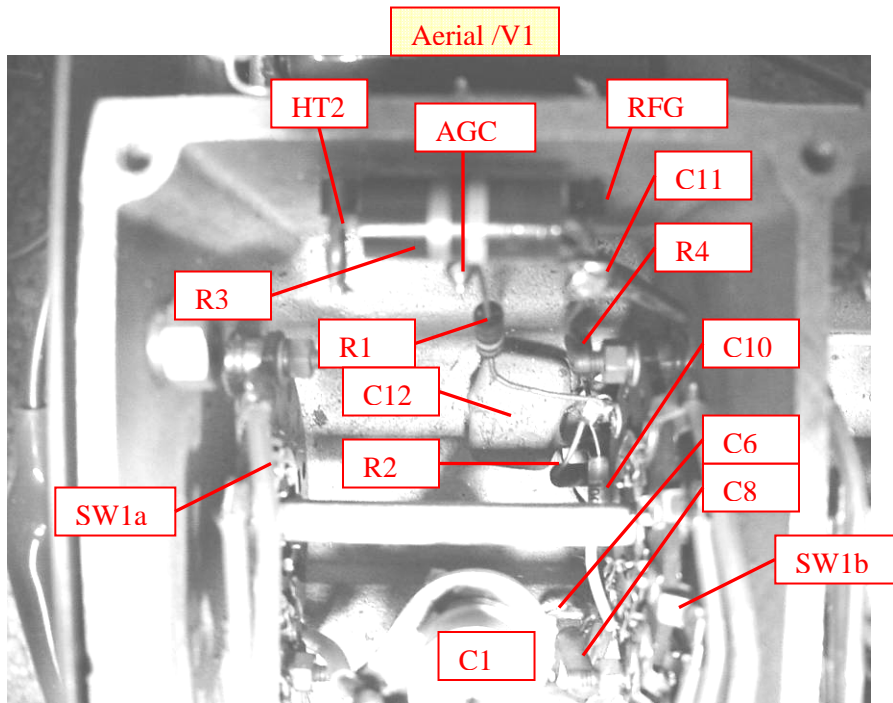
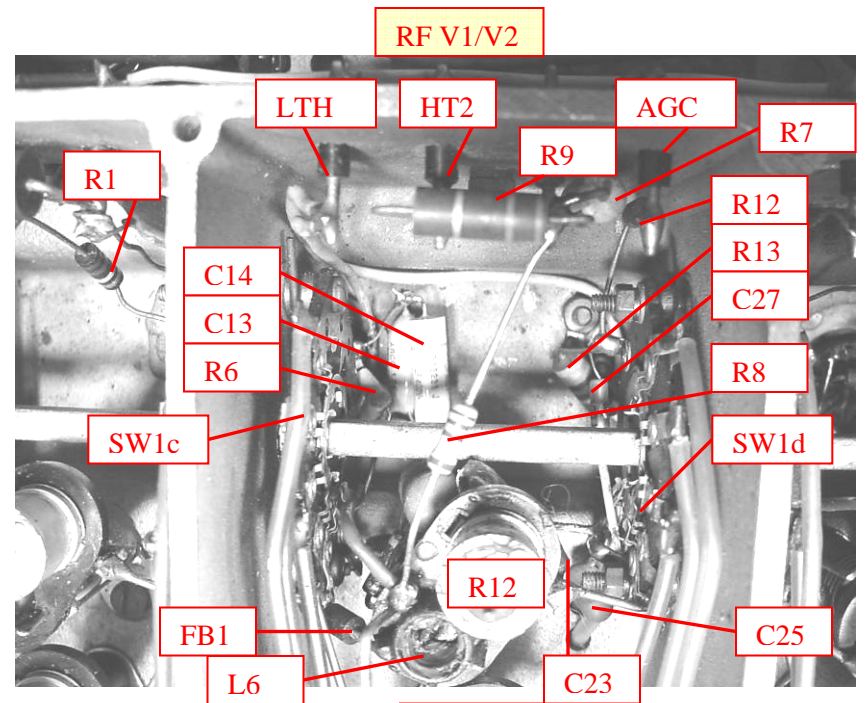
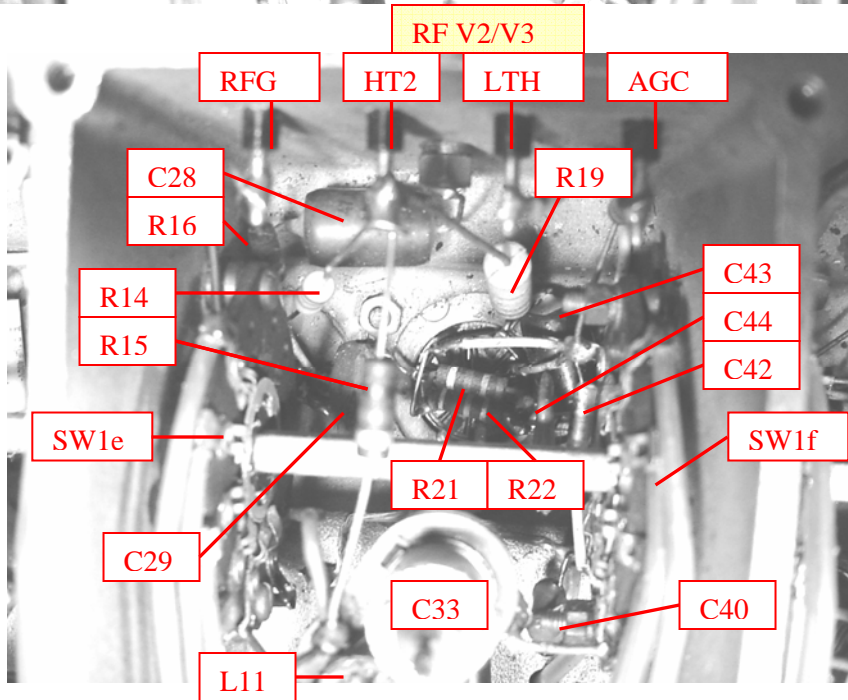
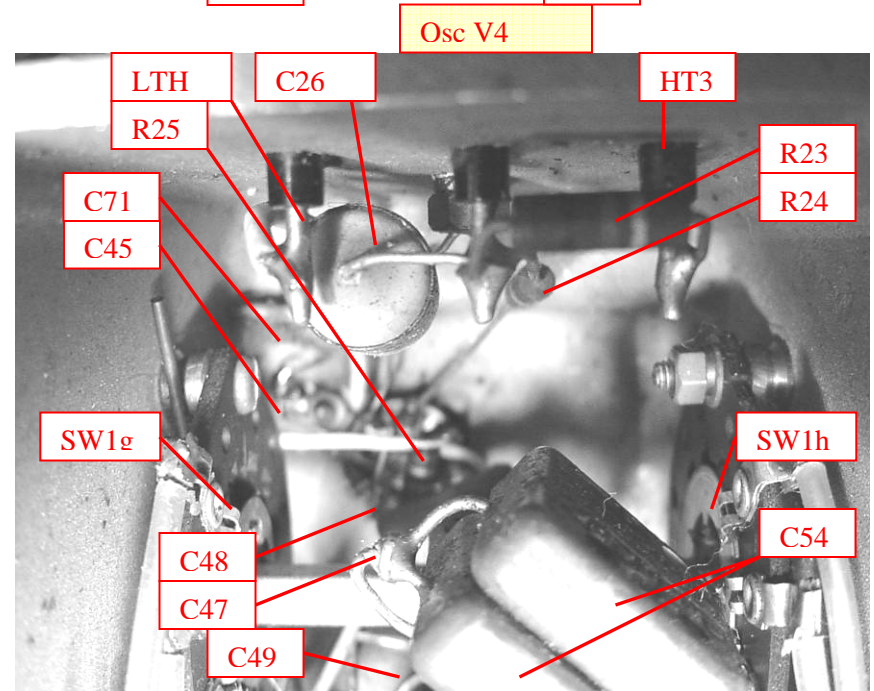
S.940 RF sub-chassis with components identified
