Practical **LRO** Range Rover P38 faultfinder

RID YOUR P38 OF NIGGLING FAULTS

The Mk2 Range Rover is prone to niggling failures caused by its complex electronics – but they can be solved with a bit of detective work, says long-time P38 owner Philip Kent. Neil Watterson finds out more

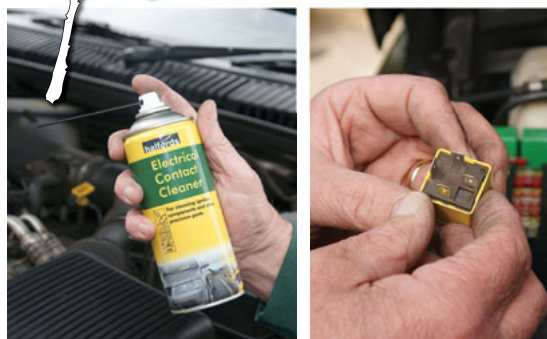
Force of habit: keeping a P38's electrical contacts clean can prevent problems from ever taking a hold. Philip sprays the lot every couple of years – a very good plan

After a number of annoying failures on his Range Rover, he decided to make a point of going over the whole vehicle every couple of years, removing every electrical connection and cleaning the contacts.

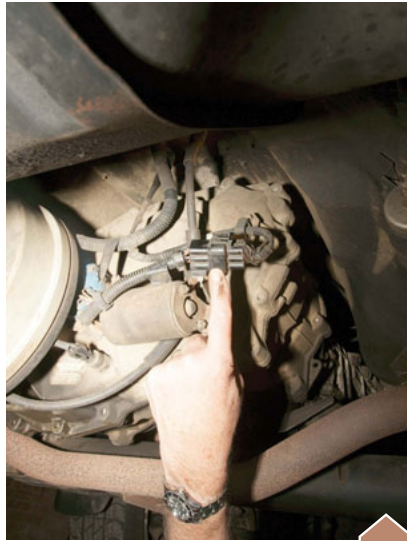
NON-OPERATIVE TRANSFER BOX

Failure to change ratios when the high/low transfer box is selected is a reasonably common occurrence on those P38 Range Rovers that never venture off-road.

In this case, Philip soon found the cause – the connector block on the gearbox was full of road grime and the connectors were dry. After a quick dismantle and a spray with some electrical contact cleaner it was all clipped back up and the transfer box now works as it should.

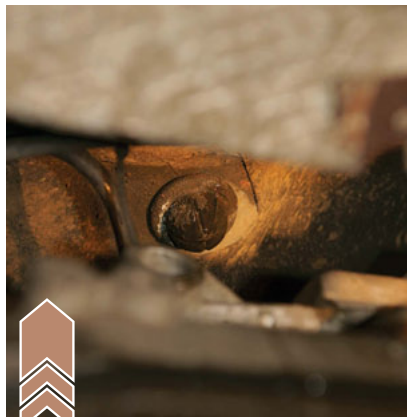
WET FOOTWELLS

Add wet footwells to a fluctuating temperature gauge and you'll be forgiven for fearing the worst – the heater matrix has imploded. Some garages assume the same, leading to huge bills.

Faced with this problem on a friend's P38, Philip tested the water in the footwell and found there was no anti-freeze in it, so it must have been something else at fault. Removing the dash, he found the air-conditioning drain pipe had come adrift, causing the leak.

Normally it should drain underneath the car, just above the gearbox – a domed rubber 'bung' should allow the water out and also prevent muck getting in, but it gunges up. Poke the bung with the blunt end of a pencil to clean it – wear some kind of eye protection, because the water may suddenly pour out.

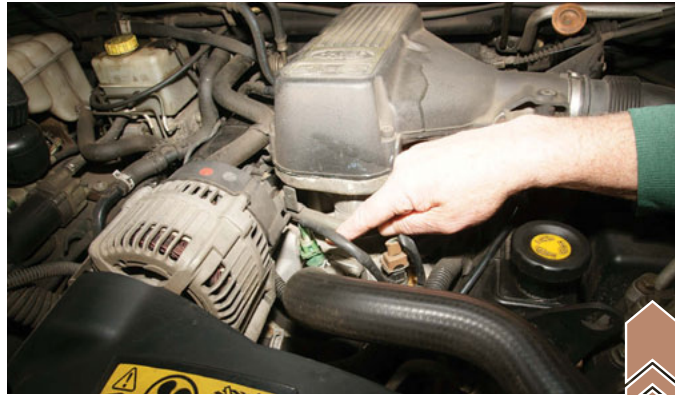
TEMPERATURE GAUGE

The 4.6-litre V8 has gained notoriety for the block becoming porous and overheating, so the last thing you want to see is the temperature needle shooting up and down as you drive along. Yes, it may be the engine is at fault, but the first thing to do is to remove the connectors to the sender on the top of the engine, clean the contacts and refit. It fixed Philip's errant readings and there's a good chance it'll do the same to yours.

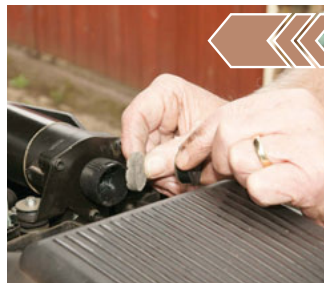
AIR SUSPENSION

The electronics do cause problems with the air suspension, but so does working the pump too hard. And sitting under the bonnet isn't the best place to keep dirt and grime from the compressor. The compressor, normally covered with a lid, is hidden away, so the filters are neglected. Take them out, give them a good clean, allow to dry and replace.

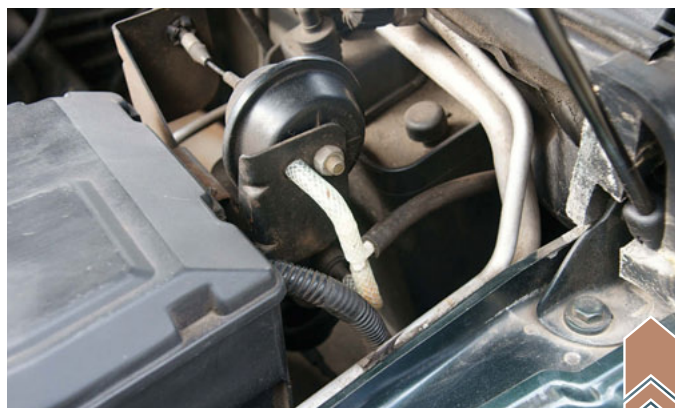
CRUISE CONTROL

'When this failed, it wasn't long before I found the source. I knew it worked on a vacuum, which is picked up from an inlet manifold and runs round the back to a diaphragm on the passenger wing.

'As I pulled the pipe off the back of the diaphragm, I noticed it was perished – enough to destroy the vacuum. A bit of fuel hose of the correct diameter now fills the space and the cruise control works again.'
