TECHNICAL ALERT

TA03 4401

Discovery Series II: Correct Installation of AT Selector Knob

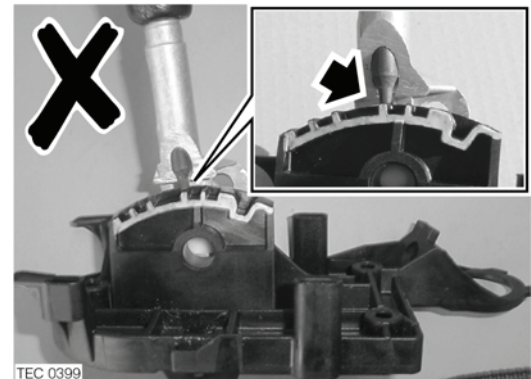
Figure 1

When fitting the automatic transmission selector knob after a service repair, the park release button rod can be damaged. The damage can result from incorrectly positioning the gear selector when the selector knob is fitted. (Figure 1)

Illustration shows the **incorrect** position of the gearbox selector when fitting the gear knob.

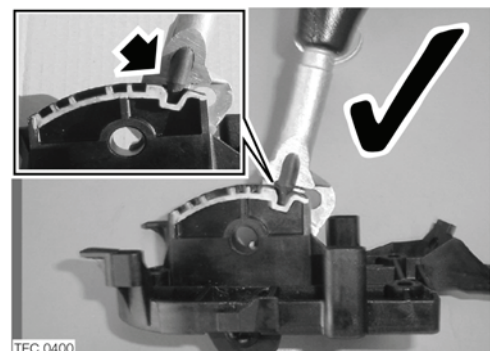
Figure 2

Illustration shows the **correct** position of the gearbox selector when fitting the gear knob.

When fitting the automatic transmission selector knob, the selector **MUST** be in the PARK (P) position (Figure 2) to ensure that:

- The latching rod is not damaged
- The latching rod does not cause damage to the raised segments of the selector detents.
