TECHNICAL INFORMATION

Service Action Idler Pulley

No: H369
 Ref:
 Issue: 2
 Date: 02/04/00

IDLER PULLEY MAY CAUSE PREMATURE BELT WEAR

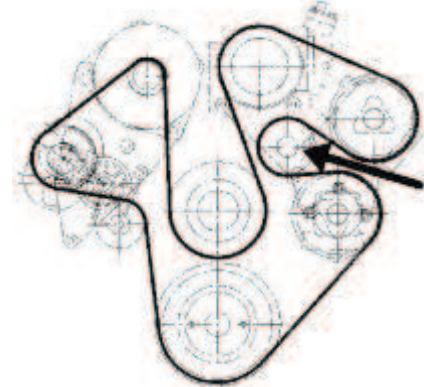
Figure 1

**Discovery Series II
ACE-equipped Belt Routing**

1. Refer to Workshop Manual repair sections 26.25.19 and 86.10.03 for 99MY vehicles and disassemble the idler pulley and the belt system as follows:
 - Remove the cooling fan assembly using special tools LRT-12-093 and LRT-12-094.
 - Remove the bolts securing the drive belt cover and remove the cover.
 - Release the drive belt tensioner.
 - Remove the belt.
 - Remove the idler pulley identified by the arrow in the illustrations. (Figures 1, 2 or 3)
2. Clean all pulley grooves in all locations.
3. Inspect and verify that there is no damage to any groove in the belt pulley system.
4. Install new idler pulley provided in kit PQR1010170K.
5. Torque the idler pulley retaining bolt to **50 Nm (37 lbf.ft.)**.
6. Inspect the belt for damage before installation.
7. Install the belt following the WSM procedure.
8. Install the cooling fan assembly.
9. Install the drive belt cover.

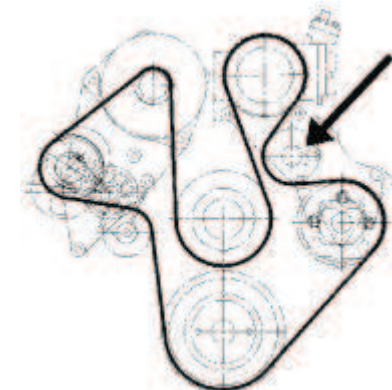
Figure 2

**Discovery Series II
NON-ACE Belt Routing**

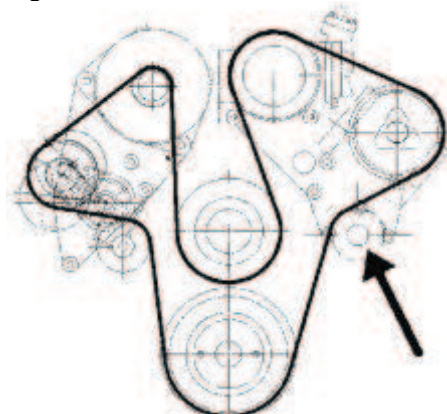
Figure 3

Range Rover Belt Routing
