TECHNICAL INFORMATION

Inoperative Seat Back Functions

No: 86/03/99/NAS
Ref: WSM Section 76
Issue: 1
Date: 03/12/99

DISCOVERY SERIES II (LT) ALL

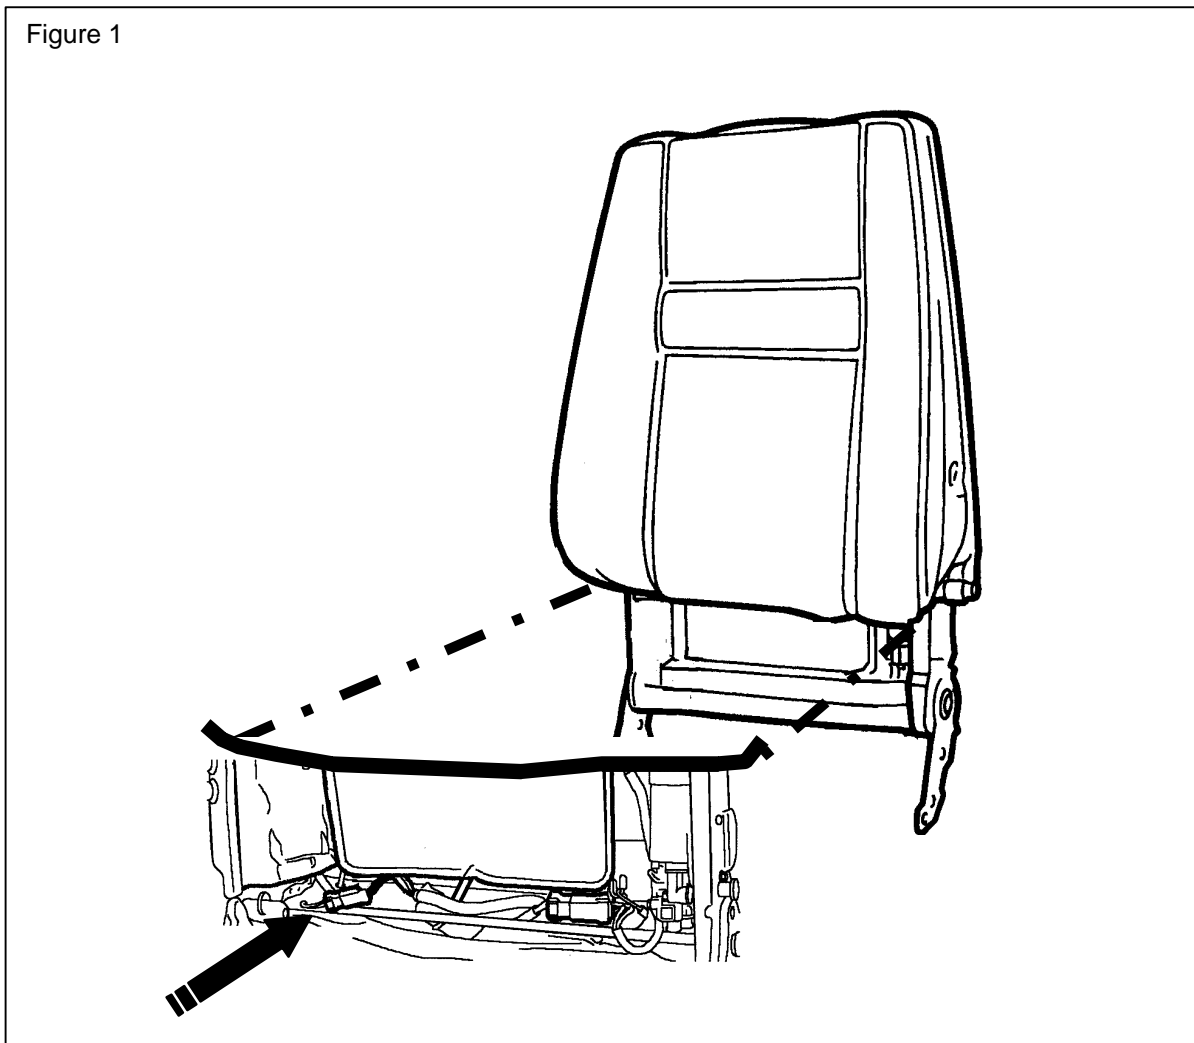
Figure 1

The seat back lumbar/squab recline wiring harness may be routed in a way that allows an unprotected area of the harness to come in contact with the seat frame. As a result, damaged wire insulation can allow the circuit to ground causing blown fuses in positions 2, 3 or 4 in the satellite fusebox under the seat. Seat functions controlled by these fuses will be lost.

To resolve the symptoms outlined above, repair the harness and install a section of convoluted tube to protect the wire from shorting. Secure the tubing in position on the harness using electrical tape.

2. Remove the seat cover enough to allow lifting of seat back (squab) foam and access to the wiring harness leading to connector C0974 as shown in Figure 1.
3. Locate portion of damaged wiring harness.
4. Repair harness as required.
5. Fit convoluted tubing and tape tubing to wiring harness, protecting harness from seat frame edges in the area where damage had occurred.
6. Replace blown fuses.
7. Verify that seat controls function properly.
8. Reposition seat back (squab) foam and install seat covering and trim.
