# TECHNICAL INFORMATION

## Sport and Manual Mode Light Illuminated

No: 86/04/03/NAS  
Ref:  
Issue: 1  
Date: 05/02/03

Discovery Series II (LT) up to 2A740268

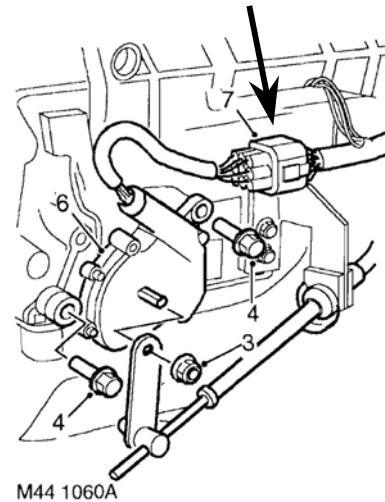
Figure 1

The customer may complain that the "S" or "M" symbols for the transmission are illuminated without having changed the shift mode. Water may enter the gearbox starter inhibitor switch harness connector via the harness joint causing this symptom.

1. Refer to the RAVE Electrical Library connector view C0675 to identify the start inhibit/neutral safety switch connector location.
2. Inspect the switch harness connector C0675, for corrosion. (Figure 1)

### Connector C0675

1. If corrosion is evident, refer to the RAVE Workshop Manual section 44.15.19 and replace the start inhibit/neutral safety switch. (Figure 1)
