TECHNICAL INFORMATION

Viscous Fan Renewal Method Change

No: 26/04/05/NAS
 FGN LT303-03
 Ref:
 Issue: 1
 Date: 18 Jul 2005

Discovery Series II (LT) All

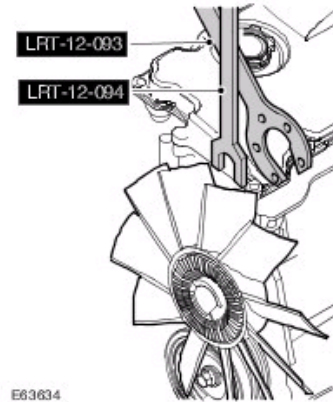
Figure 1

REMOVE AND INSTALL VISCOUS FAN COUPLING – NEW PROCEDURE

1. Remove viscous fan coupling as follows:
 - Remove the upper fan cowl.
 - Remove the viscous fan coupling unit using tools LRT-12-093 and LRT-12-094.
2. Install viscous fan coupling as follows:
 - Position the viscous fan coupling unit and tighten using tools LRT-12-093 and LRT-12-094.
 - Install the upper fan cowl.
