Kenwood TS-830

Survival Guide

Kenwood TS-830 Survival Guide, ed. [Olaf Rettkowski](#), DL9AI, ver.1.2, 03 Dec 2002

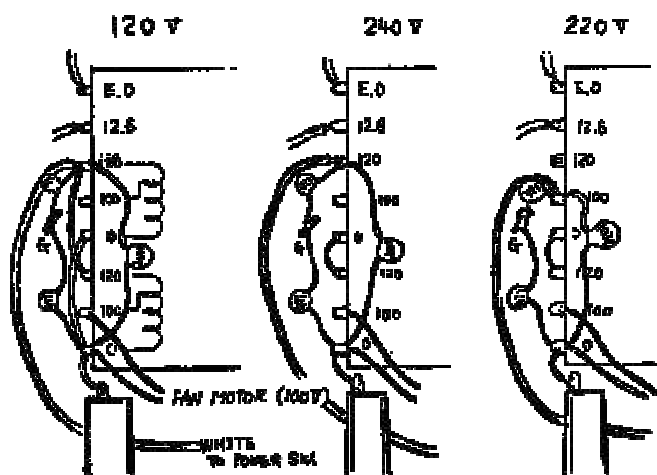
5. Change the AC fuse from 6 A to 4 A. Tag the power cord at the back of the radio to indicate that the transformer is strapped for 240 V AC, and the power fuse should be 4 A, and not 6 A.

6. Replace the bottom cover and reconnect power to verify your work.
