APPENDIX A. RUNNING DESIGN CHANGES/FIELD SERVICE BULLETINS

The factory provided these ten Field Service Bulletins to 8X32 dealers and customers. Each Bulletin describes a remedial procedure for a specific problem, or a hardware change necessary to implement an improvement in the machine's design.

8X32 FIELD SERVICE BULLETIN #1

TITLE: PANEL BOARD CONNECTOR

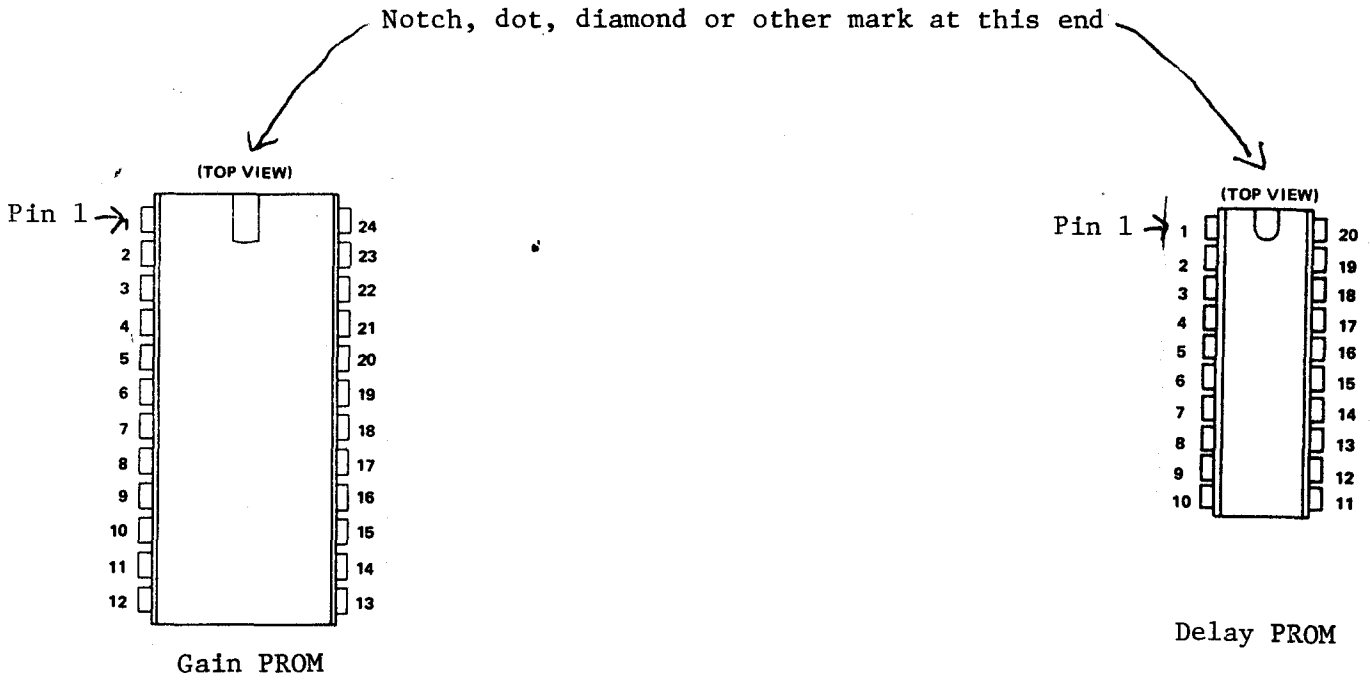
Change The Delay PROM: Referring to Fig. 2, identify the Delay PROM, the one toward the rear of the chassis in socket position U10. This will either be designated as X116-5, 116-5, 0525-5 or may possibly have no identifying sticker at all. Note the pin 1 end of the IC (toward the rear of the chassis). The new IC must go in just this way. Remove this IC with an IC extractor, or if one is not available, gently pry up each end a little bit at a time using a very small screwdriver. Be very, very certain that when the IC is removed none of the pins have become bent or damaged. Then place the IC in the conductive plastic foam. Next, lift the PROM provided with this kit, Part #0525-6 and check it to be sure that the pins are parallel and straight in both axes. Carefully position the IC with the pin 1 end toward the rear of the unit, the same end where the pin 1 end of the original IC

Change the Gain PROM: Refer to Fig. 2 again to identify the second PROM for replacement. This will be labeled 0527-4 or possibly X124-4. It is in IC socket position U85. As before, use an IC extractor or screwdriver to carefully remove the IC. Replace it, again, carefully referring to Fig. 3 for orientation. Carefully check that all the pins have gone into the socket, that none have bent under the body or splayed out to the side.

****You must re-install with pin 1 correct, or you will destroy the IC!****
