The Yorkville In-House Method for Repairing AP Series Amps

M1146 AP-4040

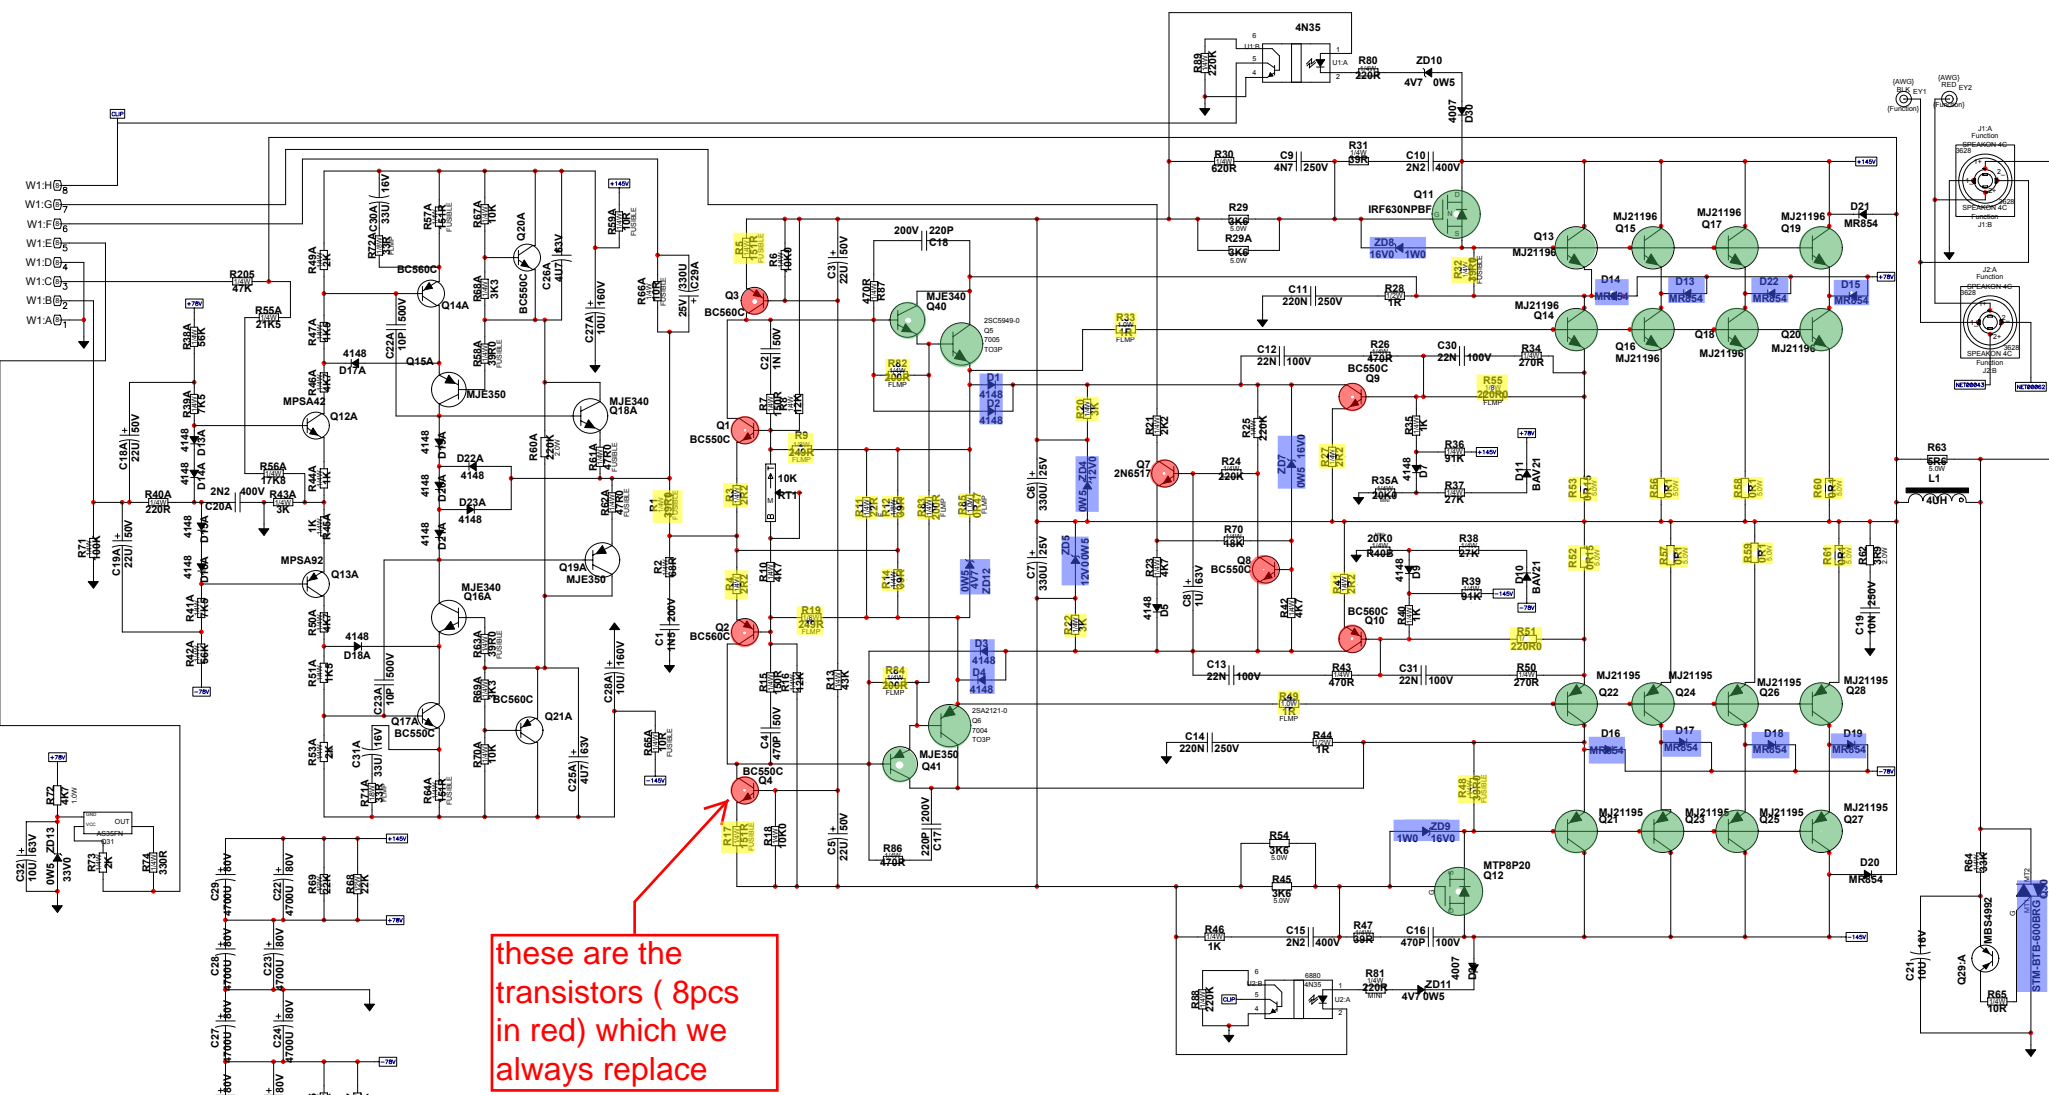
There are 8 TO-92 transistors (RED dots). NEVER measure them - ALWAYS replace them

these are the transistors (8pcs in red) which we always replace

Red NEVER MEASURE THESE, Always replace these 8 transistors
