Bulletin
Number 5011

1948 LAND-ROVER

1948 LAND-ROVER AND UNIT NUMBERS

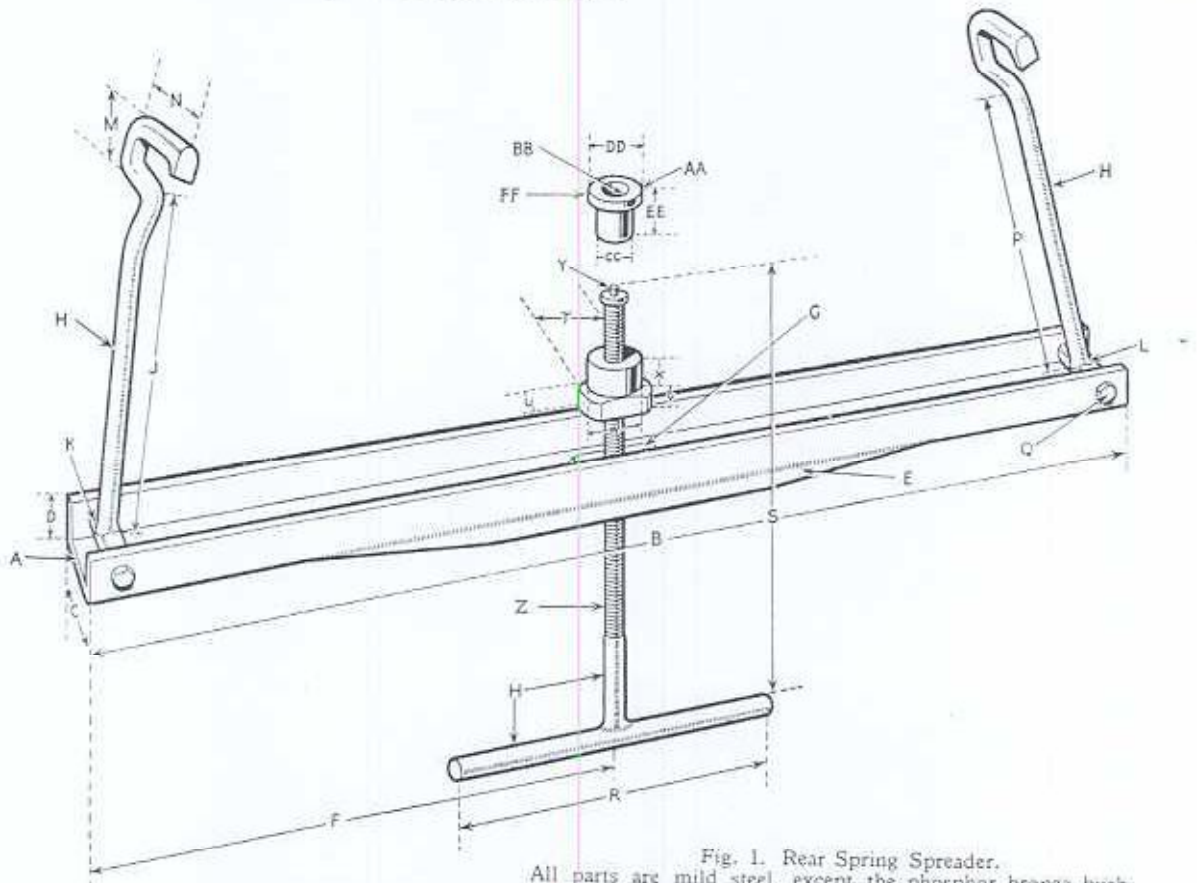
Some form of spreader is required when removing or replacing rear springs owing to their large static deflection; a suitable pattern is shown in Fig. 1.

Fig. 1. Rear Spring Spreader.
All parts are mild steel, except the phosphor bronze bush.

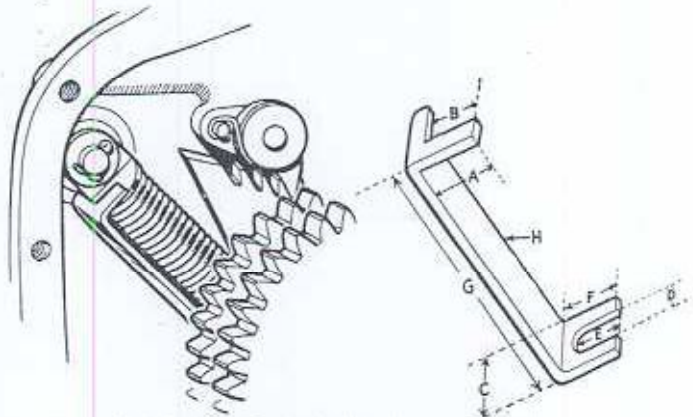
Fig. 2. Clip for hydraulic plunger assembly.

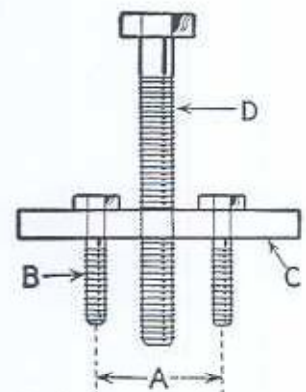
The extractor illustrated in Fig. 3 is of a common design and the method of using should be clear from the sketch.

Fig. 3. Extractor for water pump impellor.

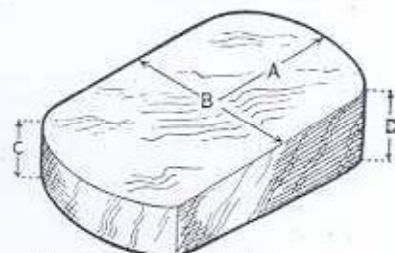
When removing a front coil spring by jacking under the spring support plate and removing the six bolts securing the plate to the bottom suspension link, a packing block between the jack pad and plate is essential, to ensure that the plate remains square with the link members. A suitable tapered wooden block for use with the normal garage Hi-Lift jack is illustrated at Fig. 5.

Fig. 5. Packing block for front road spring removal.

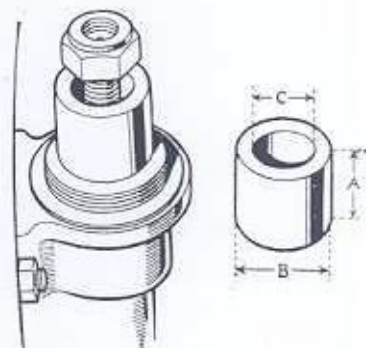
To ensure correct end-float on the swivel pin thrust bearing, it is essential that the swivel pin be pulled well home into the swivel column. To assist in this operation the collar shown in Fig. 6 should be fitted and the pin tightened up with the $\frac{3}{4}$ " fixing nut, before fitting the thrust bearing and shims.

Fig. 6. Collar for swivel pin assembly.

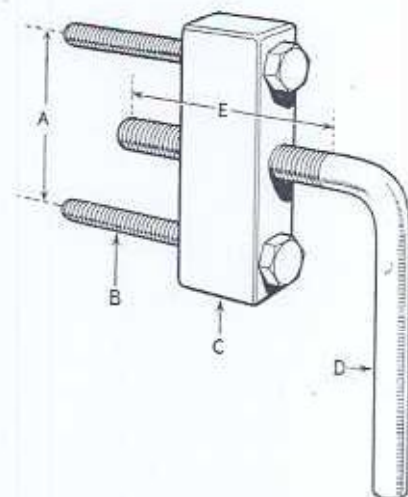
Easy removal of the camshaft chainwheel can be effected by utilising the two $\frac{3}{8}$ " Whit. threads provided in the chainwheel, in conjunction with the extractor illustrated in Fig. 7.

Fig. 7. Extractor for camshaft chainwheel.

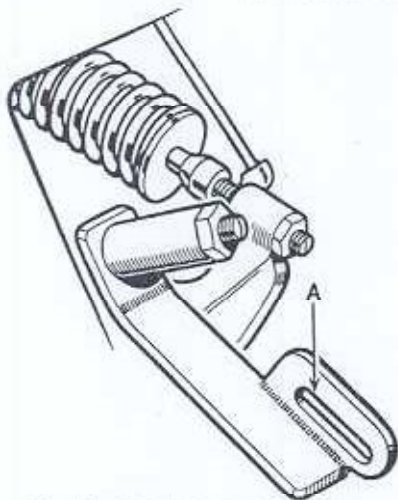
The bracket shown in Fig. 8 is designed to allow a dial test indicator to be used on No. 1 exhaust rocker, thus facilitating the accurate location of the E.P. position.

Fig. 8. Bracket for valve timing.
A — Secure dial test indicator here.

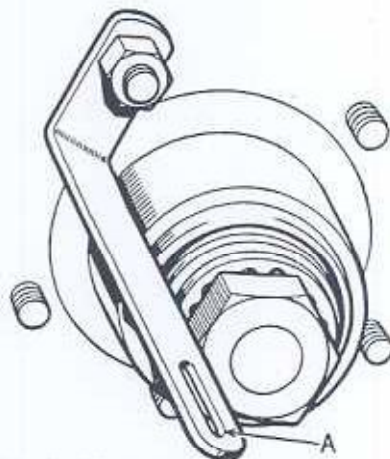
Fig. 9. Bracket for front hub end-float.
A — Secure dial test indicator here.

The front hub end-float must be accurately set to .003 in.-.004 in. (0,08 mm.-0,1 mm.), and the use of a dial test indicator in conjunction with the bracket shown at Fig. 9 is the best method of ensuring the correct setting.

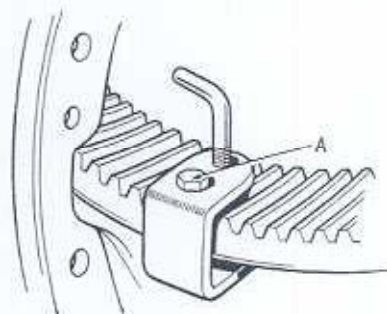
The differential crownwheel backlash must be set accurately to .007 in. (0,18 mm.); the use of a dial test indicator clamped to the crownwheel by means of the bracket illustrated and bearing on the housing flange is the only reliable method of setting to this figure.

Fig. 10. Bracket for crownwheel backlash.
A — Secure dial test indicator with this bolt.

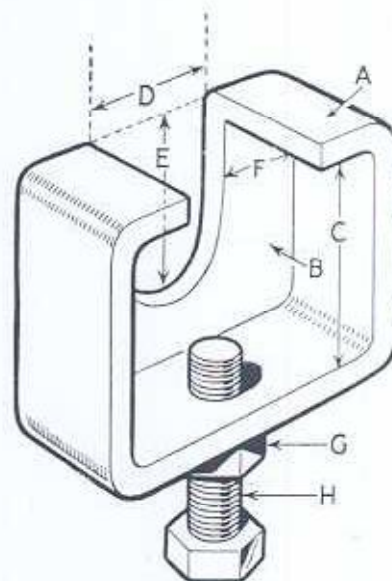
The drop arm on "60" and "75" models is pulled on to a tapered spline on the steering rocker shaft and removal may therefore prove difficult unless the extractor shown at Fig. 11 is employed. To effect removal disconnect the drag link ($\frac{7}{16}$ " self-locking nut), remove the $\frac{7}{8}$ " nut securing the drop arm, turn the road wheels on to full right lock and fit the extractor over the lugs on the drop arm boss from the front.

Fig. 11. Extractor for drop arm.

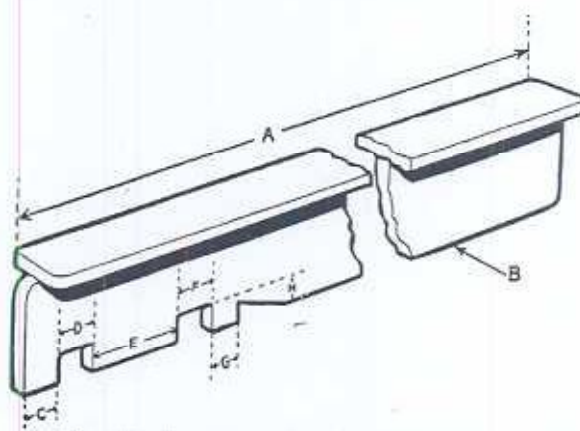
The illustration shows a bar spanner designed for adjustment of the serrated locking nuts securing the crownwheel.

Fig. 12. Bar spanner for crownwheel adjustment.

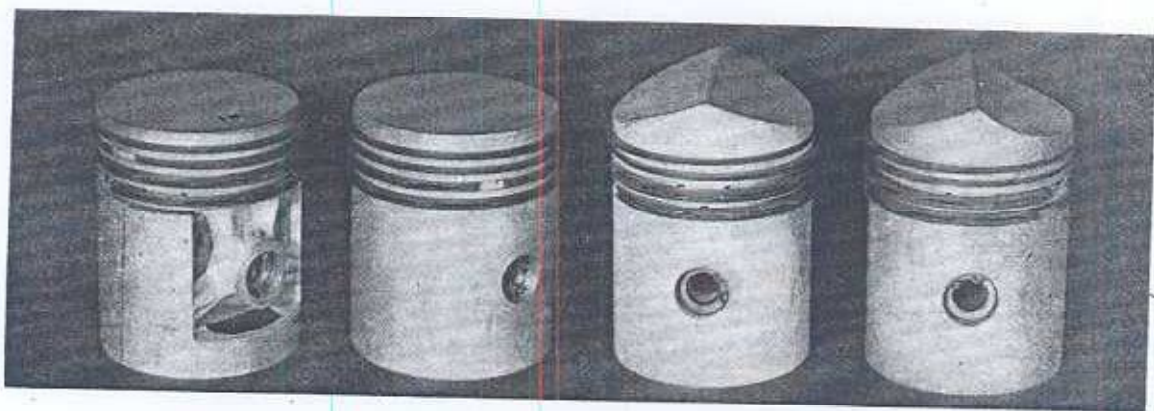
Nelson Bohnalite pistons have split skirts, while the Lo-Ex and Specialloid have solid skirts.
See Figs. 1—4.

Fig. 1. Nelson Bohnalite
10, 12, 14, 16 and 20 H.P.

Fig. 2. Lo-Ex
16 H.P.

Fig. 3. "60" and "75"
(High compression)

A reduction in compression ratio during the 1948 season on "60" and "75" car engines was made by fitting pistons having a different crown pattern (Figs. 3 and 4). For full details of this change, see Service Bulletin 5003.
