**THE ROVER COMPANY LIMITED**  
**S E R V I C E   D E P A R T M E N T**

**Rover Service News Letter No. 51**

January, 1955

**TO ALL DISTRIBUTORS AND DEALERS**

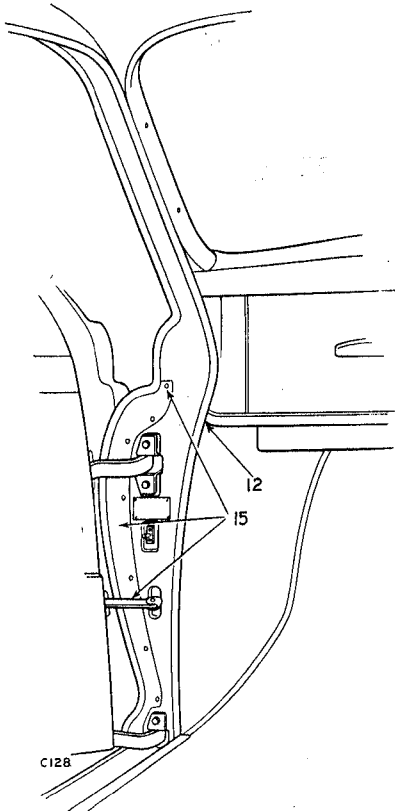
Fig. 6. Front door pillar, left-hand side.

The sealing of the rubber retaining plates on the 'A' post should be checked from the top to the level of the door check straps; add sealing compound where necessary. (See Fig. 6, Item 15.)

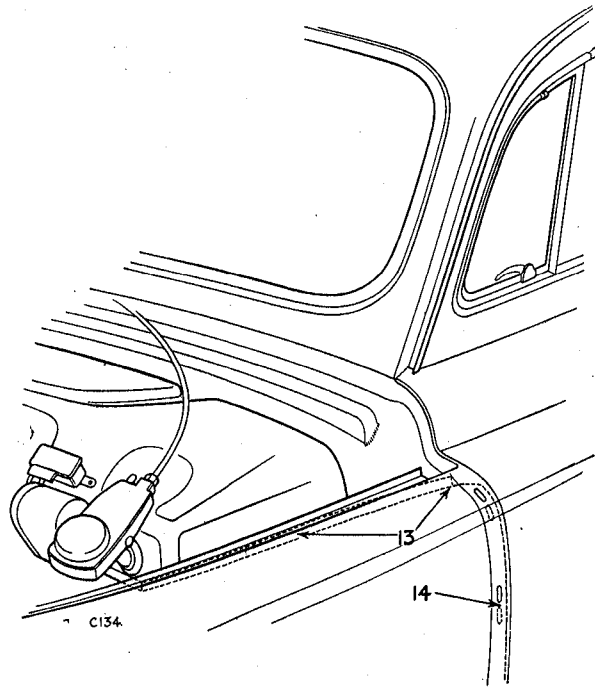
Fig. 7. Scuttle, left-hand side.

The spot welded seam, and the joint between the seam and the rear face of the 'A' post. Paint over with Bostik as necessary. (See Fig. 7, Item 13.) The angle for attaching the wing is bolted to the side of the dash by four set bolts. The slotted holes in the scuttle should be sealed with Prestik washers with 1½ in. (48 mm.) diameter aluminium washers on top; both being under the angle. (See Fig. 7, Item 14.)

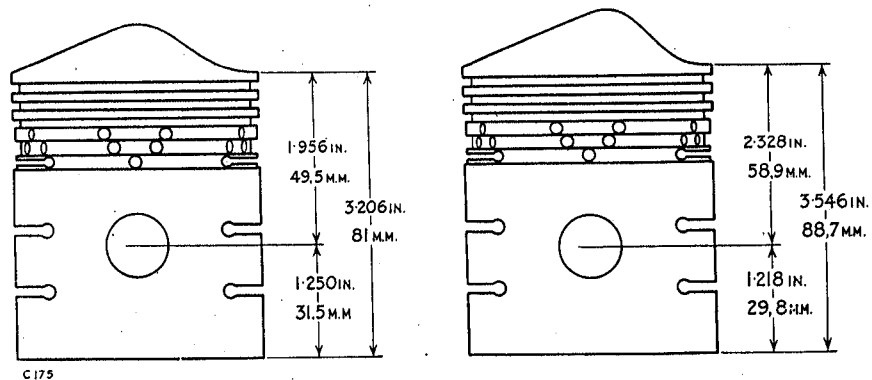
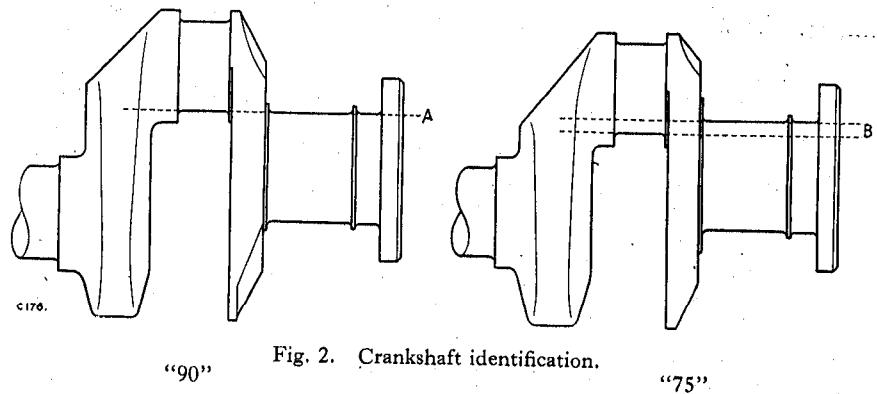
Fig. 1. Piston identification.

- Item 117 SUBJECT: PISTONS AND CRANKSHAFT.**  
**MODELS:** 1954-55 "90", 1955 "75".  
**REMARKS:** As the cylinder bore size of the 1954-55 "90" and the 1955 "75" is exactly the same, with little difference in the overall height of the piston, and with the basic dimensions of the crankshaft identical; it follows that stock can easily be confused if only a superficial examination is given when binning, supplying or fitting these parts. Great care must be taken to ensure that the correct type of piston and crankshaft, for the model concerned, is supplied and fitted when engines in the above range are being overhauled.
- It is possible to fit the wrong pistons or crankshafts in either model and this could of course have disastrous results. The sketches below clearly show the means of identification of the two types of piston and crankshaft.

In addition the pistons can be identified by the casting number on the inside of the piston skirt as follows:—

“75” Casting No. M1577-2, “90” Casting No. 240633.

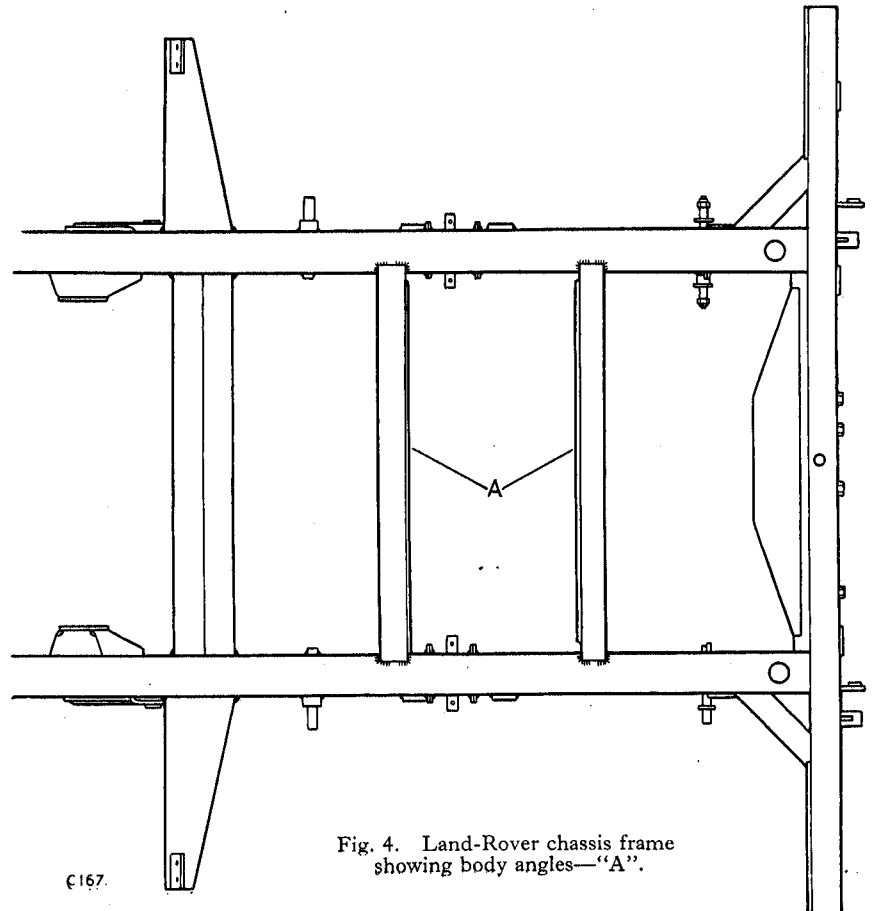
Fig. 4. Land-Rover chassis frame showing body angles—"A".

REMARKS: Future supplies of chassis frame Part No. 236805 will be complete with the body support angles suitable for the 1952-53 Land-Rover. When using these chassis frames on 1950-51 models, in the range detailed above, it will be necessary to remove those body support angles marked "A" in the sketch below.
