6.4.3 Wafer Quality and Saw Damage

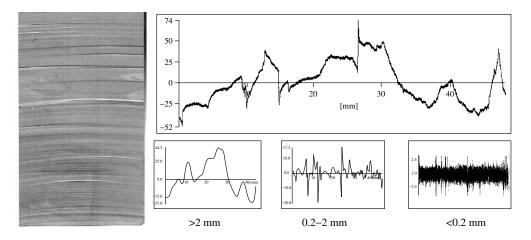
Figure 6.20 Surface structure of a wafer with grooves resulting from uneven cutting. It also shows the bowing of the wire under load during sawing. The surface profile measured by a laser scanner profiler is depicted on the right. Different wavelengths filtered from the profile are shown below

On a length scale of about 100 μ m, the surface may have a wavy topology that is not detrimental unless sharp steps occur. On the micrometer-length scale the surface shows a certain roughness, which is directly related to the microscopic sawing process as described before. The extent of saw damage, which has to be etched away before solar cell processing, lies typically in the range of 5 to 10 μ m.
