## History of Frequency Traceability at HP-Santa Clara

Bob Pitcock/Hewlett-Packard

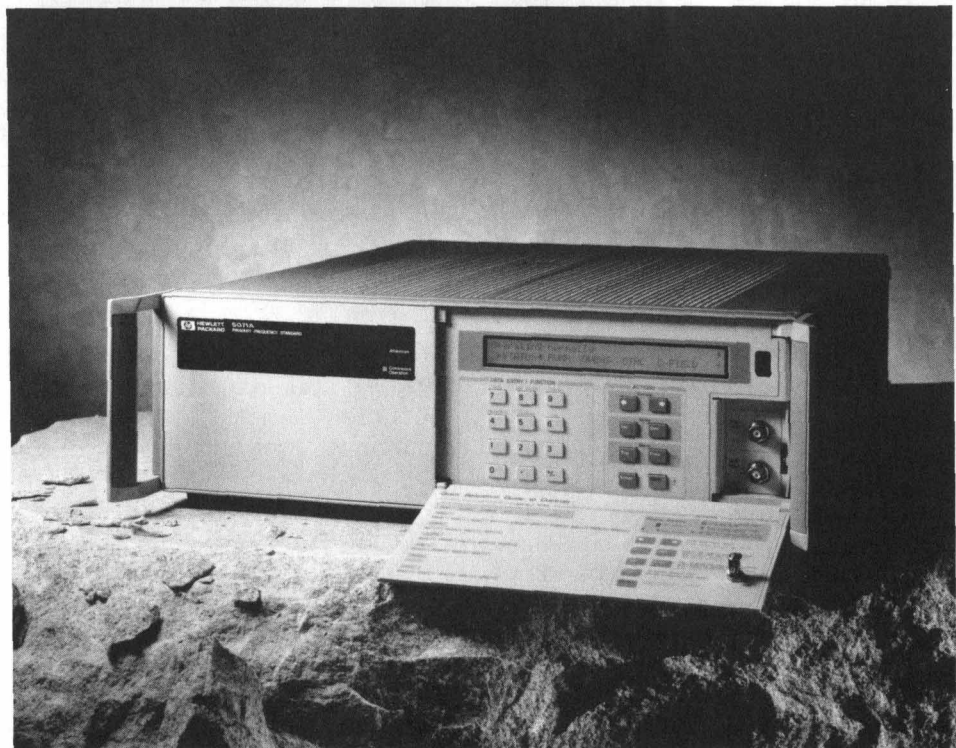
HP 5071A Primary Frequency Standard.

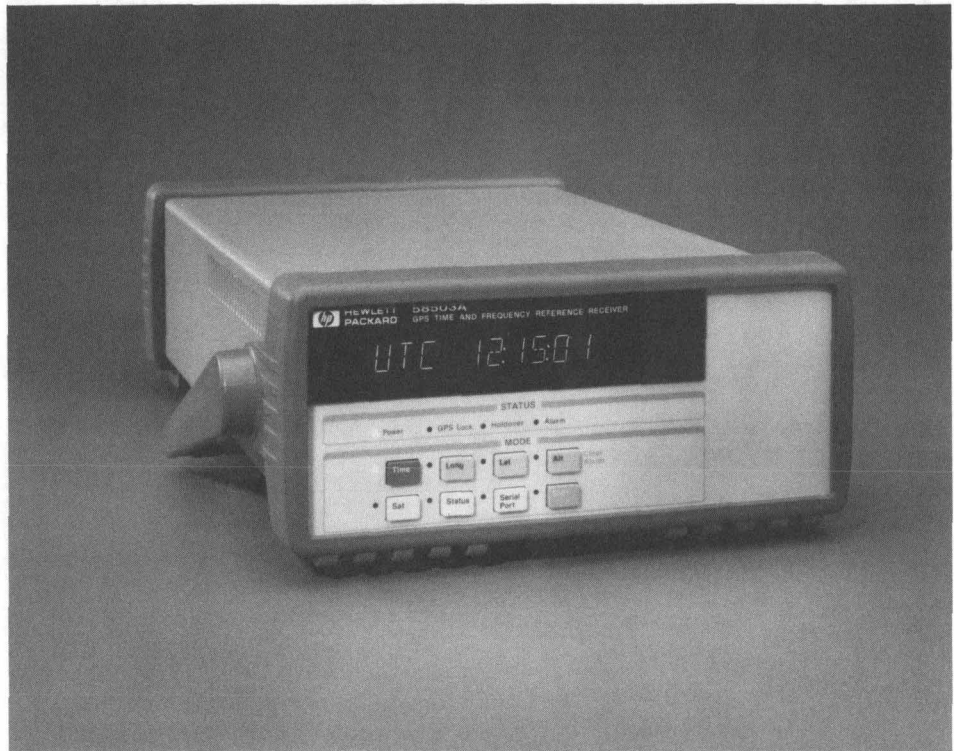
**HP 58503A GPS Time and Frequency Reference Receiver.**

The FMAS system consists of an Intel™ 486 PC, GPS receiver, time interval counter with 40 picosecond resolution, and a modem. The signal from the GPS receiver is compared to our primary frequency standard. Over a period of time, 30 days for us, we can obtain very accurate frequency uncertainties. In order to improve our uncertainty, we have replaced the NIST GPS receiver with our HP 58503A. The performance of the system is at least ten times better now than it was before. Over a 30 day
