# German Battleships 1939–45

Gordon Williamson • Illustrated by Ian Palmer

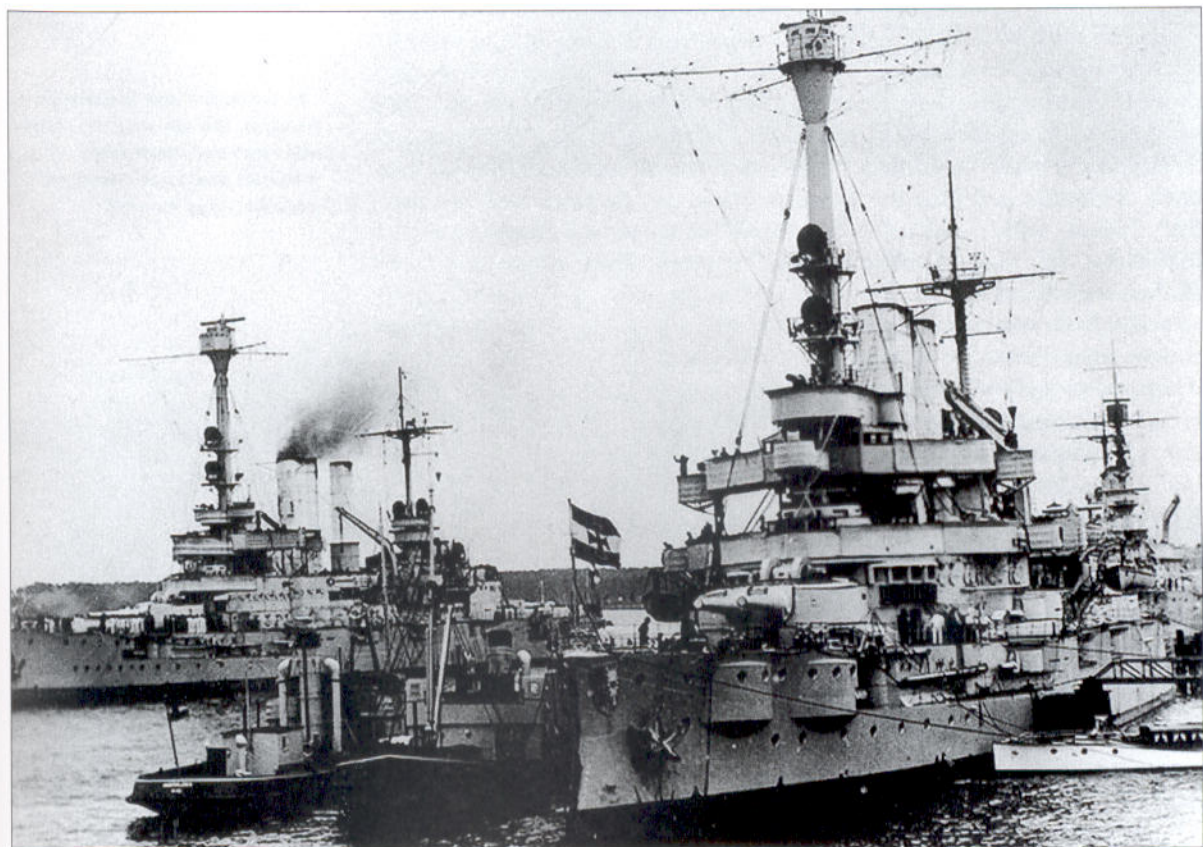
The two dreadnoughts *Schlesien* (left) and *Schleswig-Holstein* (right) in their post-refit form, with the forward funnel removed. This pre-1935 photograph shows the old flag of the Reichsmarine being flown on the bow flagstaff.

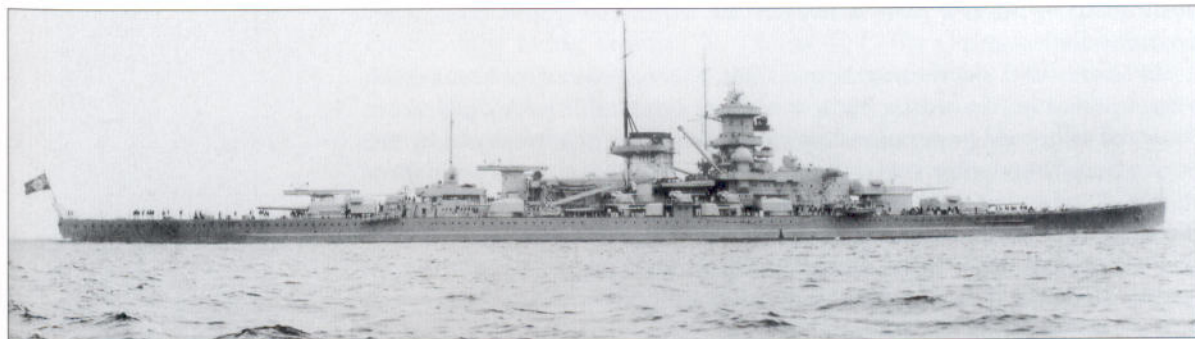
An excellent broadside study of *Scharnhorst* as originally completed. At this point she was almost identical to *Gneisenau*.

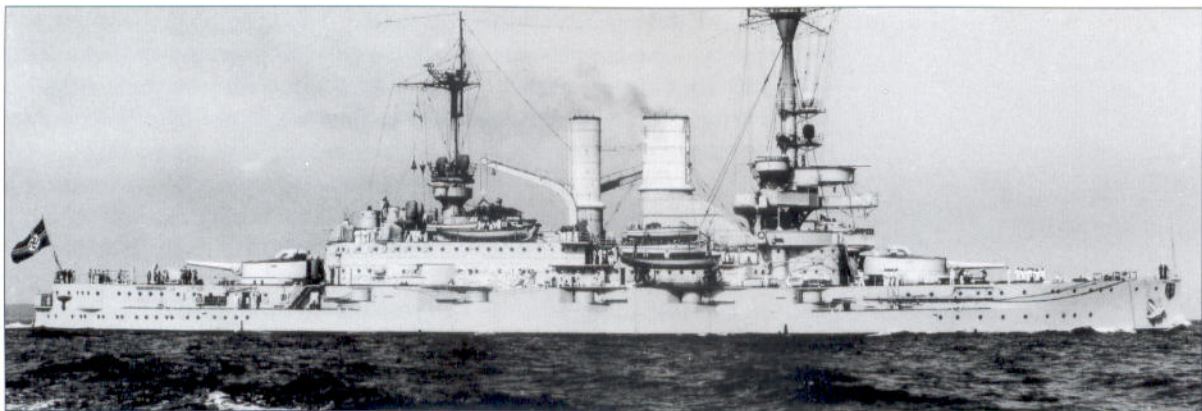
*Schleswig-Holstein* after her refit. Note the new *Reichskriegsflagge* being flown in this post-1935 photograph. Note also the large bronze eagle and swastika mounted on her hullside near the stern.

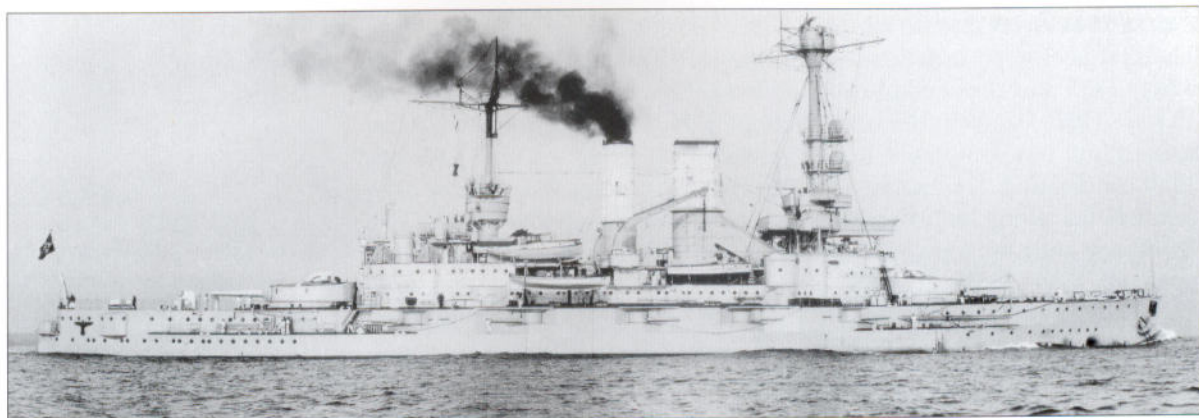
**Schlesien, post-refit. The two sisters were virtually identical by this point.**

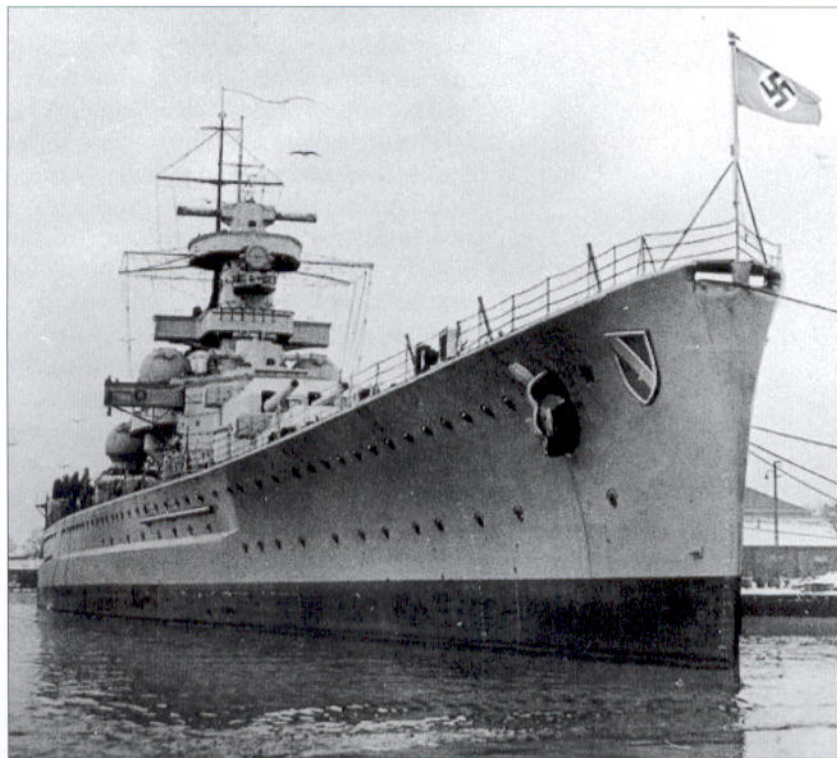
**A bow view of the *Scharnhorst* in her initial form with straight stem. The 'mattress' radar antenna for the FuMO system has not yet been fitted to the rangefinder on her foretop. During her refit, the anchors were also moved from the hullside ports to clunes on the edge of the deck.**

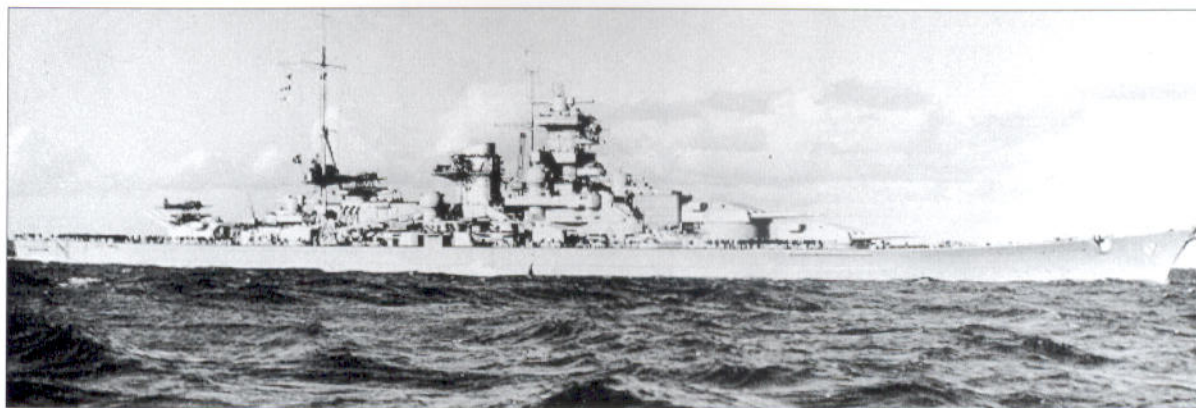
**Scharnhorst in post-refit form with 'Atlantic' bow and angled funnel cap, but still retaining the second aircraft catapult on turret 'Caesar'. Although very similar to Gneisenau, her identity is immediately established by the siting of the mainmast, which on Gneisenau remained sited to the rear of the funnel.**

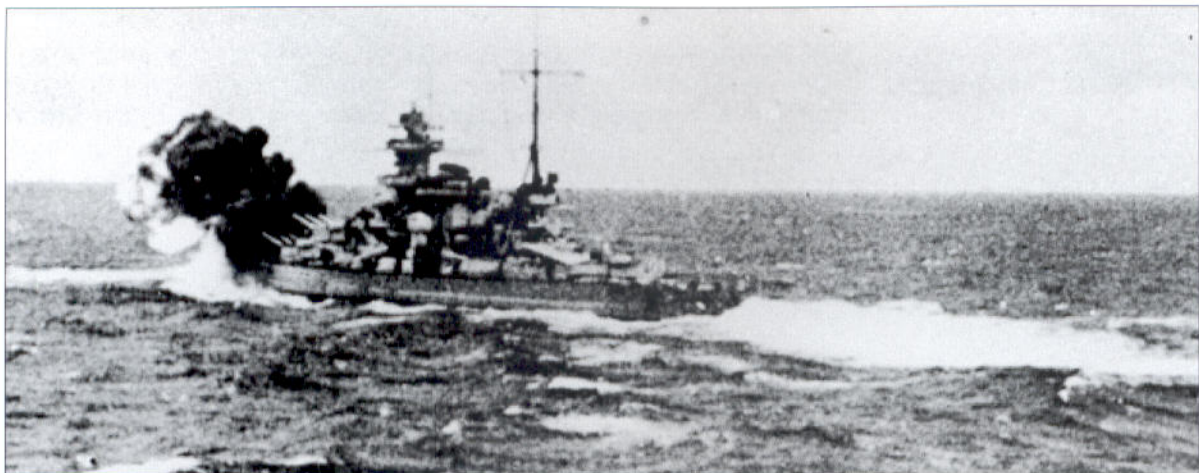
**Scharnhorst at sea during the engagement with *Rawalpindi*. She has just fired a salvo from her forward main armament.**

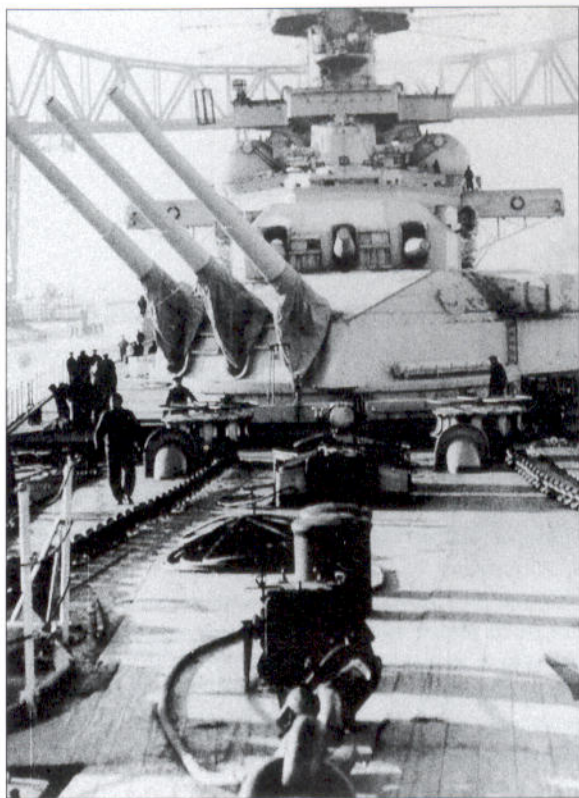
The view towards the forward turrets 'Anton' and 'Bruno' from the bow of *Scharnhorst*, gives a good impression of the huge size of her main armament. Note that the canvas blast bags are fitted on the gun barrels of turret 'Anton' only. This shot also gives a good view of the large searchlight mounted on the face of her tower just above the bridge.

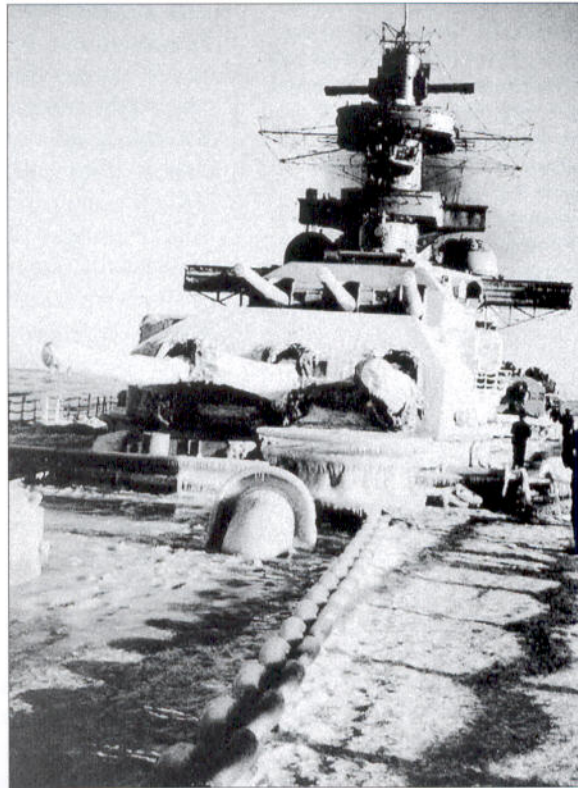
**A further view from the bow of *Scharnhorst* shows just how heavily iced this area became during severe winter weather, a problem exacerbated by her tendency to ship vast amounts of water over the fo'c'sle in heavy seas.**

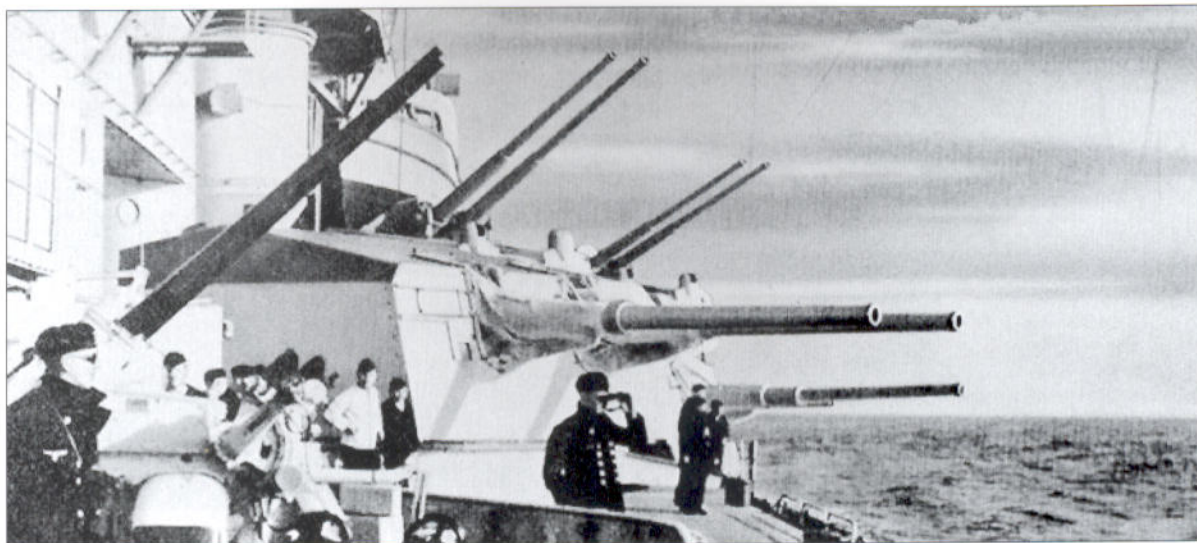
An excellent view of one of *Scharnhorst's* secondary turrets, mounting 15cm guns. The guns shown at high elevation behind this turret are those of her main 10.5cm flak batteries. One of the ship's boats can be seen just above these flak guns.

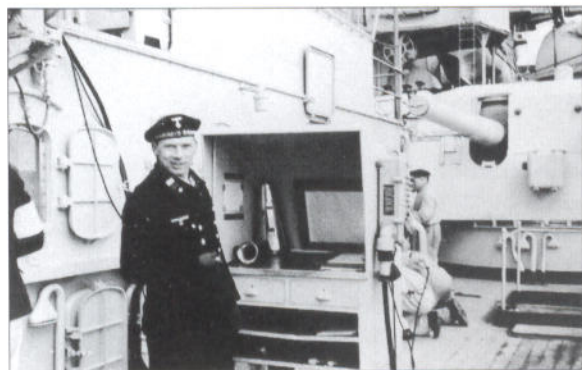
Another detail view taken on *Scharnhorst's* starboard side main deck looking forward towards one of her secondary armament turrets.

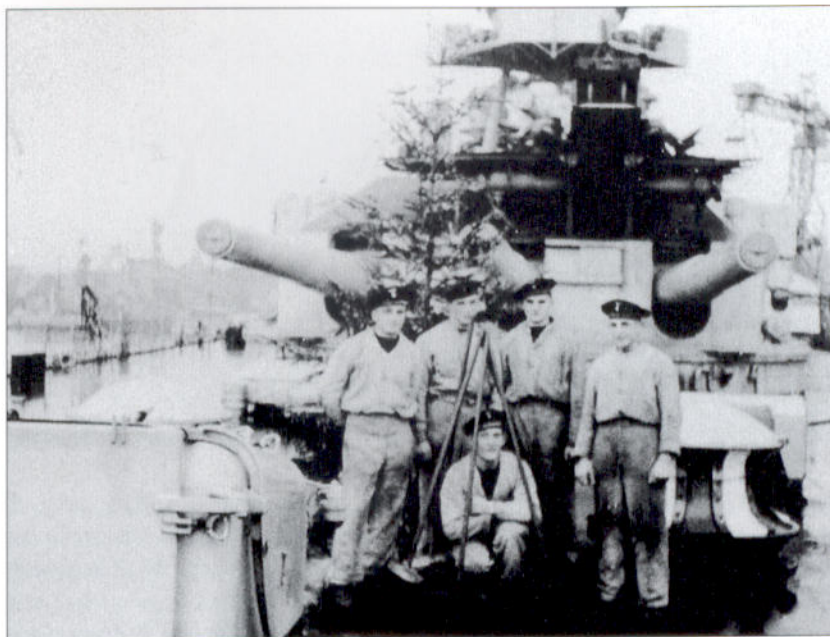
Crewmen in working rig pose for a photograph on *Scharnhorst's* quarterdeck. The catapult on turret 'Caesar' can just be discerned, as can the darker red-coloured paint on the turret roof. Given the tree visible behind these crewmen, it is assumed that this photo was taken around Christmas time.

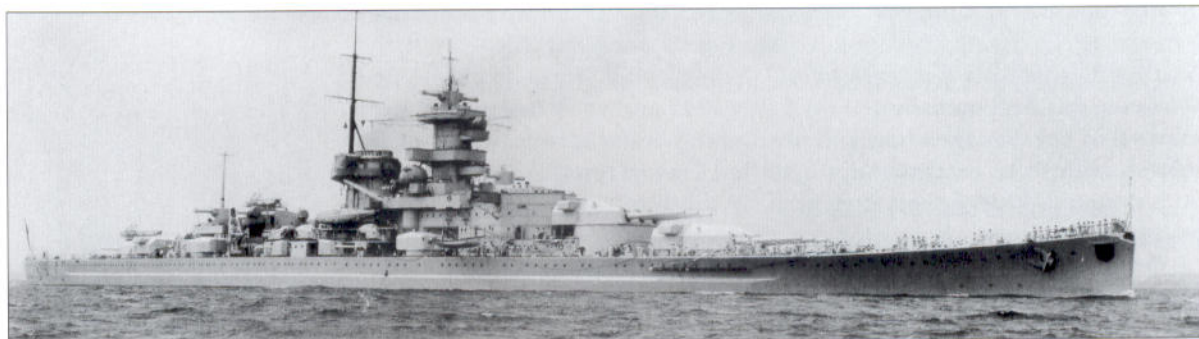
With several of her crew members in their summer whites on the fo'c'sle, *Gneisenau* ploughs through the calm waters of the Baltic.

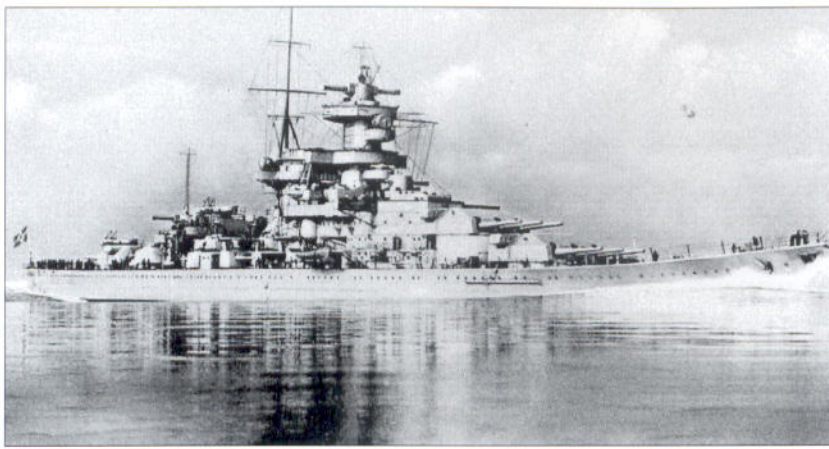
*Gneisenau* is seen here in her initial form, with straight stem and with the catapult still fitted over turret 'Caesar'. Given the flat calm seas and the sizeable bow wave (compared to the previous photograph), it seems likely that this shows her at high speed during her trials.

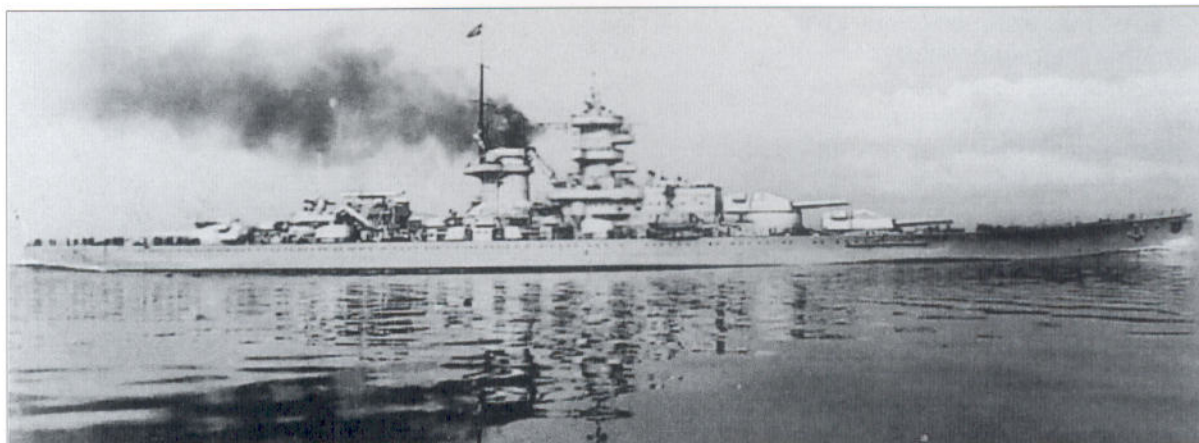
**Gneisenau as depicted on a period propaganda photograph. This shows her graceful lines to good advantage.**

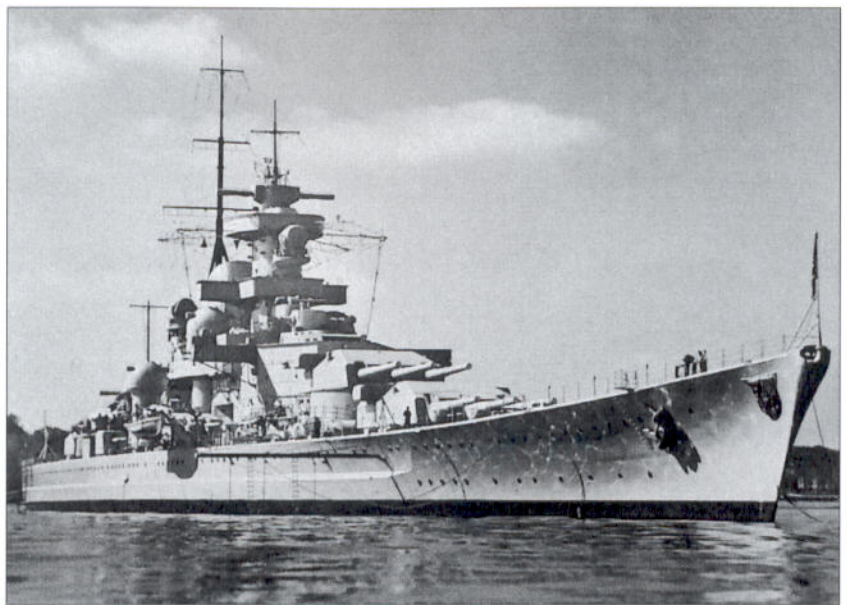
This view shows *Gneisenau* after her refit, now sporting the raked 'Atlantic' bow, which did little to cure her tendency to ship considerable amounts of water over her fo'c'sle at speed or in heavy seas. The angled funnel cap can just be seen by the base of her mainmast. That this is a pre-war photograph is confirmed by the presence of the ship's crest on the bow. It was removed on the outbreak of war.

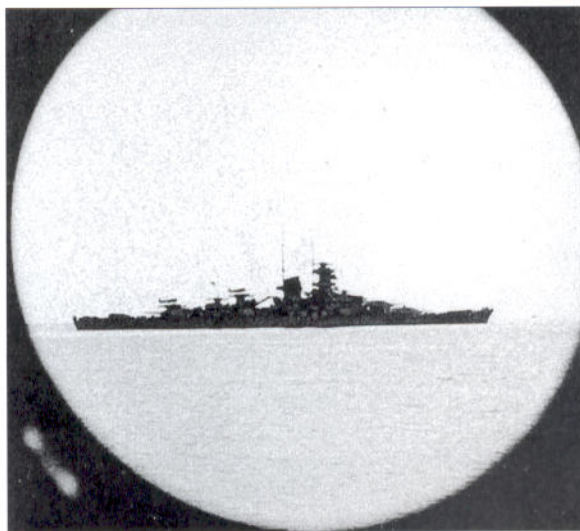
*Gneisenau*, framed by one of the portholes on her sister, the *Scharnhorst*. Though this shows her in post-refit form, she still sports the catapult on turret 'Caesar'. The tiny silhouettes of her Arado 196 seaplanes can be clearly seen.

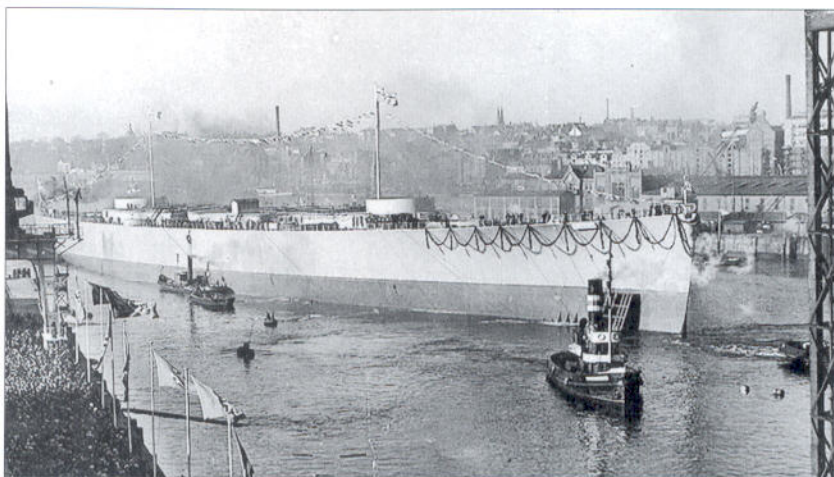
*Bismarck's* hull slides onto the waters at the Blohm & Voss yard in Hamburg on 14 February 1939. She has the original straight stem that was replaced by an 'Atlantic' bow during her fitting out. Only the first level of superstructure has been completed along with the raised barbettes for turrets 'Bruno' and 'Caesar'.

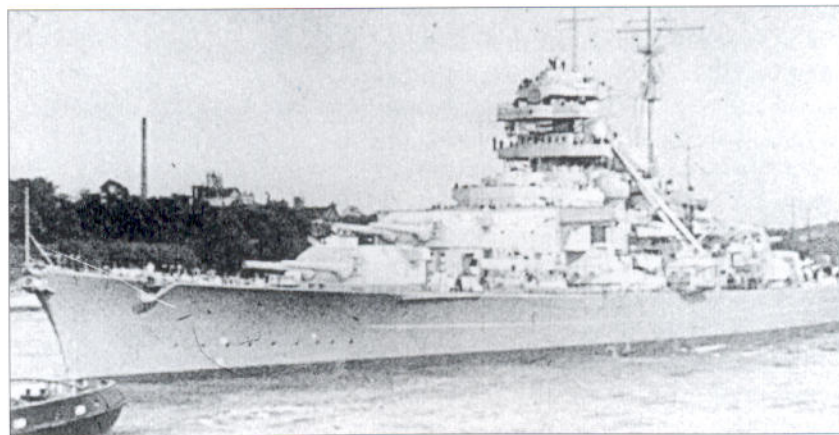
**The *Bismarck* shortly after her completion and commissioning, immaculate in her fresh light grey paintwork. Note that the main fire control rangefinder on her foretop has not yet been fitted.**

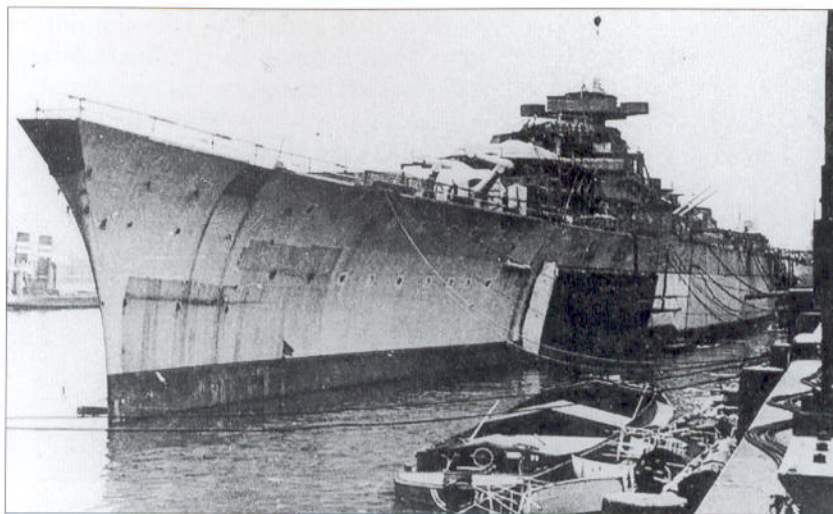
***Bismarck* during fitting out. The straight stem originally fitted has already been replaced by the 'Atlantic' bow.**

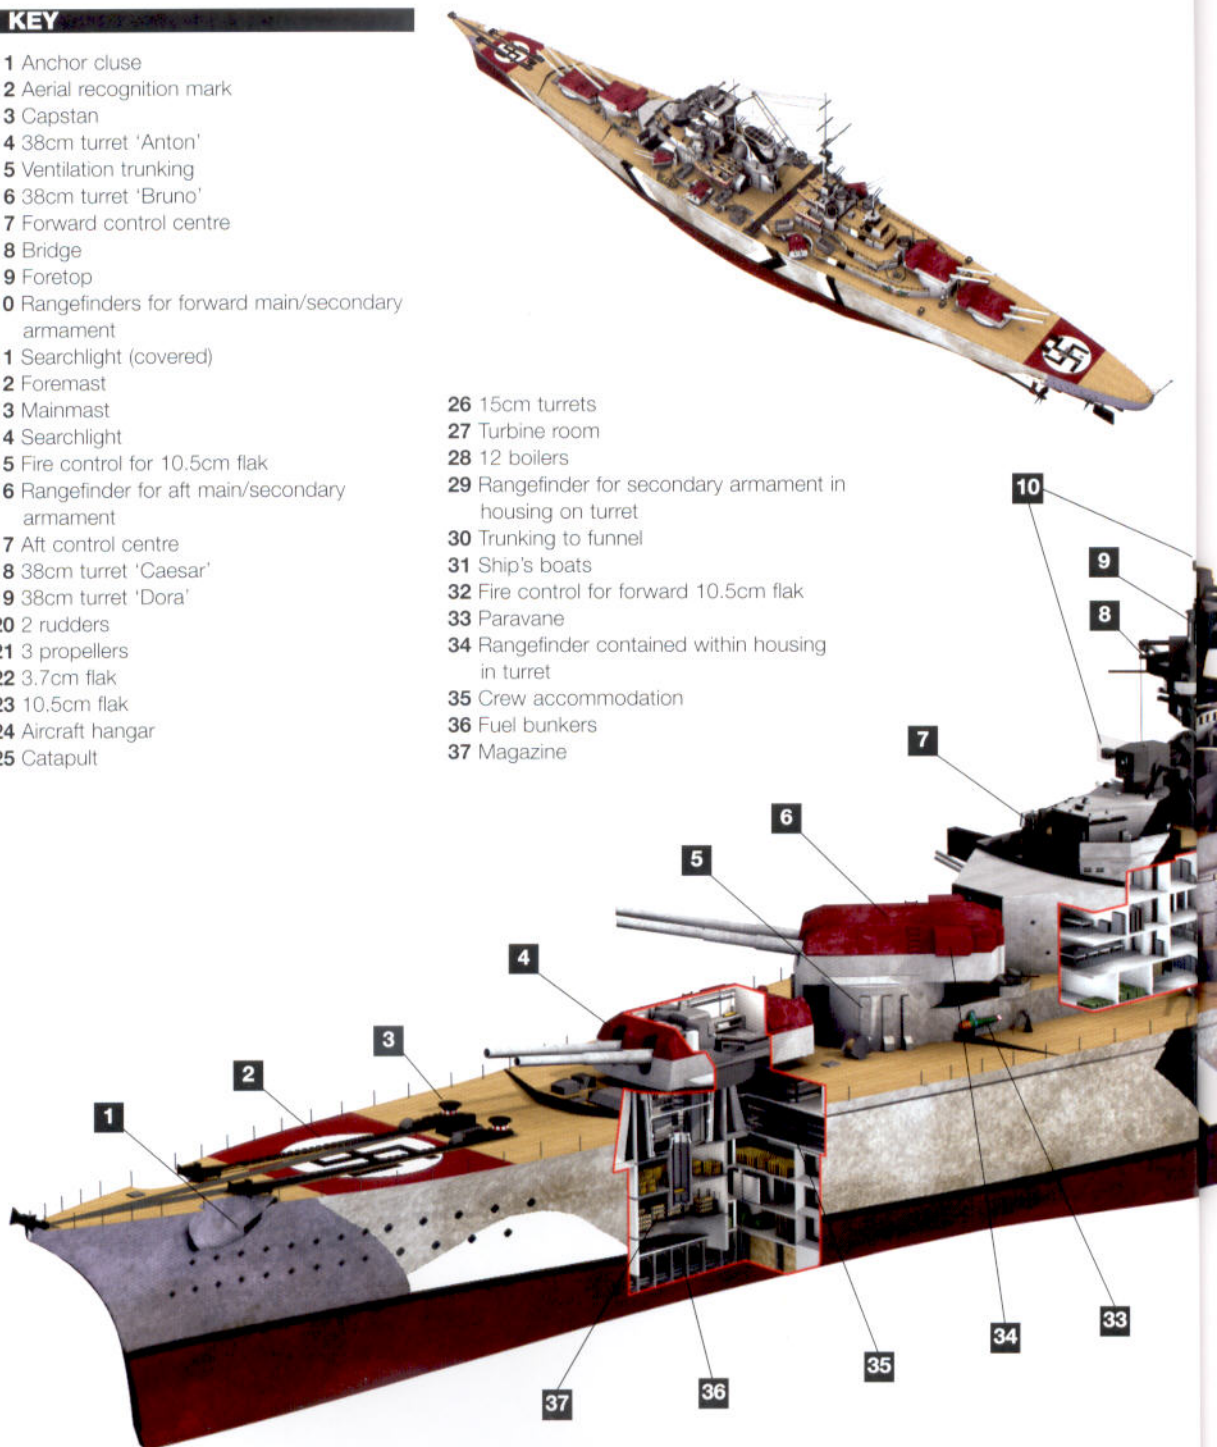
# D: CUTAWAY VIEW - BISMARCK-CLASS BATTLESHIP

- 1 Anchor cluse
- 2 Aerial recognition mark
- 3 Capstan
- 4 38cm turret 'Anton'
- 5 Ventilation trunking
- 6 38cm turret 'Bruno'
- 7 Forward control centre
- 8 Bridge
- 9 Foretop
- 10 Rangefinders for forward main/secondary armament
- 11 Searchlight (covered)
- 12 Foremast
- 13 Mainmast
- 14 Searchlight
- 15 Fire control for 10.5cm flak
- 16 Rangefinder for aft main/secondary armament
- 17 Aft control centre
- 18 38cm turret 'Caesar'
- 19 38cm turret 'Dora'
- 20 2 rudders
- 21 3 propellers
- 22 3.7cm flak
- 23 10.5cm flak
- 24 Aircraft hangar
- 25 Catapult
- 26 15cm turrets
- 27 Turbine room
- 28 12 boilers
- 29 Rangefinder for secondary armament in housing on turret
- 30 Trunking to funnel
- 31 Ship's boats
- 32 Fire control for forward 10.5cm flak
- 33 Paravane
- 34 Rangefinder contained within housing in turret
- 35 Crew accommodation
- 36 Fuel bunkers
- 37 Magazine

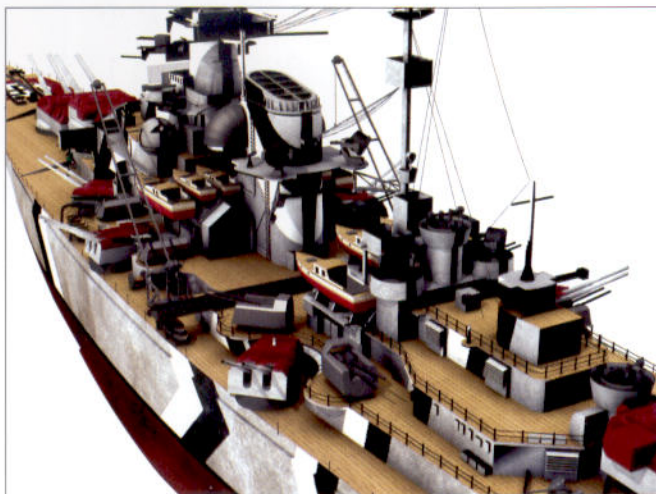
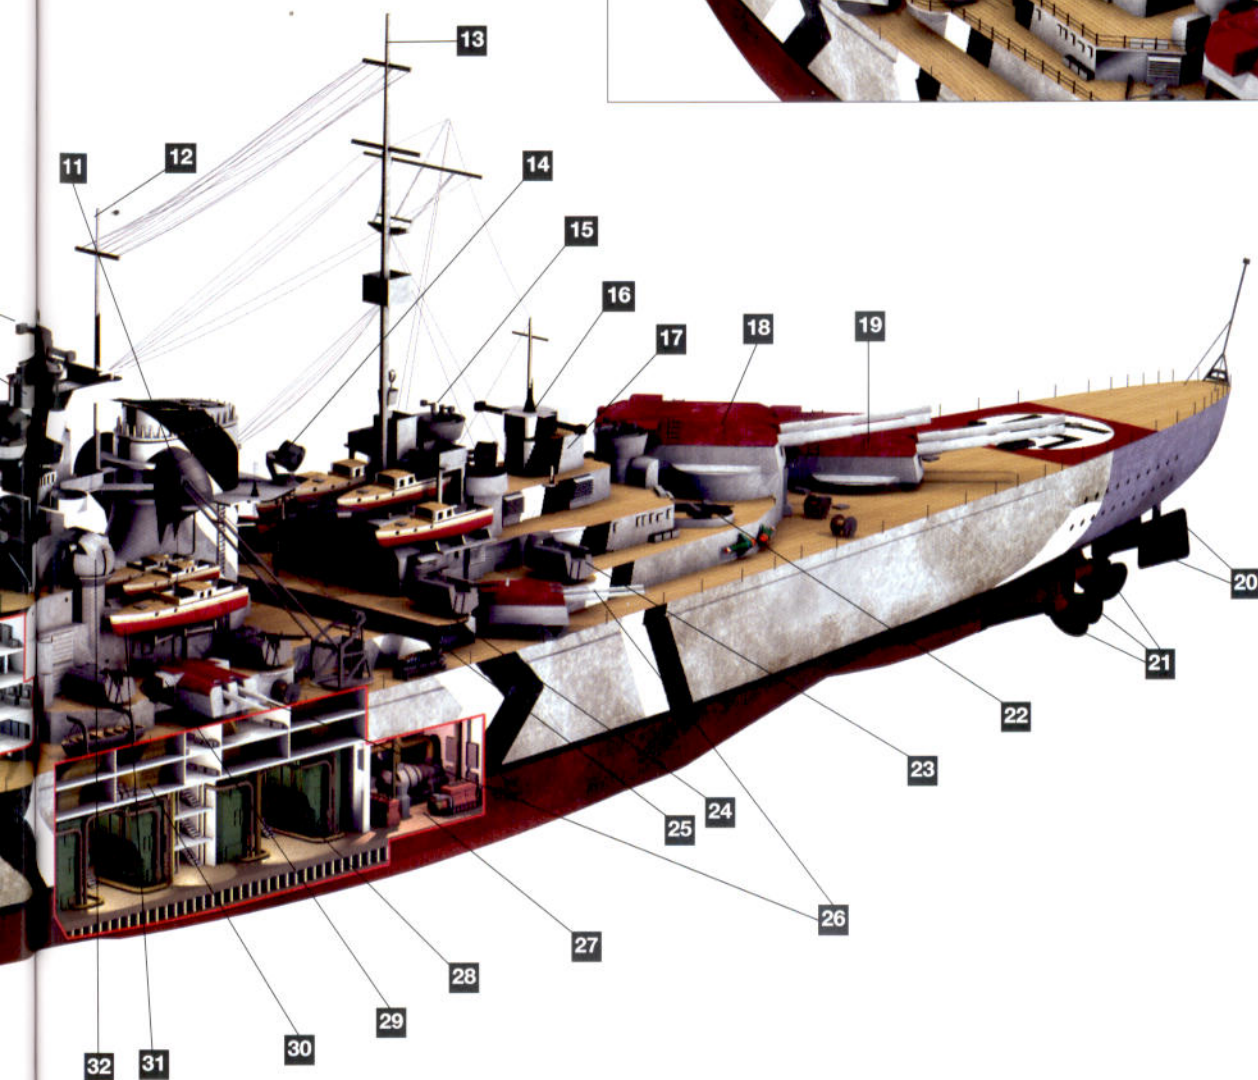
## KEY

16 x 3.7cm flak guns

20 x 2cm flak guns

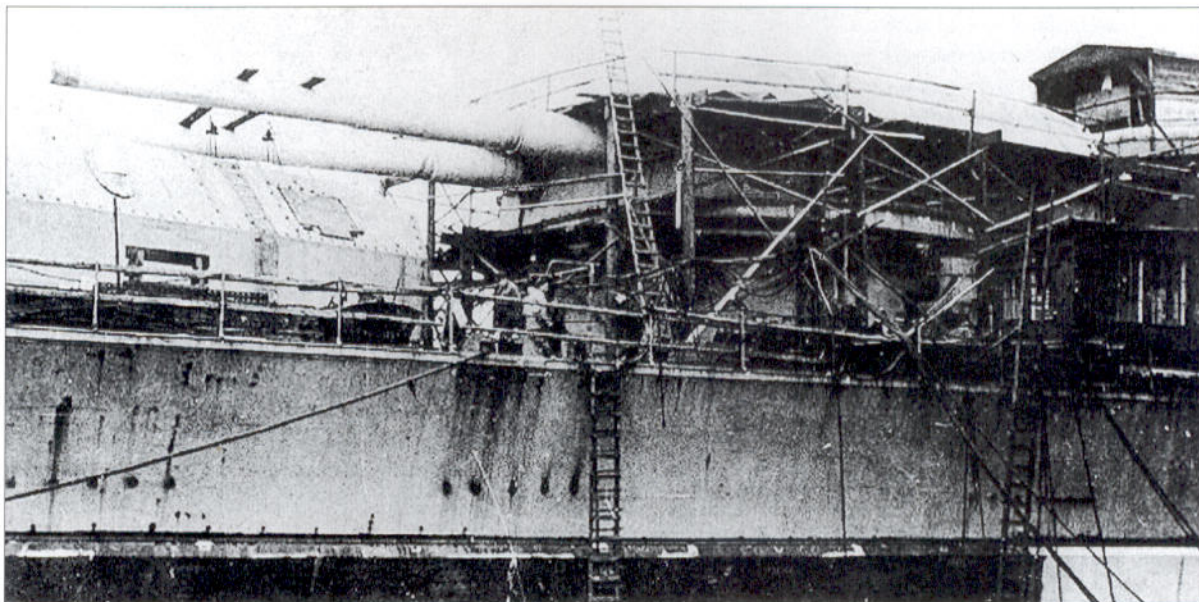
**Construction of the main 38cm gun turret 'Bruno' during fitting out. The guns are in place and work is ongoing in building the armoured turret around them. The plethora of scaffolding and ladders is typical of a ship under construction.**

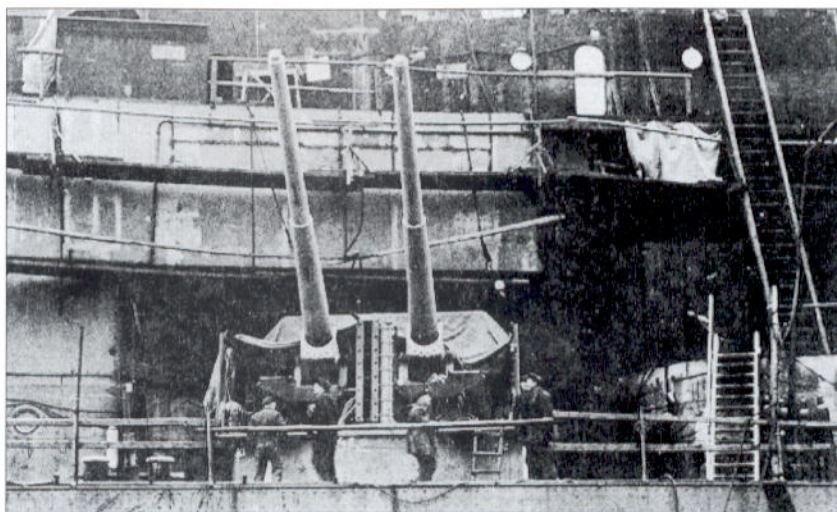
Construction of one of *Bismarck's* 10.5cm twin heavy flak guns. Note how the barrels are first installed on the base mount, and then the turret housing built around them.

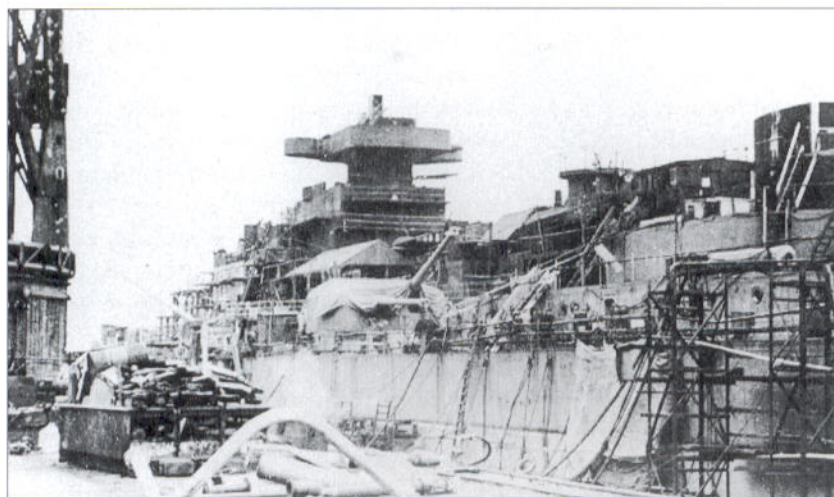
Bearing little resemblance to the sleek, graceful ship she would soon become, *Bismarck* is covered with clutter and liberally draped with electrical cabling to power the workers' tools and provide lighting to the ship's interior. The roofed structure just visible above the secondary turret is the port hangar for the ship's Arado 196 floatplanes.

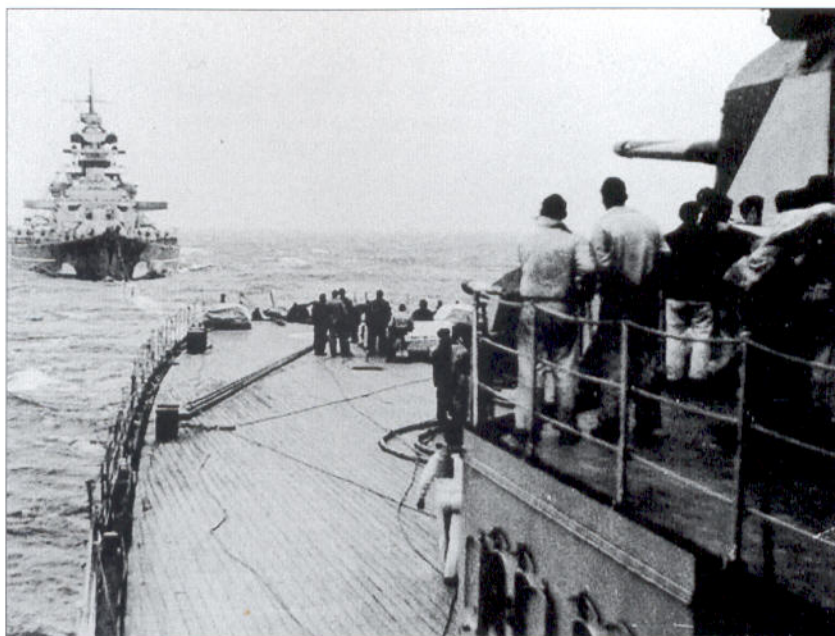
*Bismarck* carrying out refuelling from *Prinz Eugen* during training exercises. The massive beam of this huge warship can be seen to good effect here. The dark grey forward part of the hull and false bow waves can also be seen clearly.

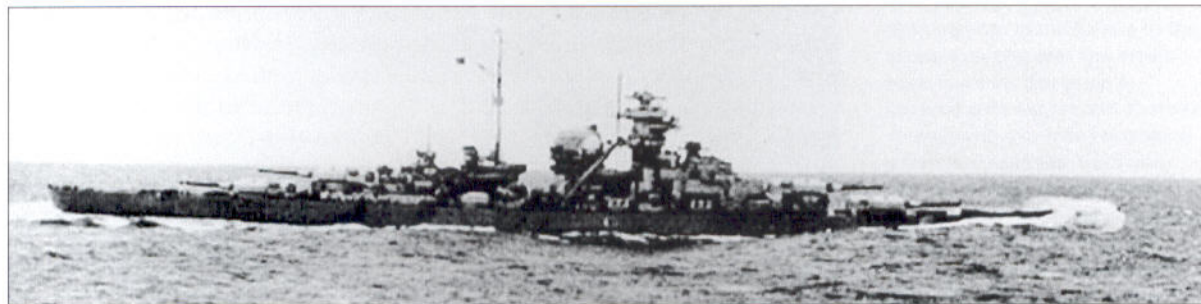
One of the last photographs taken of *Bismarck*. Shot from *Prinz Eugen*, she can be seen to be down by the bows having shipped a considerable amount of water through the hole caused by a direct hit from *Prince of Wales*.

*Bismarck*, however, had also suffered a number of hits. One shell from *Prince of Wales* had ripped a hole right through the ship from port to starboard, allowing over 2,000 tonnes of water to be shipped. Another hit caused significant flooding in one of the boiler rooms. More significantly, *Bismarck* was now suffering from an oil leak, which would make it much easier for the enemy to find and track her.

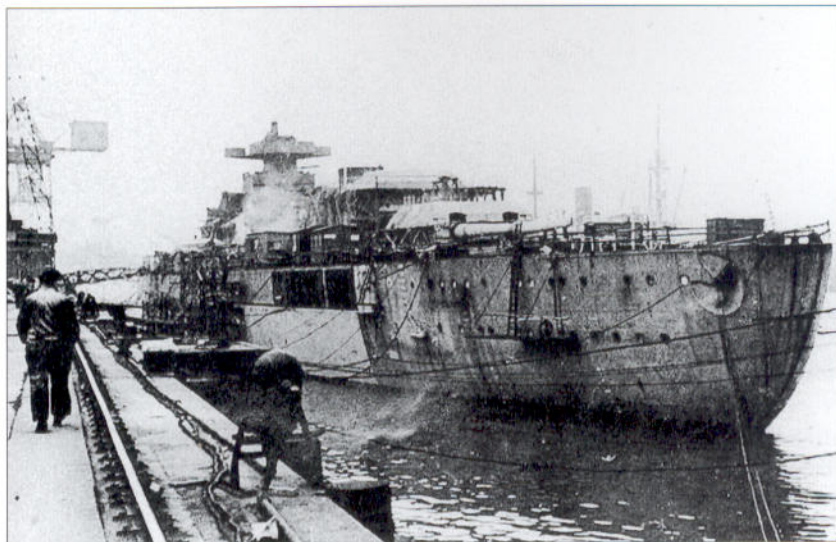
The massive turret 'Dora' can be seen in this stern view of *Bismarck* during her fitting out.

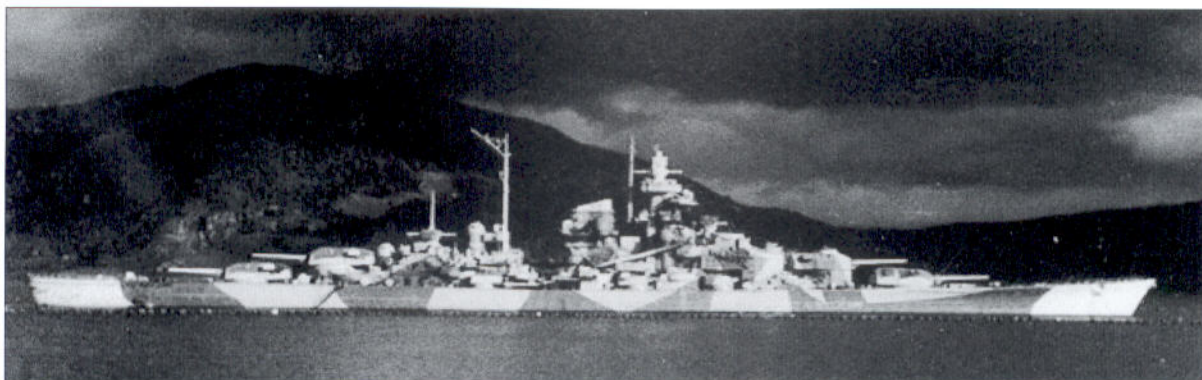
**This atmospheric shot shows *Tirpitz* at her anchorage. Note the light/dark grey splinter-pattern disruptive camouflage. This was one of several paint schemes sported by *Tirpitz* during her service career. Additional quad 2cm anti-aircraft guns have been fitted to the roof of turret 'Bruno' and the forward part of her main superstructure, and the ship is surrounded by anti-torpedo netting.**

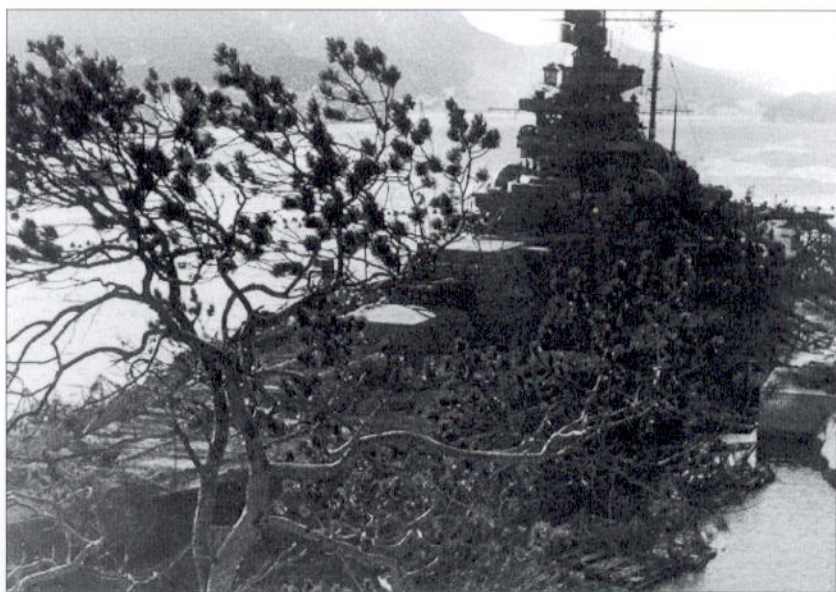
***Tirpitz* at her mooring, shrouded by camouflage netting. Even when damaged severely enough to prevent any further combat use, she represented a serious enough threat that the British spared no effort in seeking her total destruction.**

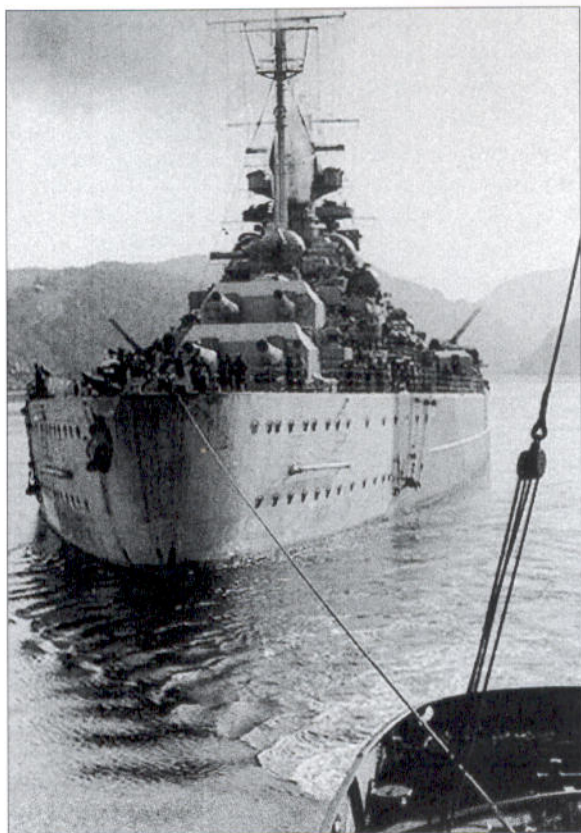
A tug slowly manoeuvres *Tirpitz* into her mooring site in the flat, calm waters of Kaafjord.

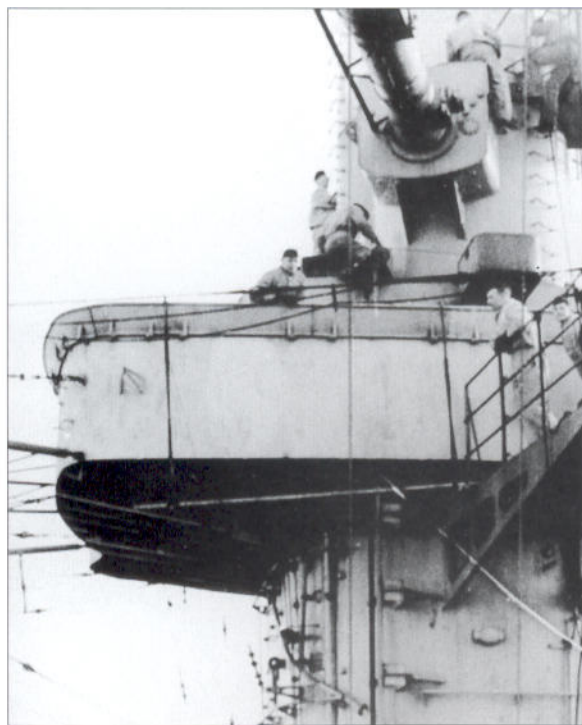
Each of the main armament turrets in the *Scharnhorst*- and *Bismarck*-class battleships, with the exception of turret 'Anton' in the *Bismarck*, was provided with 10.5m rangefinders. The viewing ports for these are within the projecting housings, which may be seen in the rear corners of these turrets. The centre of each of the three main secondary armament turrets of the *Bismarck* class were also provided with their own basic 7m rangefinder devices.

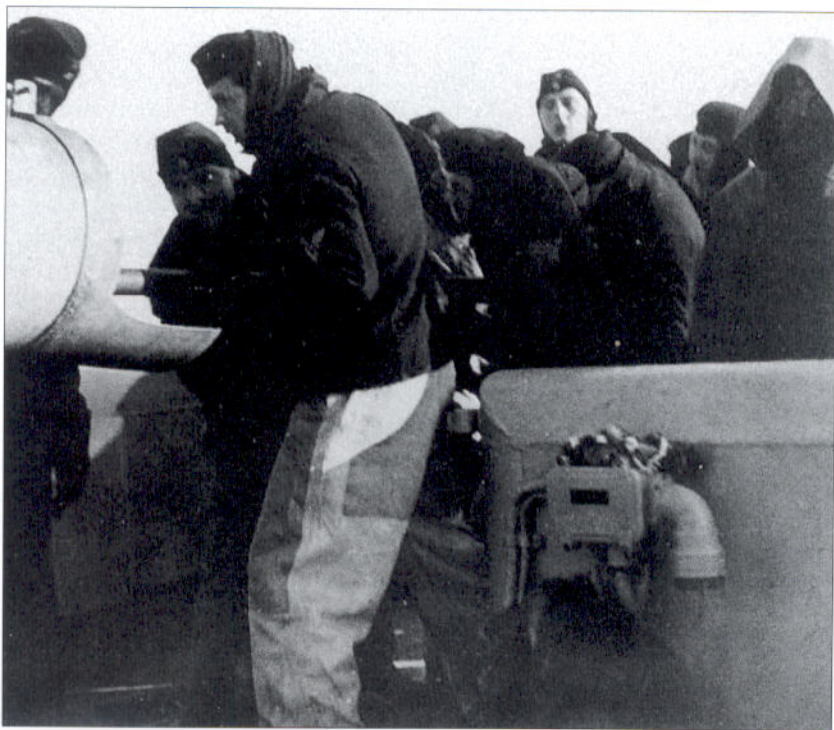
Heavy work for crewmen of the *Scharnhorst* as they clean out the bore of one of the main 28cm guns.

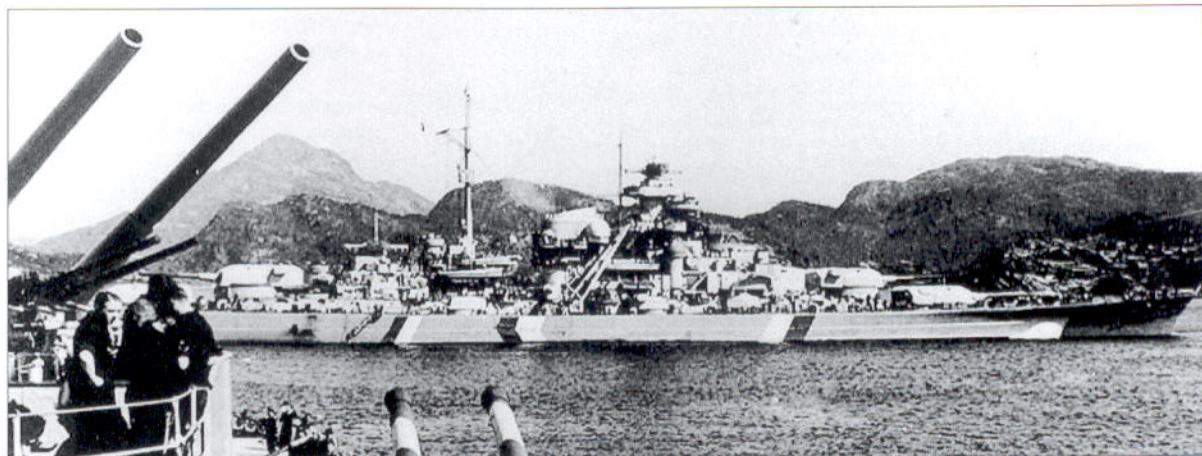
ABOVE *Bismarck* is seen here still sporting her 'Baltic' camouflage scheme of bold black/white angular stripes. Note the darker area on the forward part of her hull, and the false bow wave painted where this meets the light grey of the major portion of her hull. This scheme was painted out before she set off on Operation *Rheinübung*.

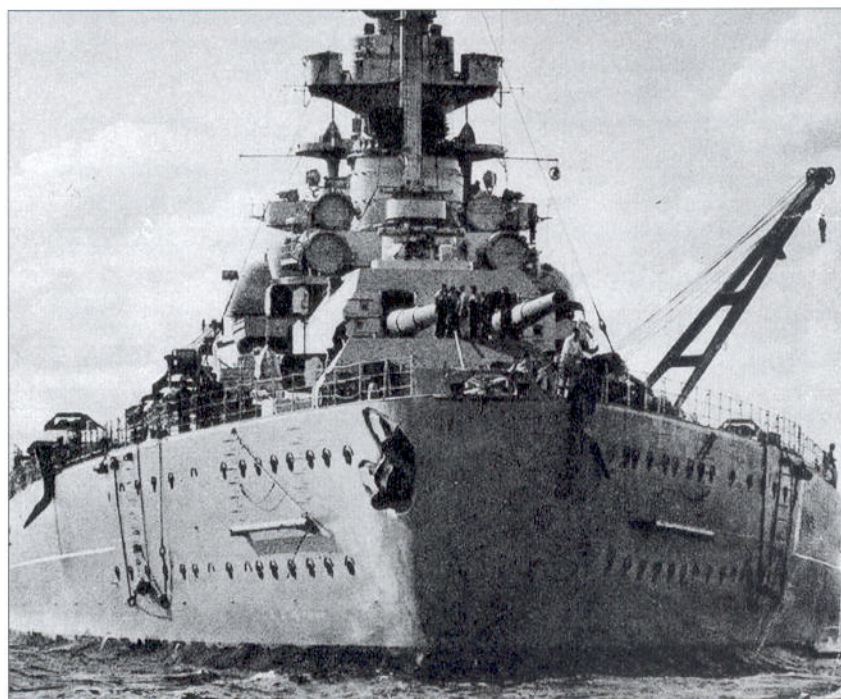
LEFT The sheer bulk of *Bismarck* is clear from this stern view. The size of the turrets can be gauged by the crew figures standing on the roof of turret 'Dora'. The large derrick seen to starboard is used for recovering the ship's boats and the Arado floatplanes.
