# JAGDPANZER 38

## 'HETZER'

1944-1945

NEW VANGUARD: 36

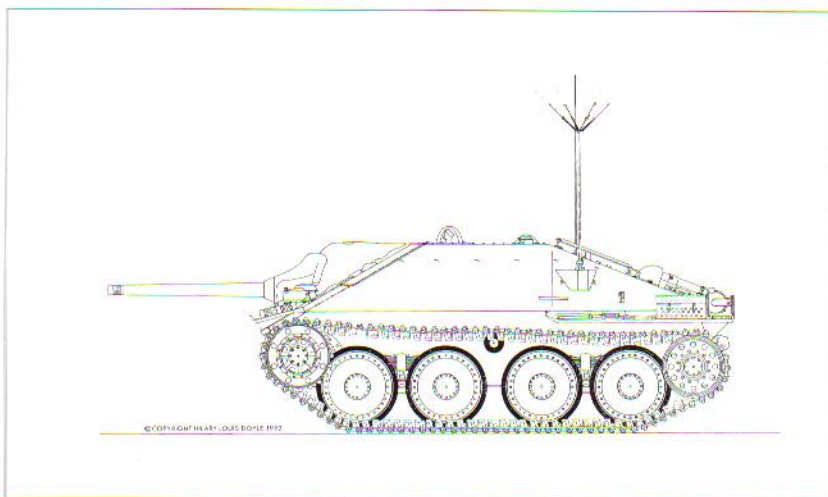
1:76 scale front and side views of the first Sturmgeschütz 38(t), Fgst.Nr.321001. This vehicle was fitted out as a Befehlspanzer (command vehicle) with the extra antenna on the left side for the long-range radio. (Hilary Louis Doyle)

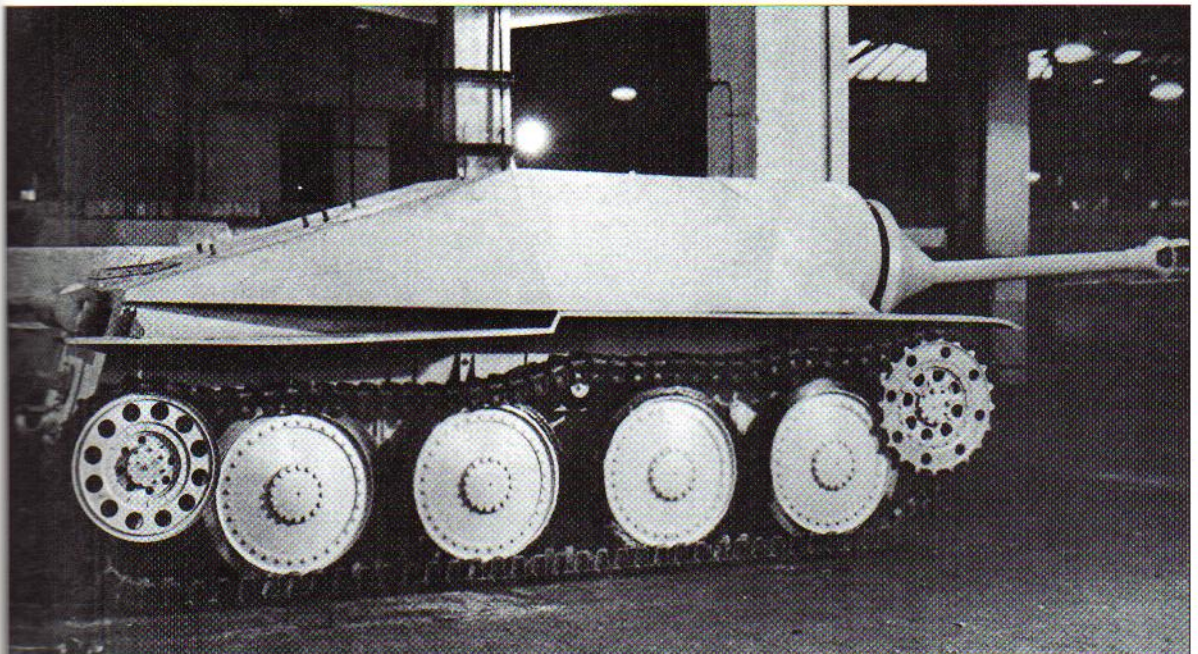
**The first wooden mock-up of the Sturmgeschütz 38(t) was ready in January 1944. The fighting compartment was shorter than on the production series. Note the longer-sloped motor cover. The front armour plate was cut vertically at the sides above the track guards. A conical mantle and a muzzle brake were planned for the 7.5cm Pak 39 at this time. (BMM)**

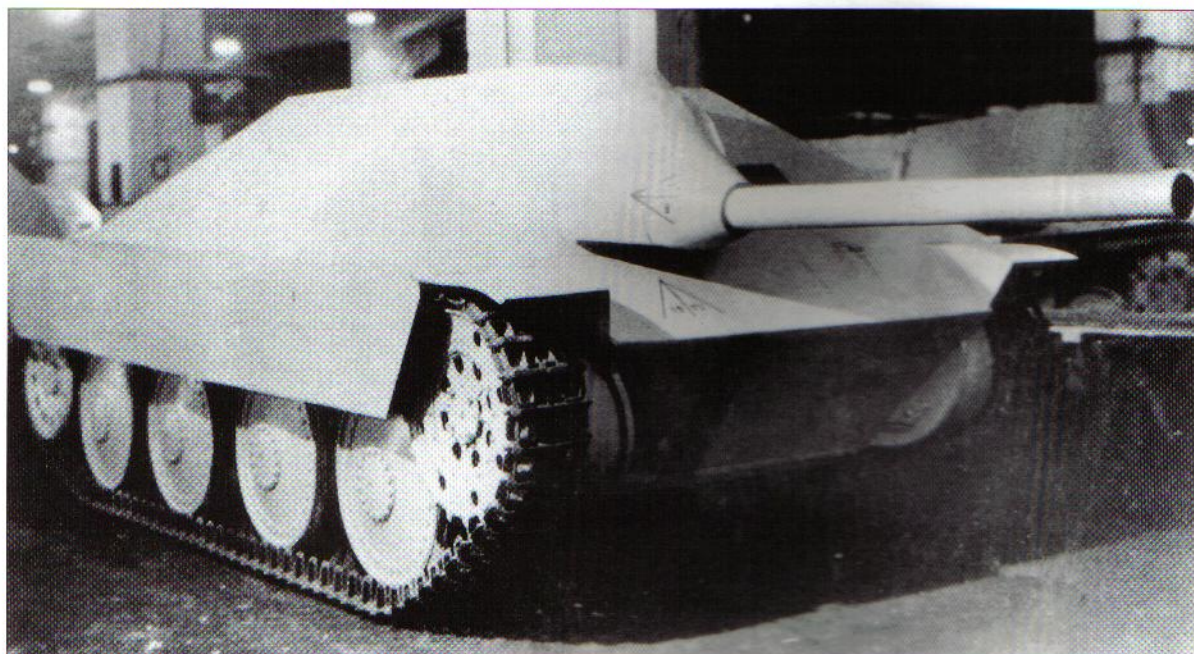
The second iteration of the wooden mock-up had a full width front plate and the sides in one piece to simplify production. The fighting compartment was extended rearwards. The hull sides were protected by Schürzen (steel apron plates). The muzzle brake was deleted from the 7.5cm Pak 39. (BMM)

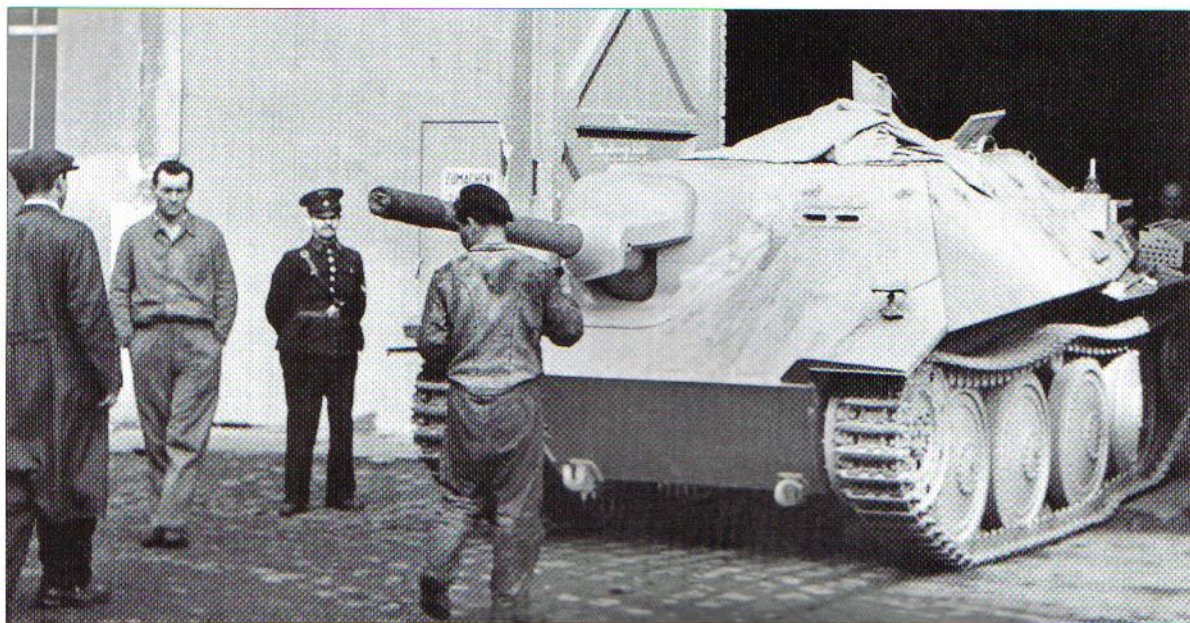
**1 April 1944, the roll-out of the first Sturmgeschütz 38(t) at BMM in Prague. This vehicle was equipped as a Befehlspanzerwagen (command vehicle) with an additional antenna for the long-range radio set. The remote-controlled machine gun was not fitted. (BMM)**

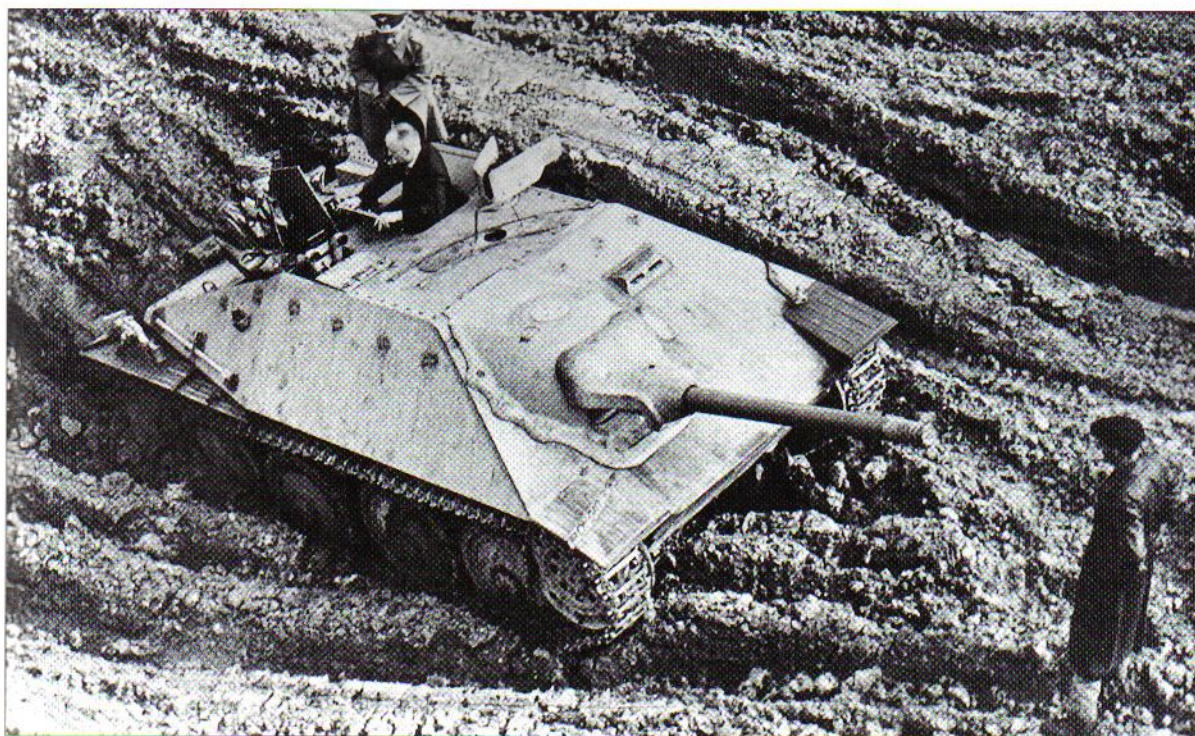
**Overhead view of Sturmgeschütz 38(t) Fgst.Nr.321003 under test. The remote-controlled machine gun has longer sides on the armour shield (similar to those used on the Sturmgeschütz Ausf. G). Note the periscope mounted behind the SF 14Z scissors periscope. The machine pistol port to the right of the driver's visor is just visible. (BMM)**

Secondary armament consisted of a Rundumsfeuer machine gun which was mounted on the roof and could be aimed and fired by the loader from inside using a sighting periscope (3x magnification with 8 degree field of view) and a trigger on the right handlebar. However, the machine gun was not belt fed and the loader had to open his hatch in order to replace the magazines. There was a gun shield fitted to the Rundumsfeuer mount to protect the loader but there was a gap at its base and its 'wings' were shortened to clear the main gun sight periscope guard.

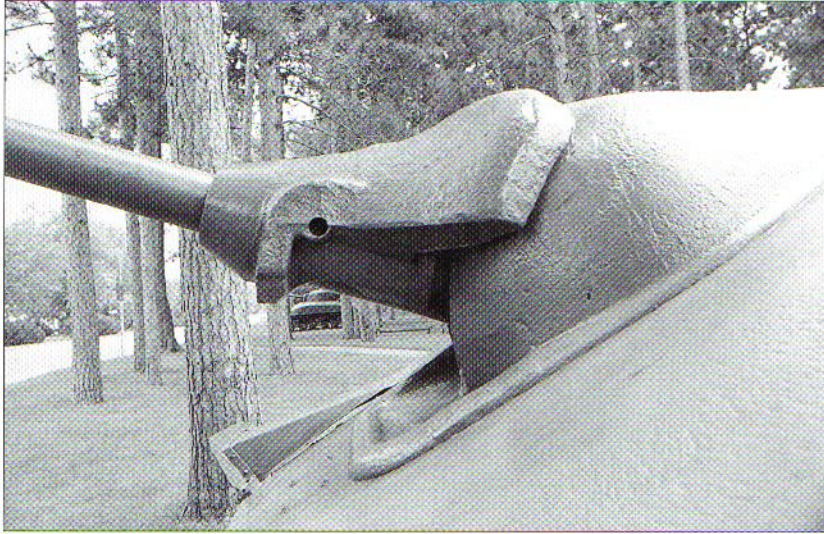
This Jagdpanzer 38 on display at the Canadian Tank Museum at Camp Borden in Ontario is Fgst. Nr. 321042. It was built by BMM in May 1944. This photograph shows details of the gun mantle. Many of the initial Jagdpanzer 38 were delivered to technical and training facilities. (HLD)

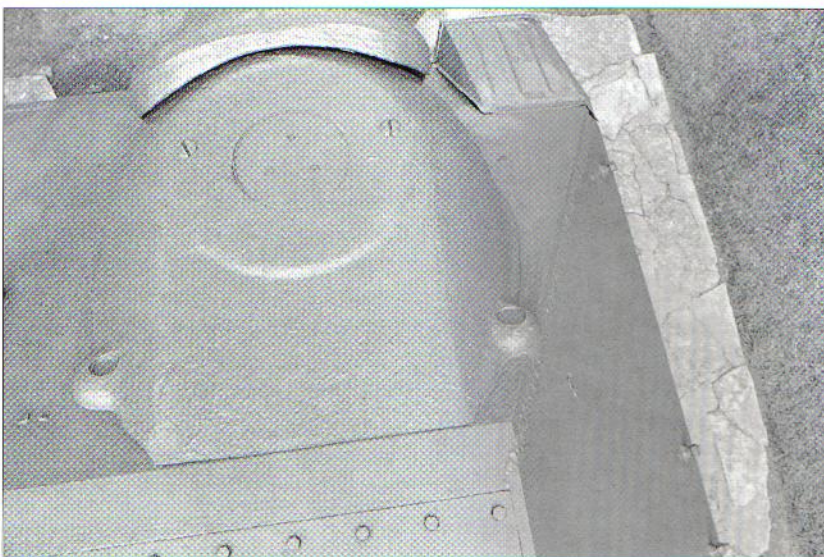
Top view of the armour mantle over the Kugellafette on the Jagdpanzer 38, Fgst. Nr. 321042, at Camp Borden shows that only two external bolts are now used to secure it on the front plate. (HLD)

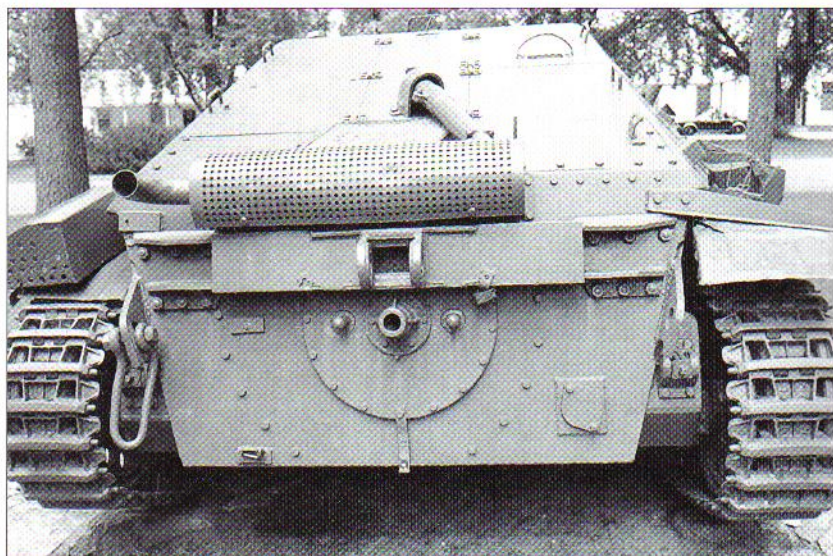
Jagdpanzer 38, Fgst.Nr.321042, is fitted with the large tow coupling which was later only associated with the Bergepanzerwagen 38. The guard over the exhaust pipe is rounded. A large hatch was provided on the sloping rear for the commander. Later this was improved by cutting out a small hatch. (HLD)

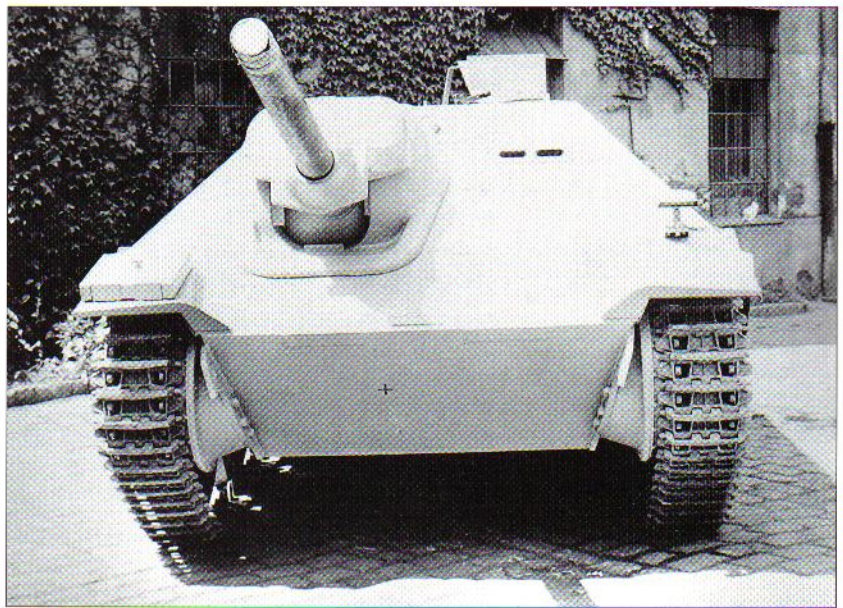
Front view of a Jagdpanzer 38 produced in late June 1944 by BMM. A rear view shows a tow coupling similar to that mounted on the Jagdpanzer 38 Fgst.Nr.321042 on display in Camp Borden. (BMM)

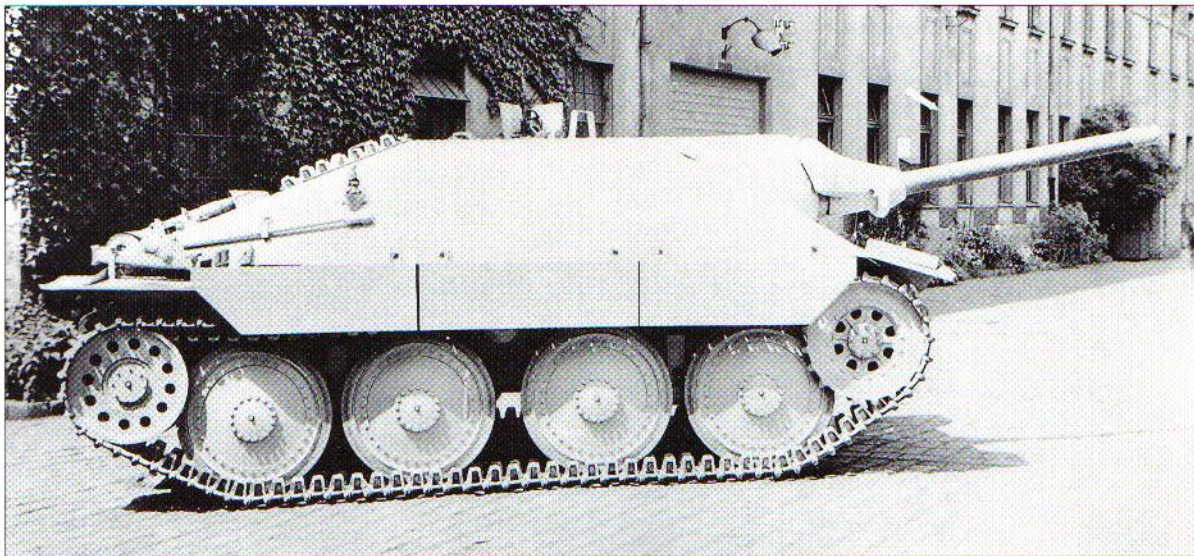
**Side view of a late June 1944 production Jagdpanzer 38 at the BMM factory. The 60mm thick armour of the original Kugellafette Ausf. III (ball mount for the gun) and inner mantle and external mantle caused a particularly nose-heavy configuration. This resulted in the characteristic nose-down tilt of these early Jagdpanzer 38. The front of the Jagdpanzer 38 was actually 10cm lower than the rear. In July 1944 forty-five Jagdpanzer 38 were issued to each of the Heeres Panzer Jäger Abteilung 731 and 743 for use in the east. (BMM)**

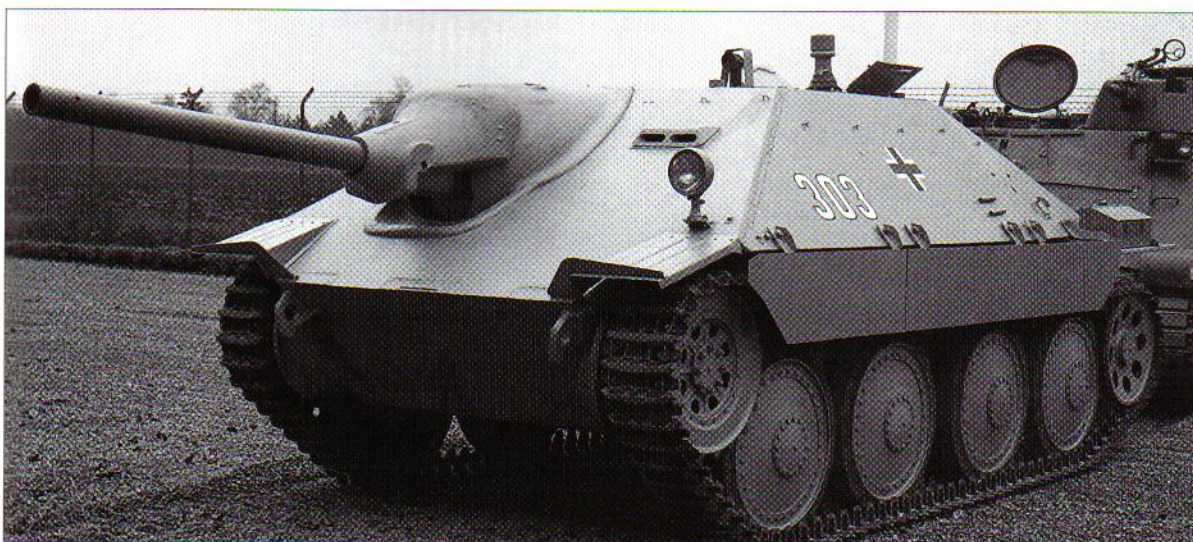
**Jagdpanzer 38 Fgst.Nr.321364 on display in the Swedish Tank Museum at Axvall. It was built by BMM in August 1944 and illustrates how there is seldom a clear cut-off between old and new components. An old mantle was still mounted on the gun. But the final lightweight Kugellafette Ausf. V, which no longer had external retaining bolts, was already fitted. The engine deck still does not feature the small radiator filler hatch. The heat guard over the exhaust muffler has been deleted. A batch of lightweight idler wheels with eight large holes was introduced during this period. (SPHF)**

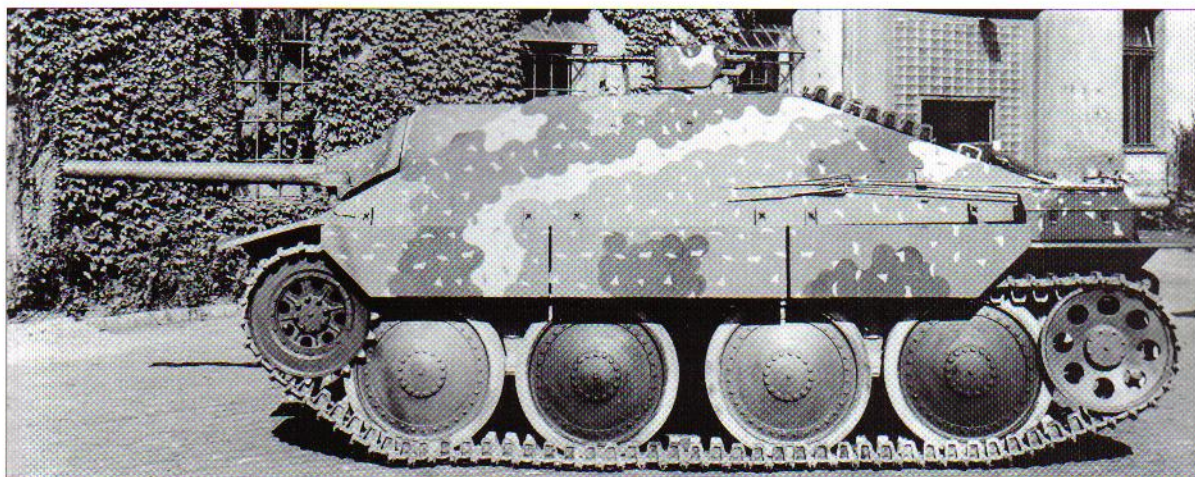
**A left front view of a late August production Jagdpanzer 38 at BMM. The Kugellafette Ausf. V and the lightweight gun mantle are of the final type. The hull still had tow lugs that were hooked on their lower surface. The factory now painted the camouflage pattern before delivery. (BMM)**

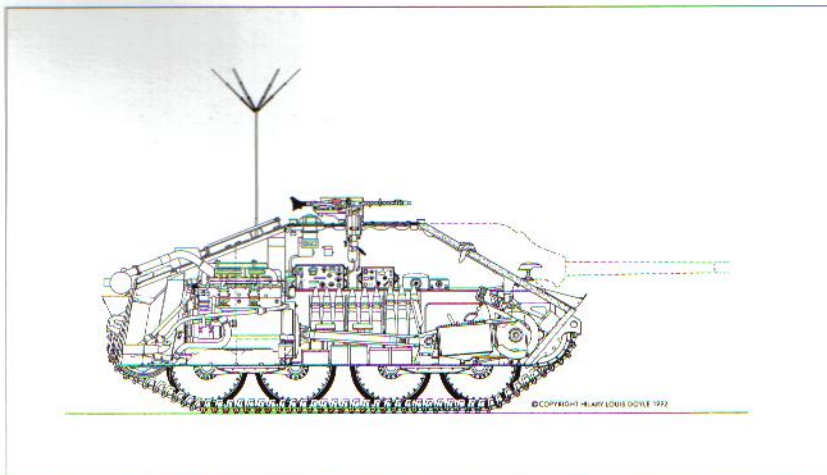
1:76 scale top and right side section views of a Jagdpanzer 38 manufactured in September 1944. This was outfitted as a Befehlspanzer (command vehicle) and this drawing shows the position of the extra radio set (Fu 8) . (Hilary Louis Doyle)

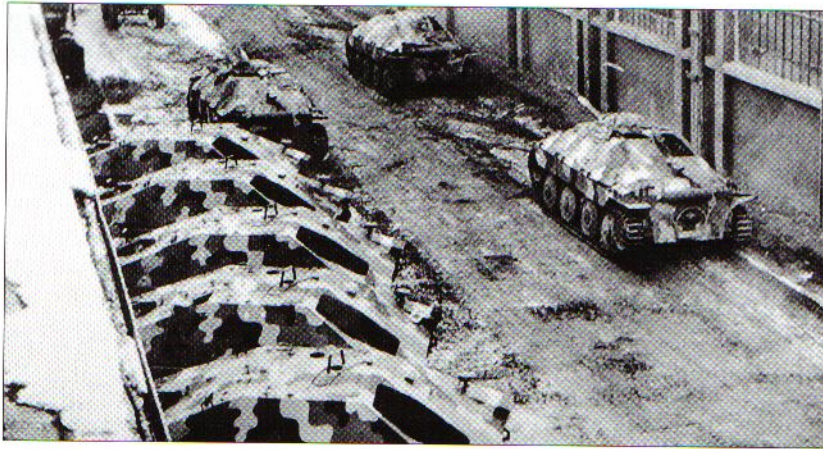
Pre-painted hulls and partly completed Jagdpanzer 38 at BMM in October 1944. The visible features of the Jagdpanzer 38 of this period were: the new driver vision block arrangements; wheels with 16 rivets; new hulls with the underside of the tow brackets notched and rear brackets lowered. The front and rear of the Schürzten was bent inwards to avoid catching and being torn off. In October the camouflage pattern at BMM was changed to a base of Dunkelgelb – RAL 7028 (dark yellow) with patches and stripes of Olivgrün – RAL 6003 (dark olive green) and Rotbraun – RAL 8017 (dark red brown). Matt black rectangles were painted on the front plate as decoys to protect the driver's vision blocks. (BMM)

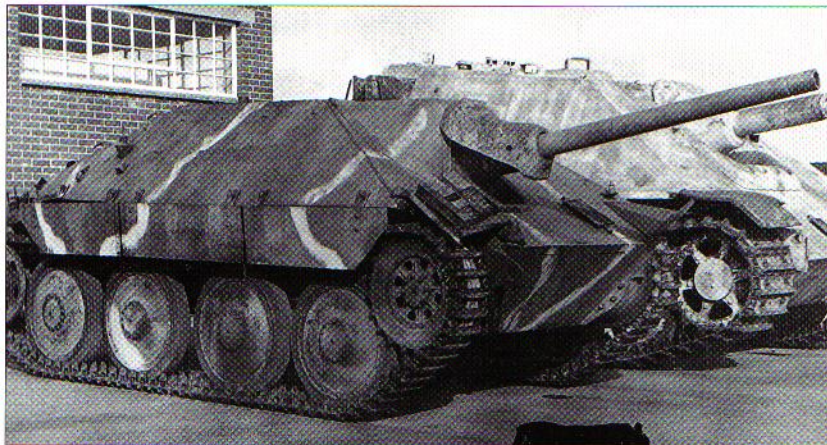
**Right front view of the Jagdpanzer 38 now on display at the Tank Museum, Bovington. This Jagdpanzer 38 was captured and examined by the British. Its Fgst.Nr. is 322111, showing that it was completed by BMM at the beginning of December 1944. The hull armour was fabricated by Skoda Pilsen. A dished six-wheel idler was used at this period. (HLD)**

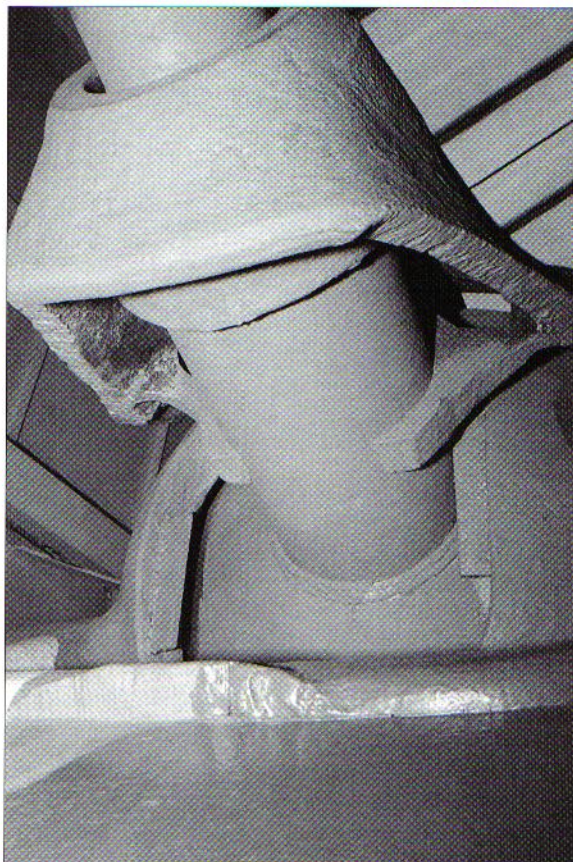
**Close-up detail of the gun mantel of Fgst.Nr.322111. (HLD)**

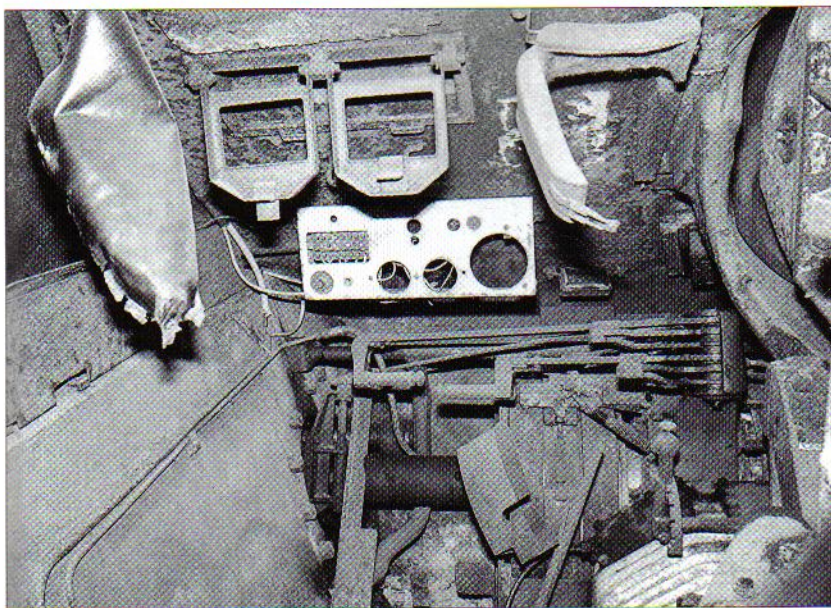
A view of the interior of the Jagdpanzer 38 Fgst.Nr.322111 shows the driver's position, now with an incomplete instrument panel and mounts for the two periscopes. (HLD)

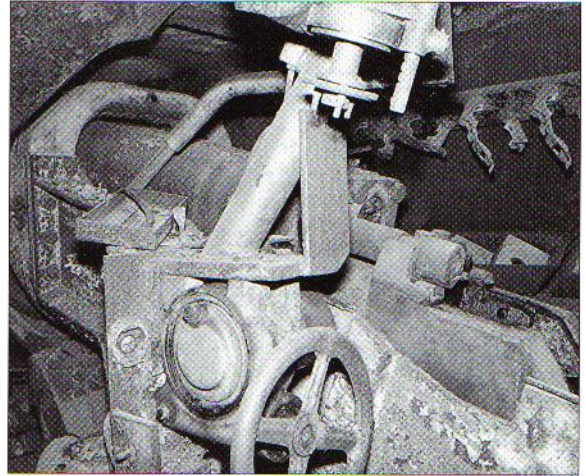
**Another view, this time from the gunner's position, shows the elevation wheel, above which is the mount for Sfl.Z.F.1a gun sight. Ammunition racks along the right hand side can be seen behind the gun breech. (HLD)**

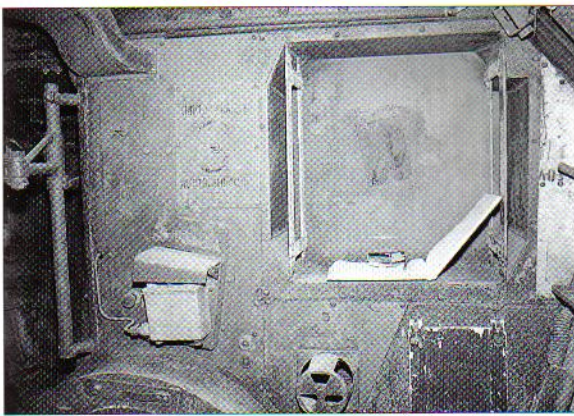
Looking to the rear inside Fgst.Nr. 322111. On the far left is the commander's position with mount for the SF 14Z scissors periscope. On the right is the inset compartment in firewall for mounting the Fu 5 radio set. (HLD)

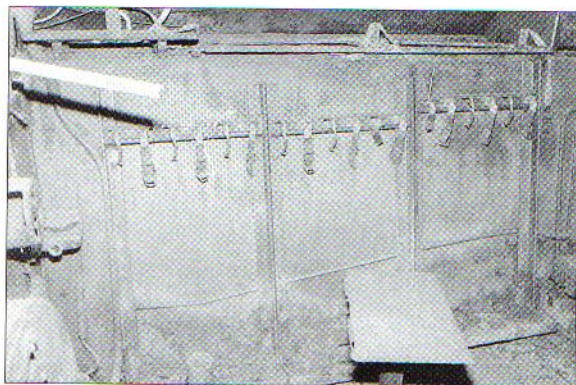
This view shows the ammunition racks alongside the driver, gunner and radio operator on the left side. (HLD)

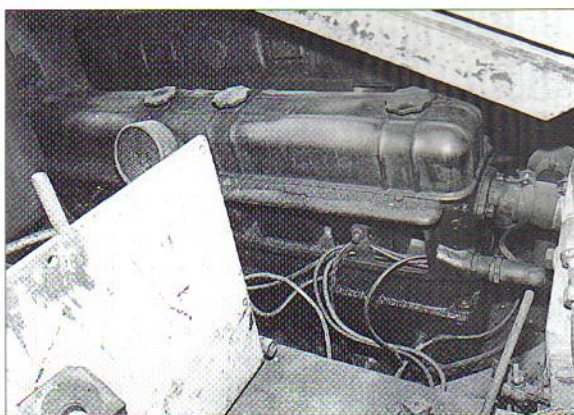
**A final view of Jagdpanzer 38 Fgst.Nr. 322111 shows the motor compartment viewed from the left side of the vehicle. The motor is a 7,754cc six-cylinder in line overhead valve 'epa AC 2800'. (HLD)**

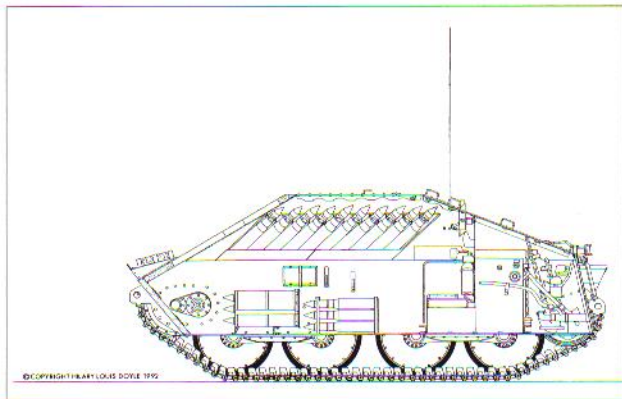
**1:76 left side section view drawing of a Jagdpanzer 38 produced in December 1944. This drawing shows the ammunition racks on the right side of the Pak. The commander's seat is at the rear of the fighting compartment, while the rear right of the engine compartment is used for tool and equipment stowage. (Hilary Louis Doyle)**

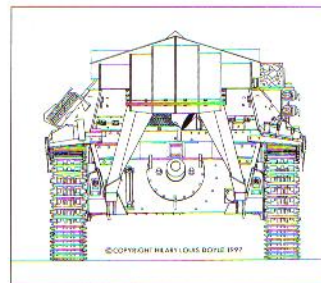
**1:76 scale rear view drawing of a Bergepanzerwagen 38 assembled in February 1945. It is fitted with winch and spade. (Hilary Louis Doyle)**

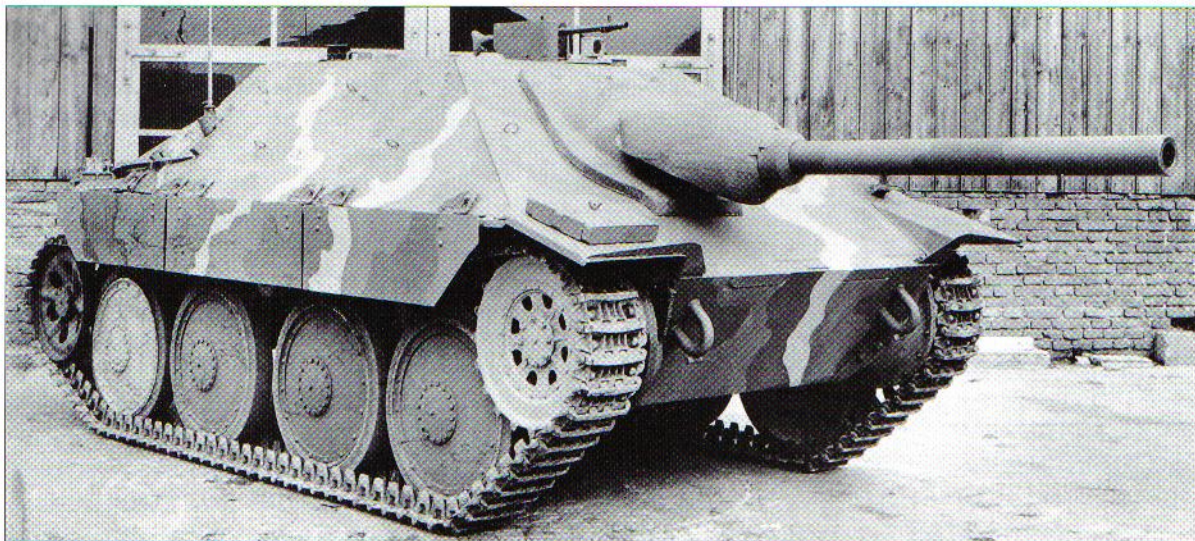
ABOVE Right front view of the last Jagdpanzer 38 starr, Fgst.Nr.322971, that was prepared for a demonstration planned for Hitler in April 1945. The rigid gun required a smaller Kugellafette (ball mount) and a new mantle. U shaped tow brackets replaced the side extension tow lugs. (BMM)

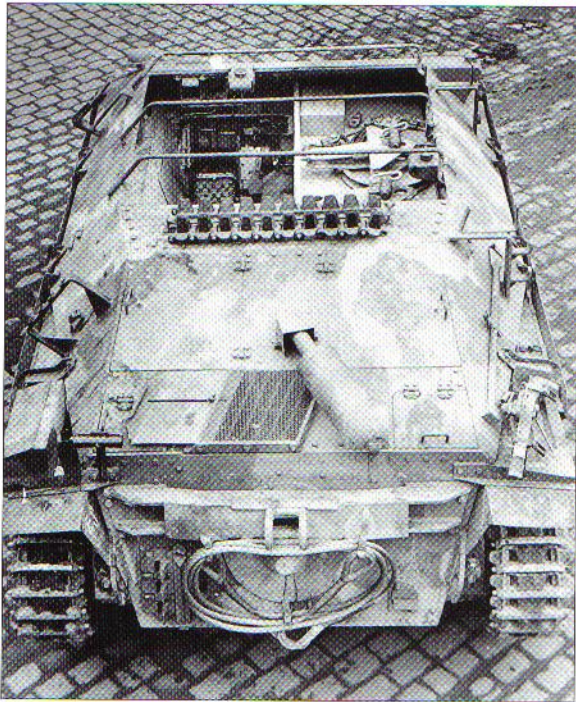
**ABOVE** Bergepanzerwagen 38 Fgst.Nr.321822 was completed by BMM in November 1944. Bergepanzerwagen were built side by side with Jagdpanzer 38 at BMM and did not have their own Fgst.Nr. series. A number of improvements had been introduced in June 1944, including brackets for carrying the unditching beam, the jib-boom crane arms and rigid towing bars were added. (BMM)

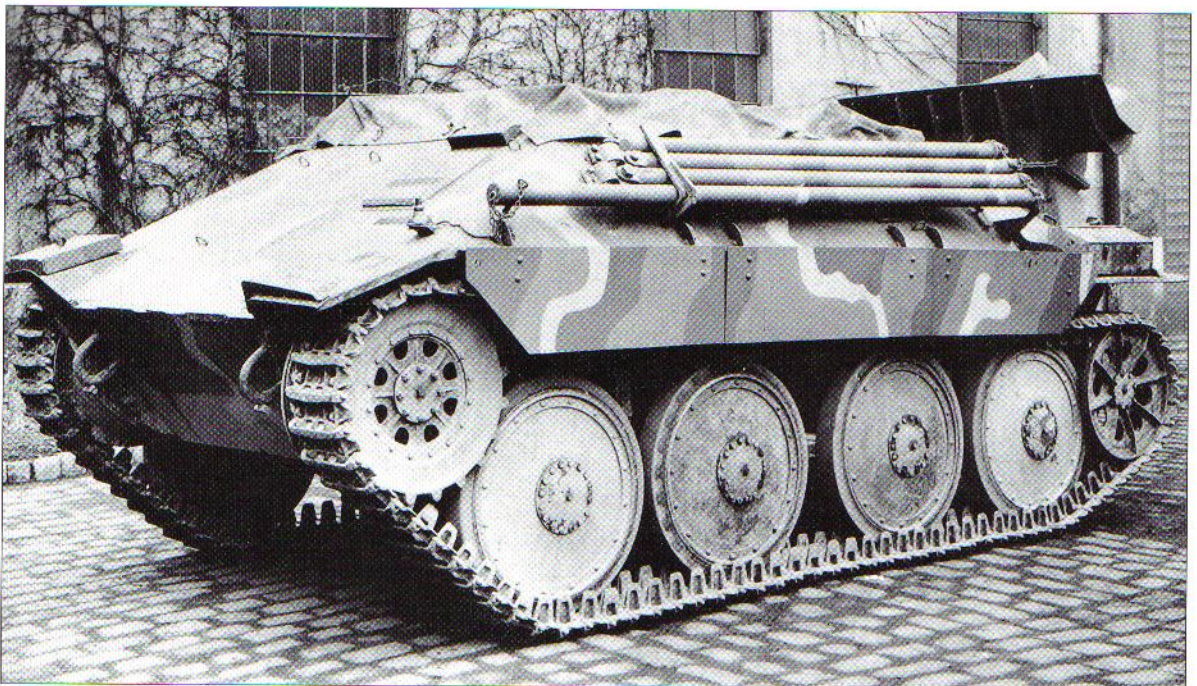
**BELOW** The final configuration can be seen in this Bergepanzerwagen 38, Fgst.Nr.322678. This was completed by BMM in February 1945. The front plate was reduced from 60mm to 30mm, saving considerable weight. A large opening vision port was provided for the driver. U-shaped towing brackets replaced the side extension tow brackets, and a winch was introduced for the first time. (BMM)
