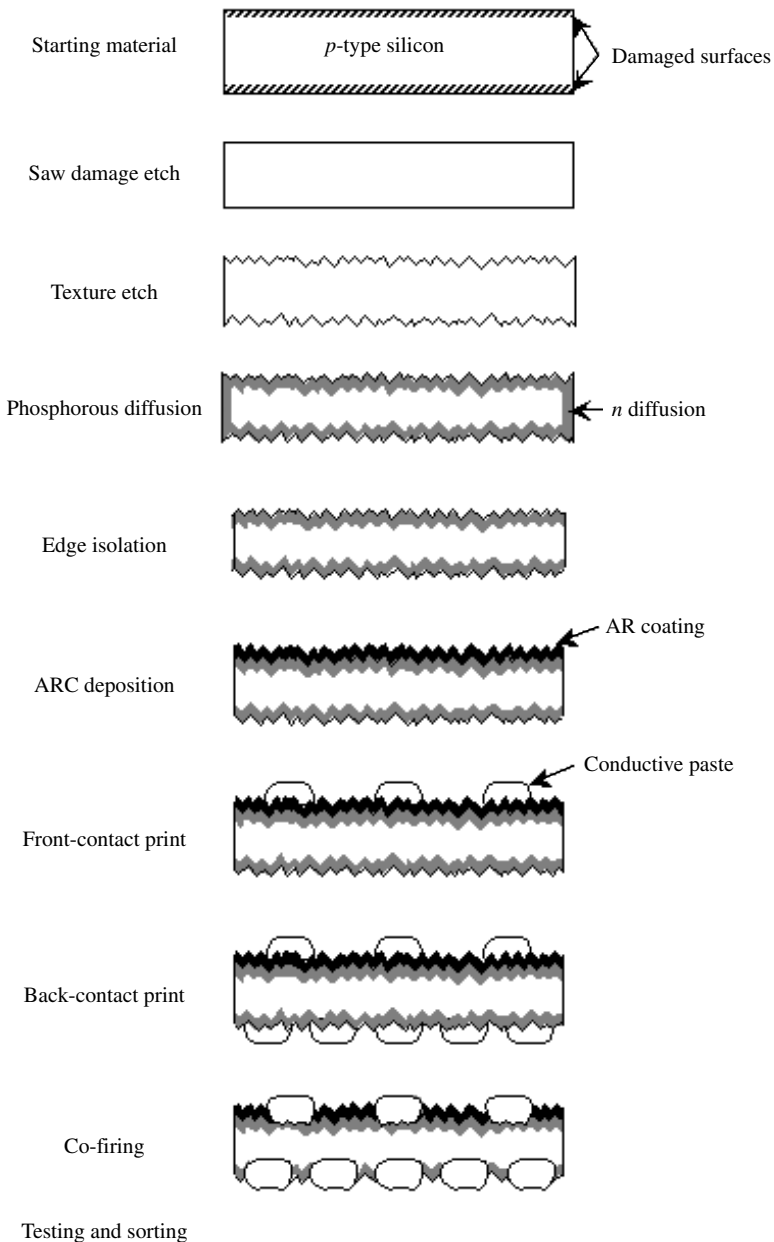
Figure 7.6 A typical processing sequence with schematic illustrations of the resulting structures
