# M8 Greyhound Light Armored Car 1941–91

Steven J Zaloga • Illustrated by Tony Bryan

# M8 GREYHOUND LIGHT ARMORED CAR 1941-91

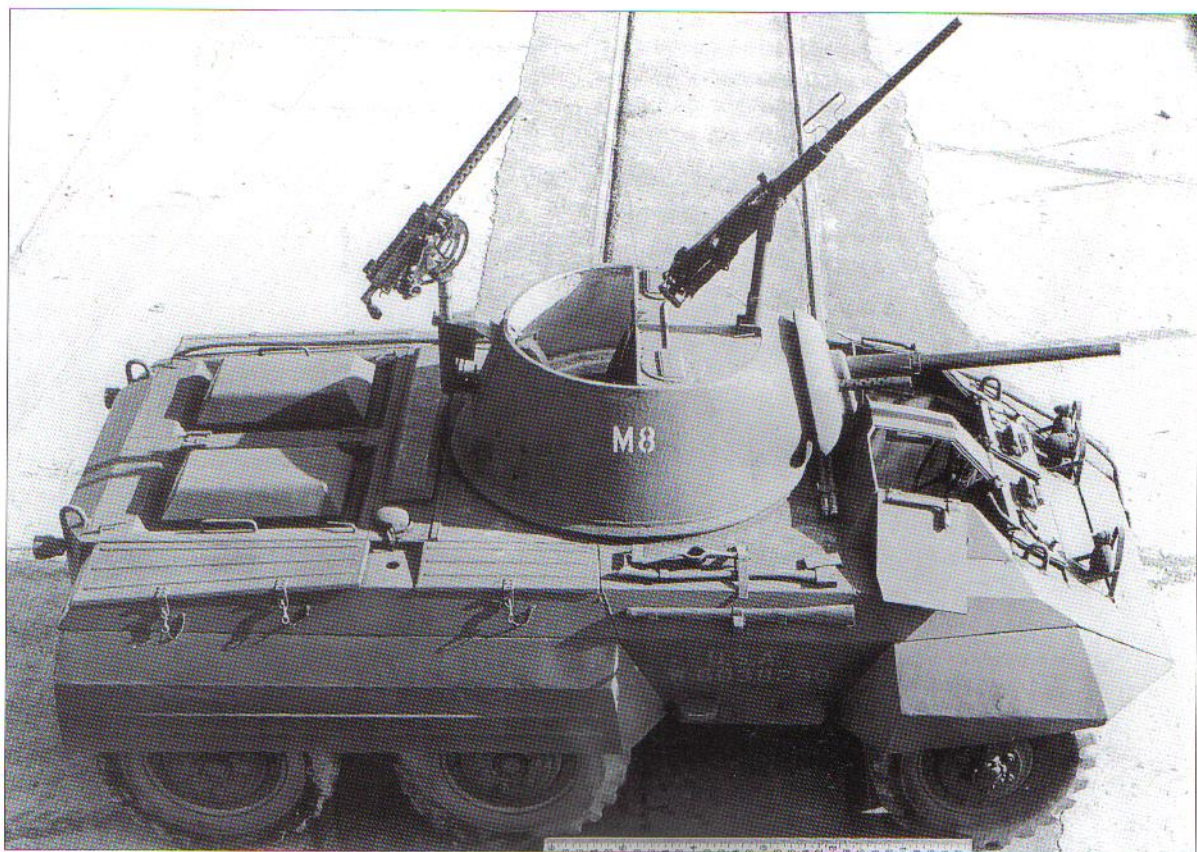
**The first production M8 armored car, serial number 6, was completed at the Ford St. Paul plant in March 1943. Like the T22E2 pilot, it used a cast turret with periscopes for the gunner and commander. The anti-aircraft machine gun arrangement had still not been settled at this time. (NARA)**

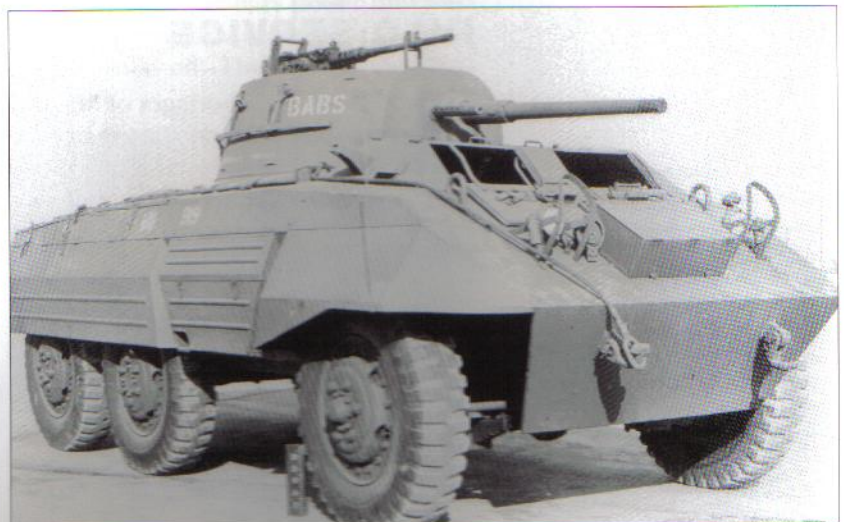
This is an example of the new production configuration in the summer of 1944 with the D67511 folding pintle bracket mount, the barrel clip on the turret roof, and the added stowage box on the glacis plate. This is from the July 1944 production run, and still retains the side mine rack which was dropped from production late in 1944. (Patton Museum)

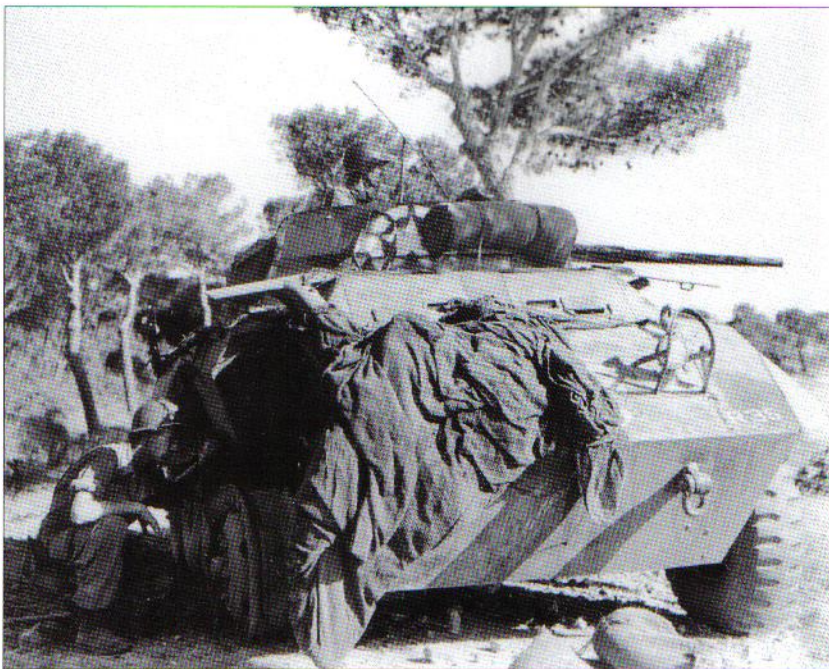
**One of the main problems with the M8 armored car in Italy was its vulnerability to mines. The floor had no armor, which led to high crew casualties when mines were encountered. One of the crewmen of this M8 looks over the damage while the turret crew keeps watch near Castiglione on July 13 1944. This particular vehicle served with a tank destroyer reconnaissance company. (NARA)**
