# PANZERKAMPFWAGEN IV MEDIUM TANK

1936-1945

**PANZERKAMPFWAGEN IV**  
**MEDIUM TANK**  
**1936-1945**

*Text by*  
BRYAN PERRETT

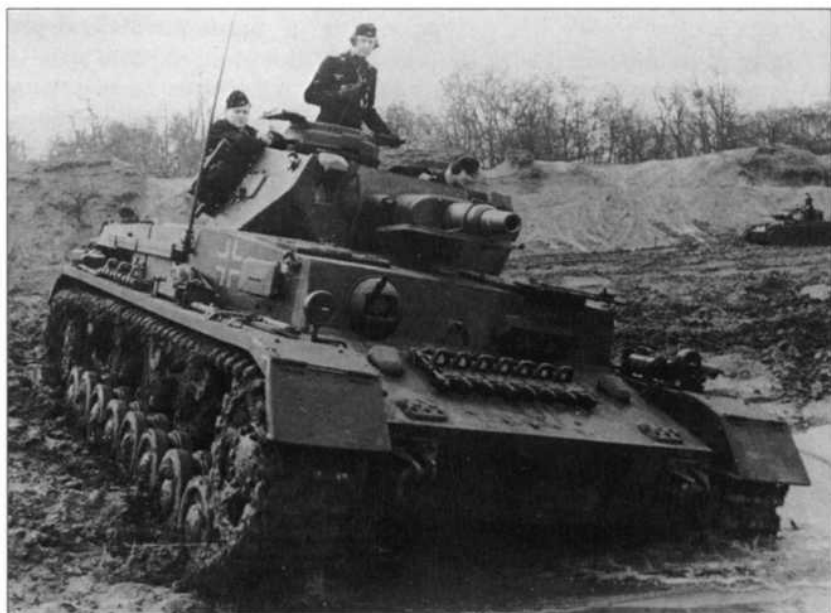
The Ausf. F1 carried 50mm frontal armour and had wider tracks than previous marks. Note the deflector rail under the gun, designed to push back the aerial when the turret was traversed to the right. (Bundesarchiv)

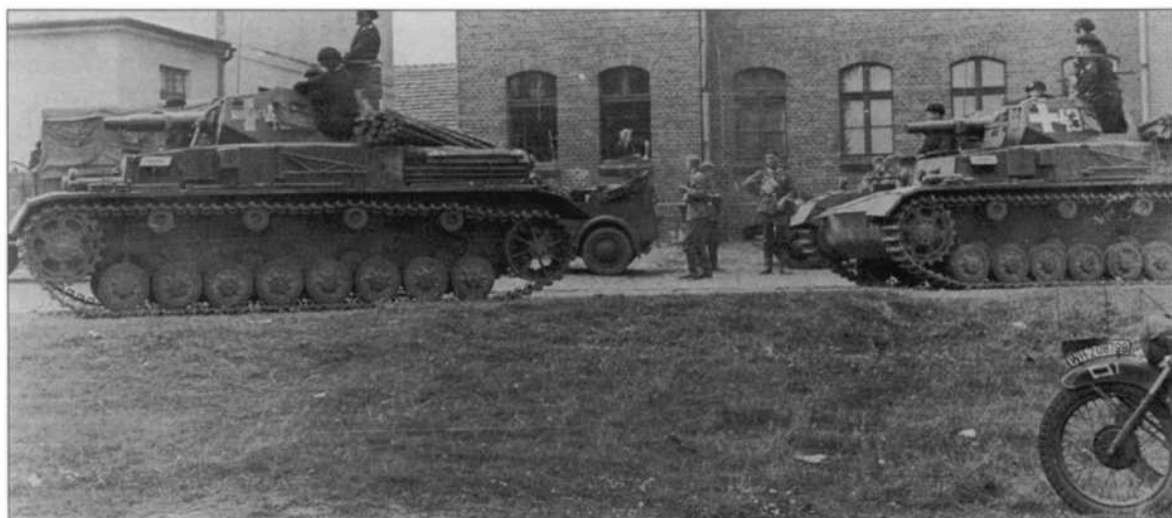
**Two PzKpfw IVs Ausf. A in Poland, September 1939. The plain white national cross was considered to be too conspicuous and was often daubed with yellow paint, as in the case of the leading vehicle. Reading their markings in conjunction with those of the motor cycle in the foreground, the tanks belong to the fourth, or Heavy company of their regiment's 1st Battalion. (Bundesarchiv)**

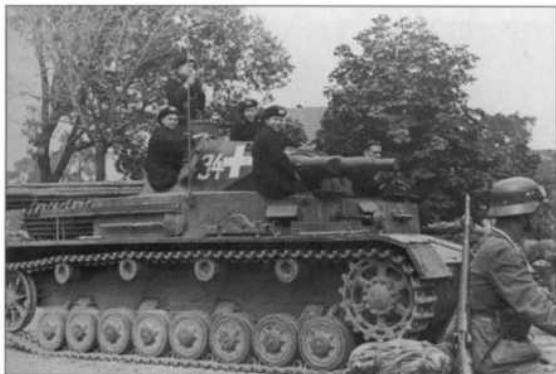
This Ausf. B probably belonged to the same unit and is identifiable by the straight front plate incorporating the hull machine-gun. The vehicle carries a small fascine for unditching purposes. See Plate A1. (Bundesarchiv)

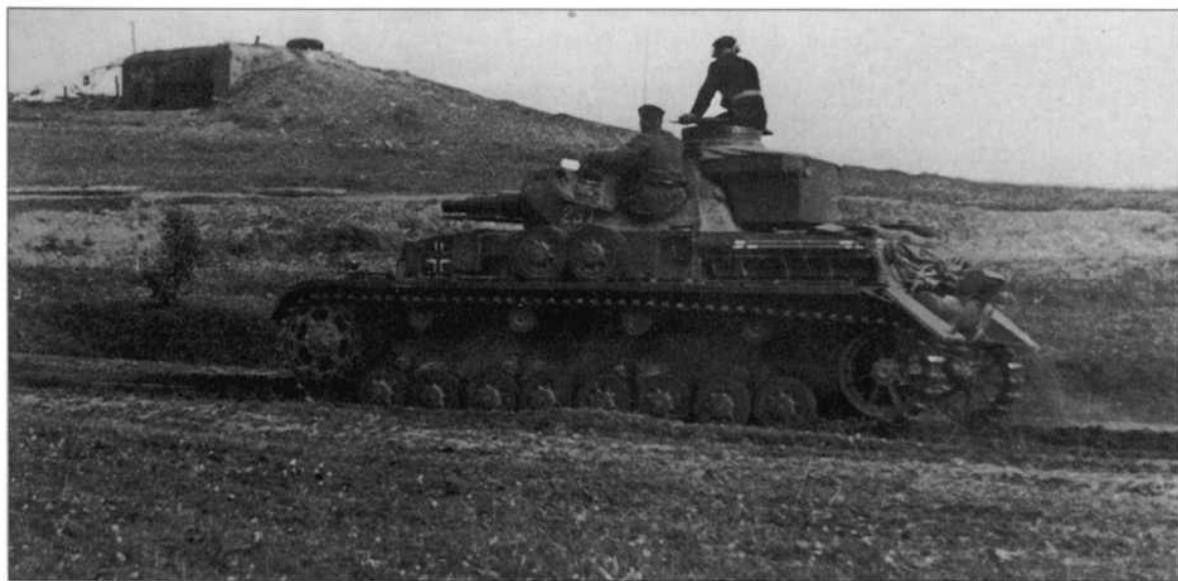
The hull machine-gun was re-introduced with the Ausf. D, of which only a few models were built, and was retained on all subsequent models. The Ausf. E, an example of which is seen here on a north German tank range, saw the cupola moved forward into the body of the turret. The smoke-bomb rack is visible at the rear of the vehicle. (Bundesarchiv)

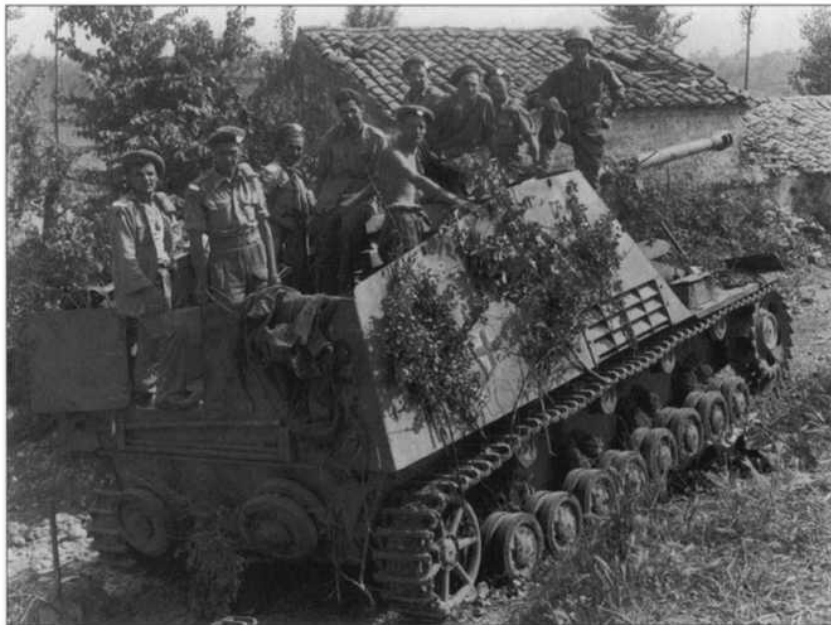
The Nashorn (Rhino) was a first-generation heavy tank destroyer and was armed with the L/71 PAK 43/1 88mm anti-tank gun. This example was stalked and killed with a PIAT by Canadian infantry near Pontecorvo, Italy. Unfortunately, the censor has erased every detail of cap badges and shoulder titles. (Public Archives of Canada)

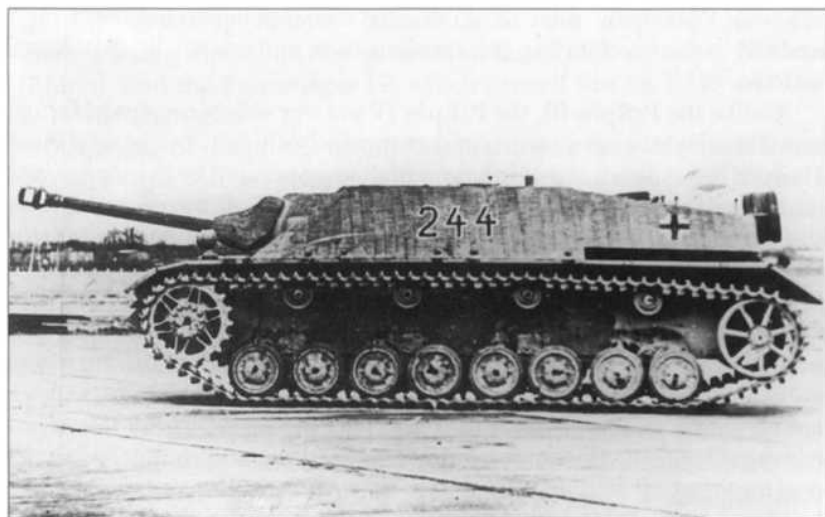
The Panzerjäger IV was a second-generation tank destroyer mounting first an L/48 (as seen here) and later an L/70 75mm gun. The vehicle displays a full coating of *zimmerit* anti-magnetic mine paste.

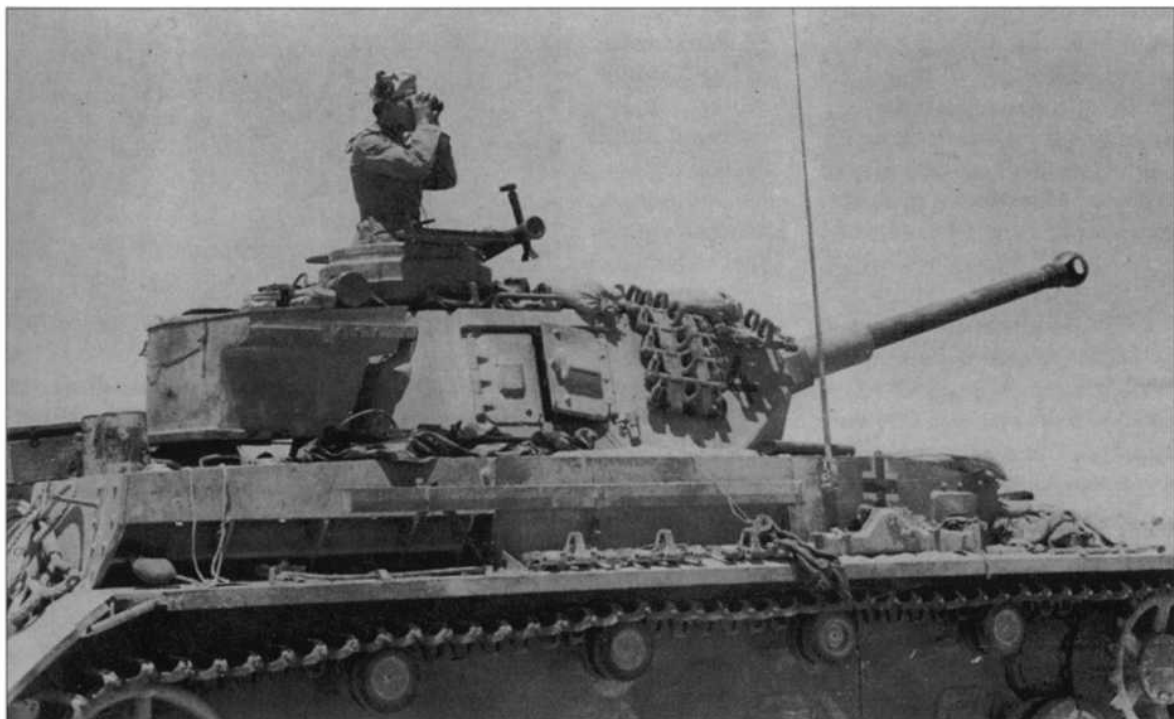
Until the arrival of the Tiger in Tunisia the PzKpfw IVF2 was the most powerful tank possessed by either side during the North African campaign. (Bundesarchiv)

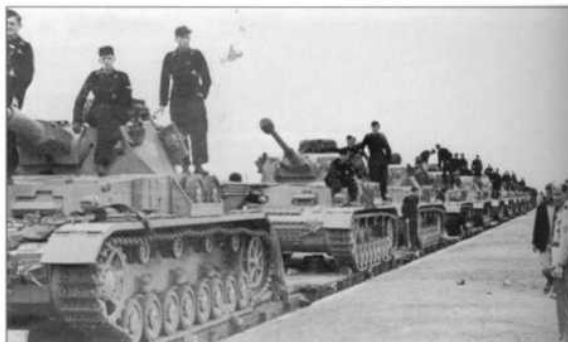
Additional 30mm *appliqué* frontal armour and the 75mm L/48 gun identify these Ausf. Gs in transit by rail through the Balkans. In such circumstances it was normal practice to lock the gun in elevation by means of an internal crutch. (Bundesarchiv)

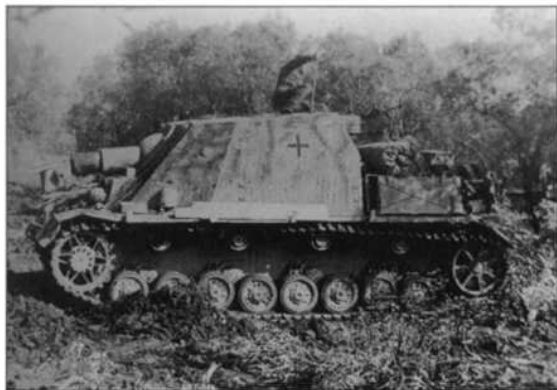
The massive construction of some buildings encountered during the street fighting in **Stalingrad** induced a demand for a heavy assault gun. The result was the **Brumbär** (Grizzly Bear), based on the **PzKpff** chassis, which mounted a 150mm **L/12** howitzer in a fixed superstructure.  
(US National Archives)

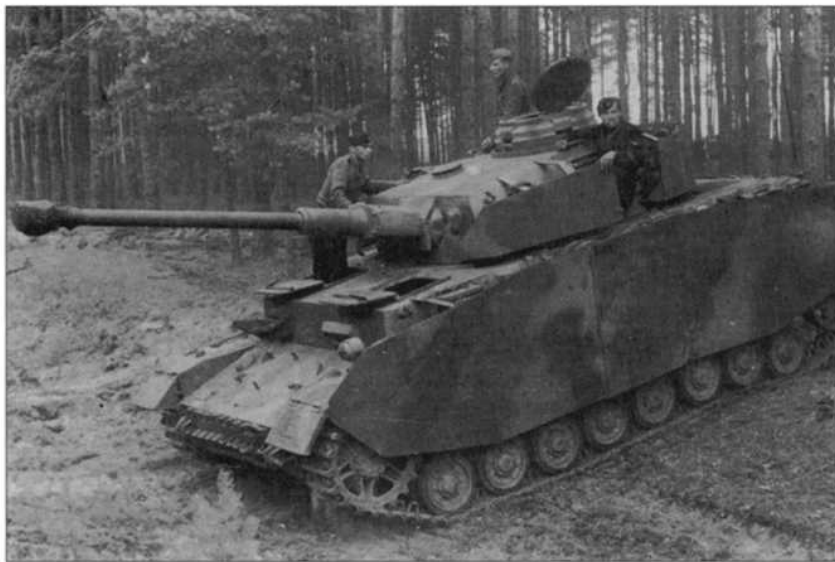
The Ausf. H had 80mm integral front armour and was fitted with side skirts and a turret girdle of spaced armour to protect it against hollow charge ammunition. The colour scheme of this particular vehicle, serving with a Waffen-SS division, is basic German dark yellow oversprayed with large dark green and rust-red patches. (Bundesarchiv)

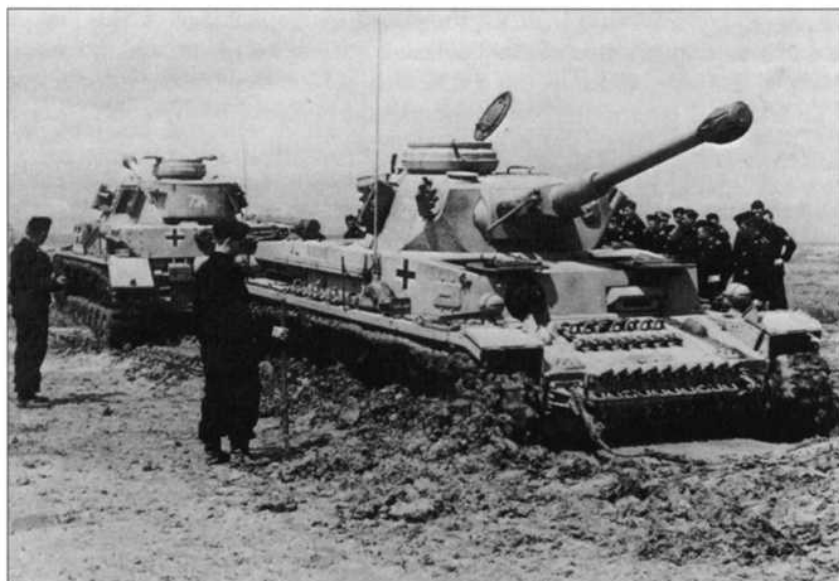
Two Ausf. Gs provide a demonstration of recovery techniques. (Bundesarchiv)

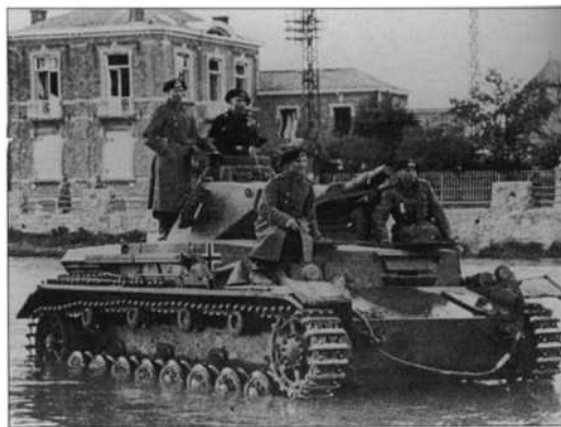
All dressed up and nowhere to go! PzKpfw IV broken down and blocking a ford which the quantity of water on the glacis plate suggests had been taken too quickly; the commander's frantic expression tells its own story. The padded black beret was worn during the Polish campaign, and by some units in France. (Charles K. Kliment)

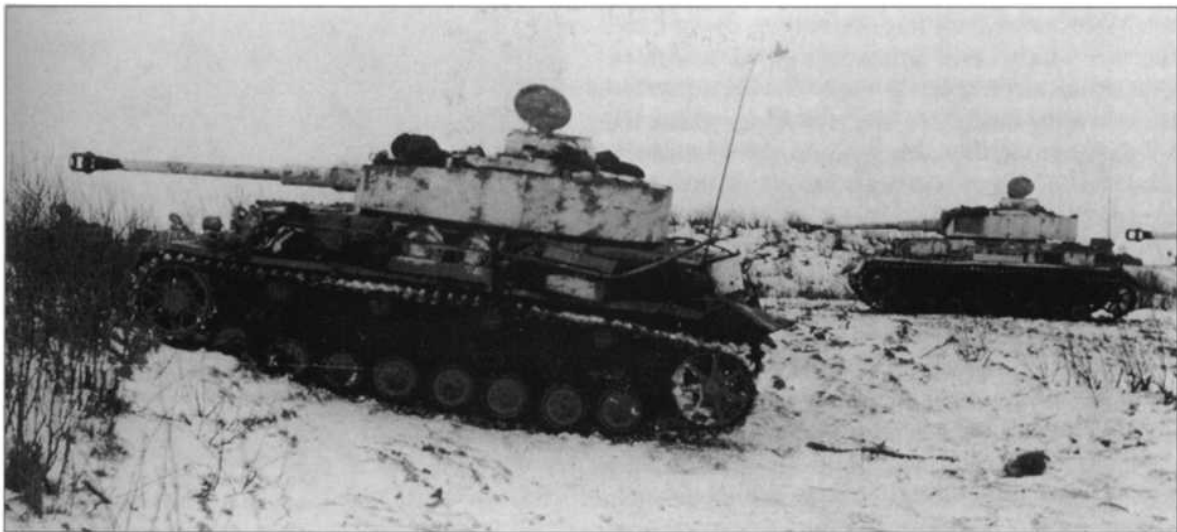
The combined weight of the L/48 and thicker frontal armour tended to overload the front suspension of the Ausf. H, keeping the leaf-springs permanently bowed. The effect of this can be seen on the nearest vehicle. Although retaining the turret girdles both vehicles have shed their side skirts, the mounting rails for which are clearly visible; the rail nearest the camera appears to be badly distorted. Note the new position of the aerial mounting. Russia, early 1943. (Bundesarchiv)

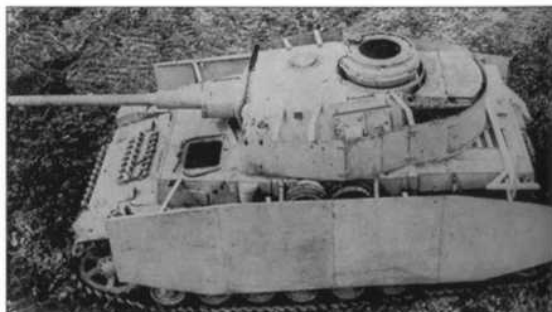
A useful high-angle shot of the Ausf. H, showing detail of turret girdle and skirt mounting stanchions. Later the skirts were mounted on a toothed rail, so that they were knocked off in collisions instead of tearing, and perhaps fouling the suspensions. (RAC Tank Museum)

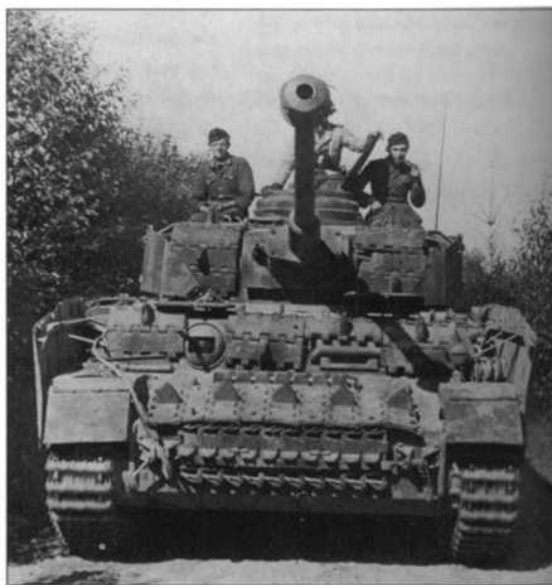
The final production version of the PzKpfw IV, the Ausf. J, dispensed with the power traverse system in favour of an increased fuel capacity. The crew of this vehicle have made good use of captured T-34 and other track links. (Bundesarchiv)

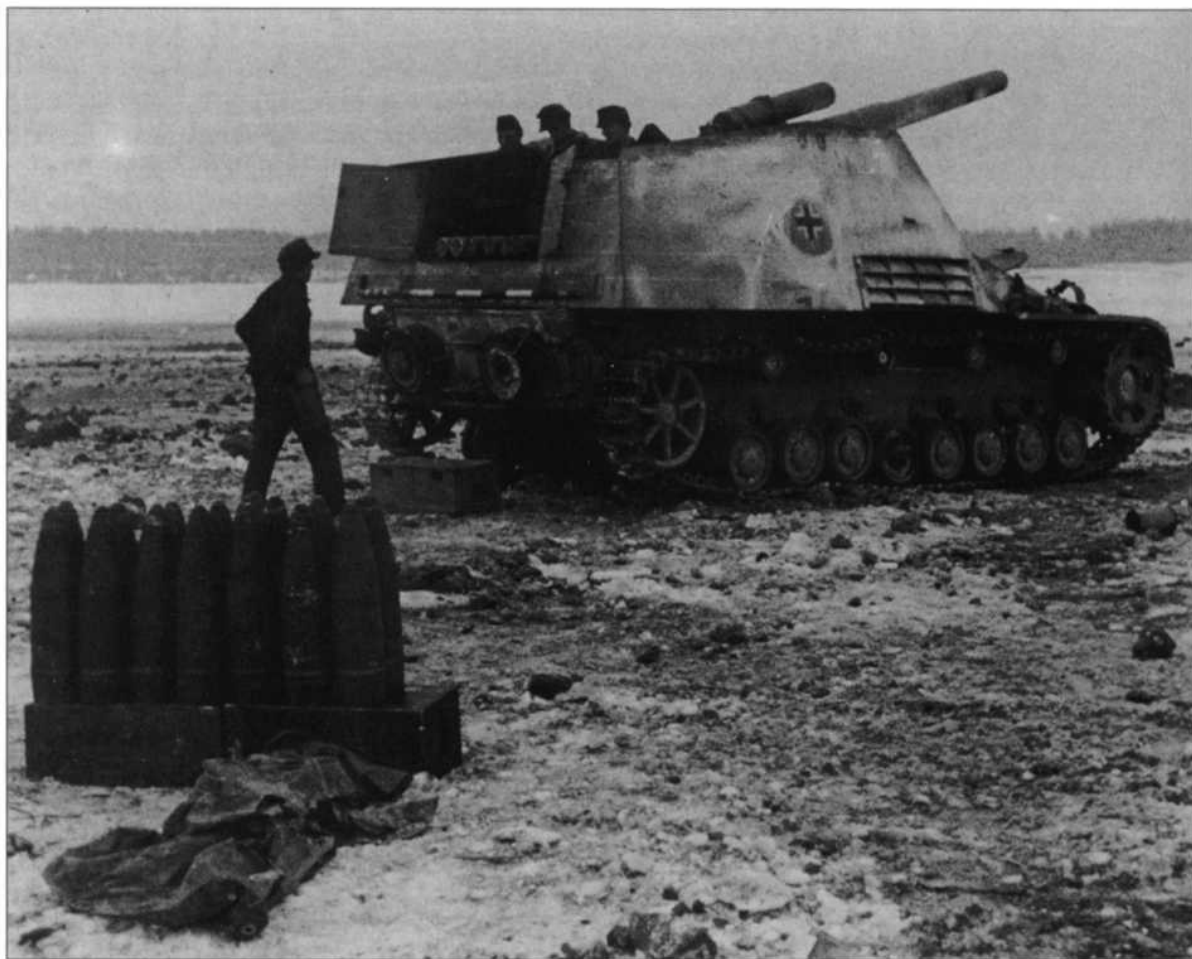
**A Hummel crew prepares to fire a sustained support programme. Panzerartillerie officers were critical of the vehicle, their principal complaints being its limited traverse, excessive height and poor protection. (Bundesarchiv)**

Like any branch of the service, the Panzer-artillerie possessed its reactionary elements, and these expressed themselves as being far from satisfied with the designs for the Hummel and its lighter companion, the 105mm self-propelled howitzer **Wespe** (Wasp). Their principal complaints were that the mountings had insufficient traverse and were too high and too poorly protected, and some effort was made to produce a gun carriage which would remedy these defects.

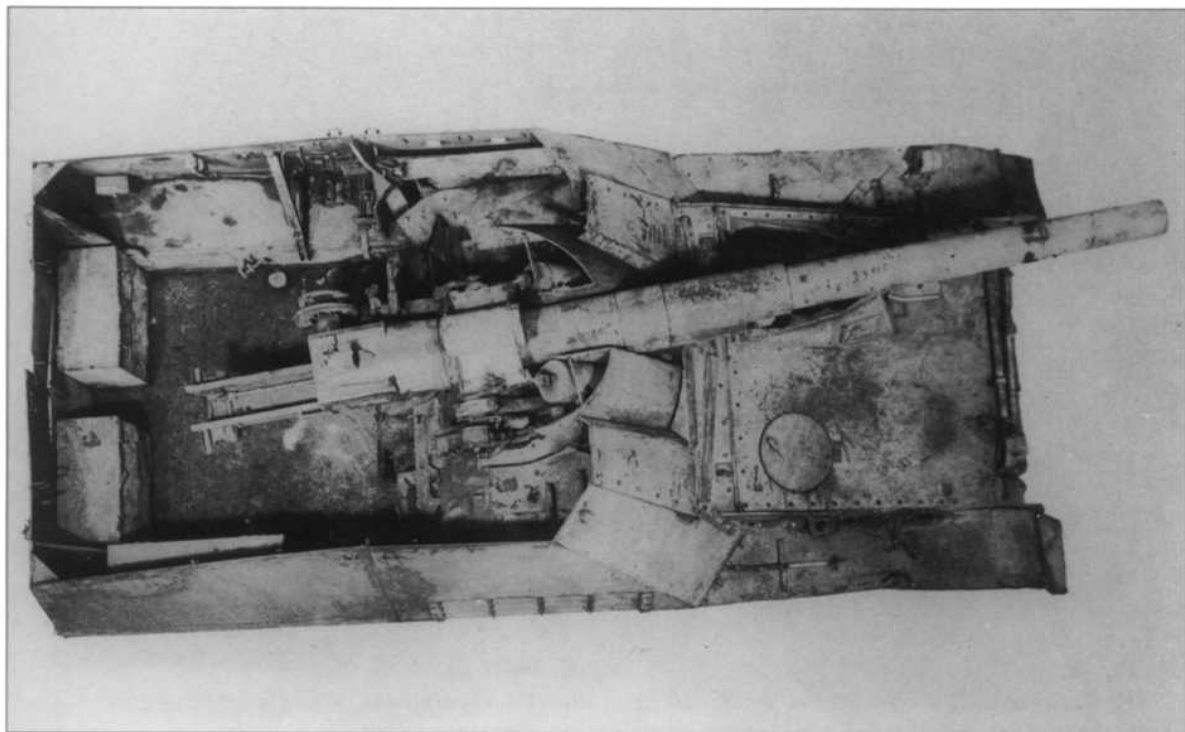
**Upper view of a Hummel 150mm self-propelled howitzer showing the internal layout of the fighting compartment.**  
(RAC Tank Museum)

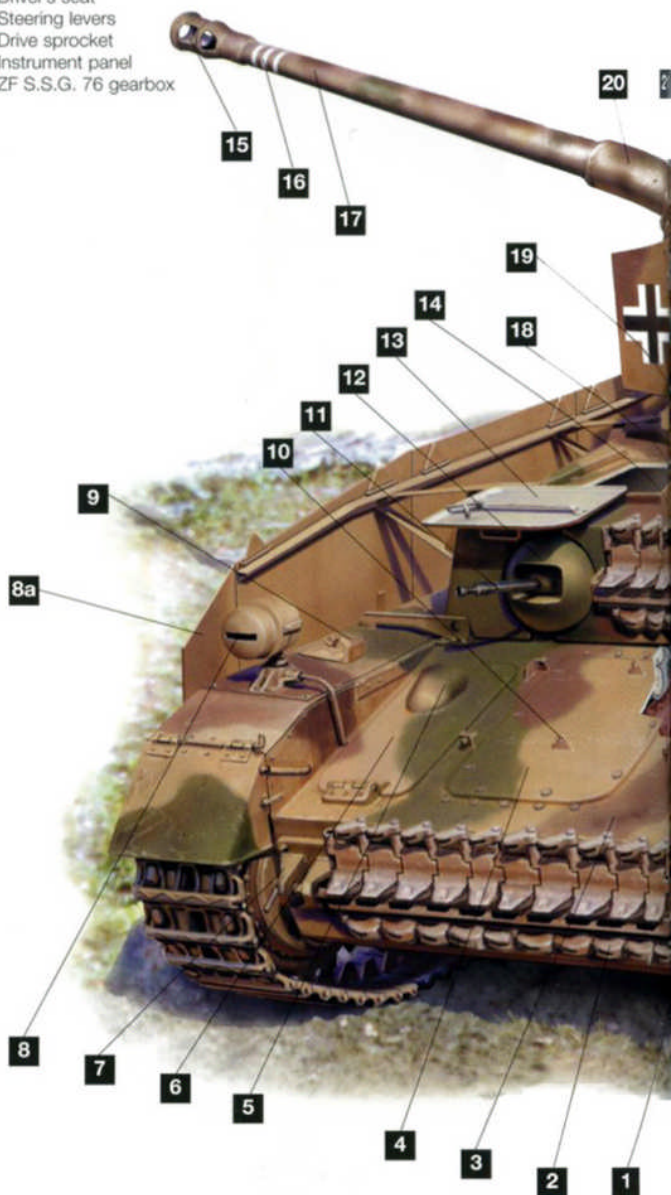
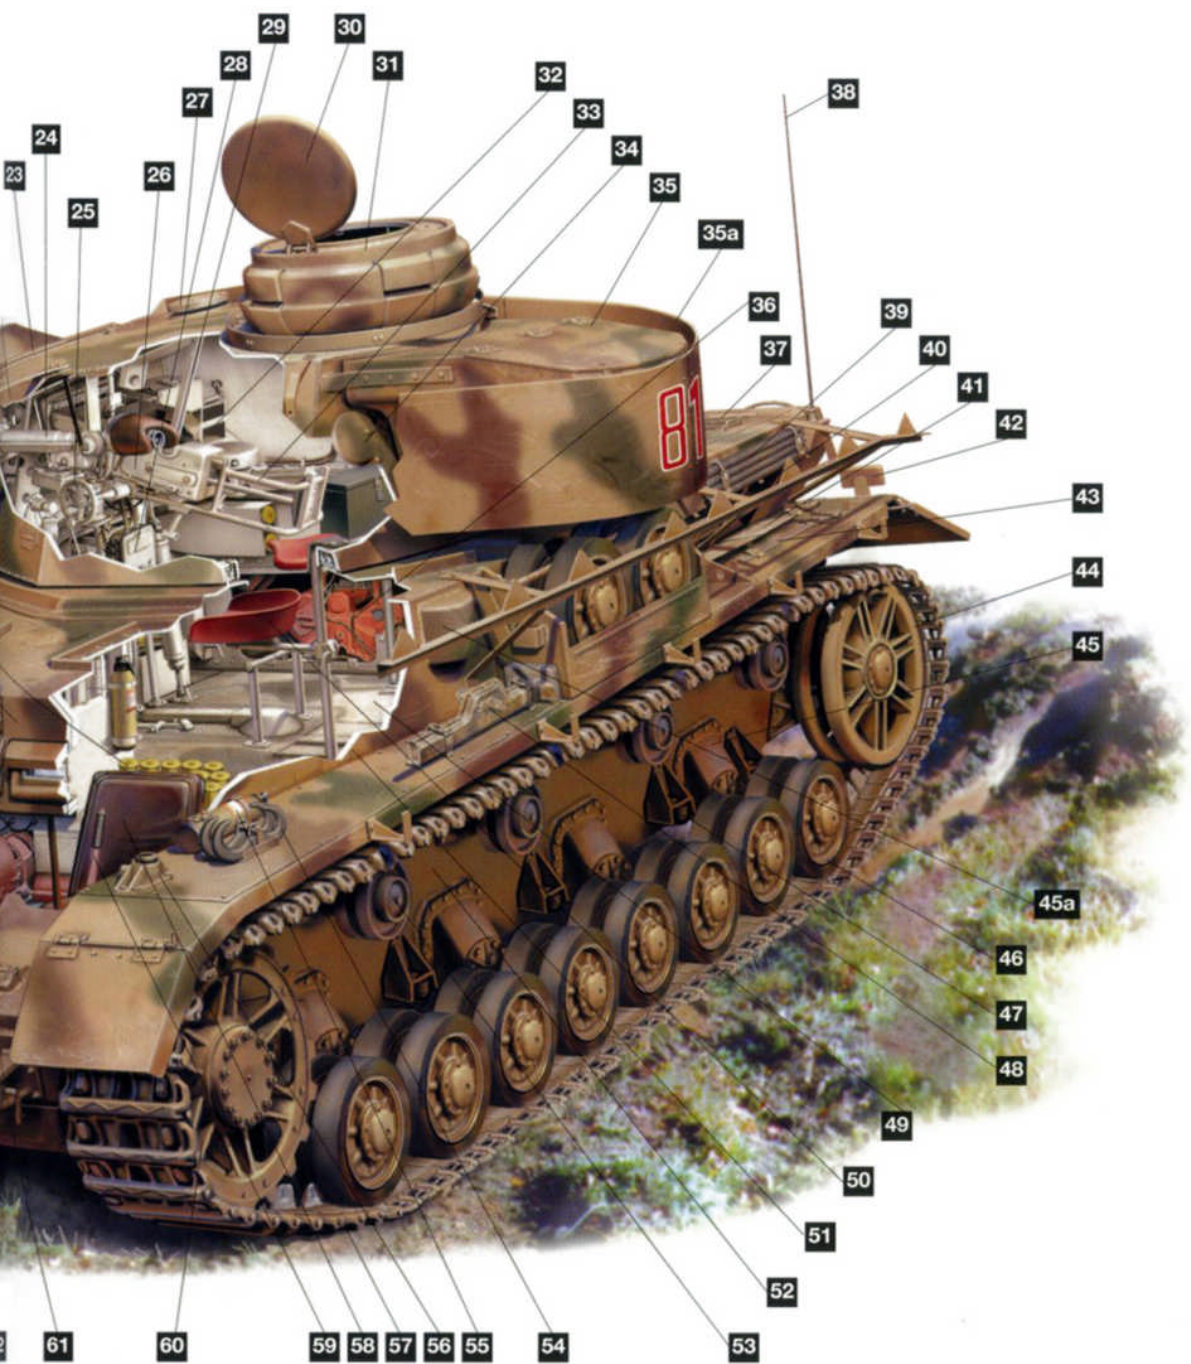
# PANZERKAMPFWAGEN IV AUSF. H

58. Driver's seat
59. Steering levers
60. Drive sprocket
61. Instrument panel
62. ZF S.S.G. 76 gearbox

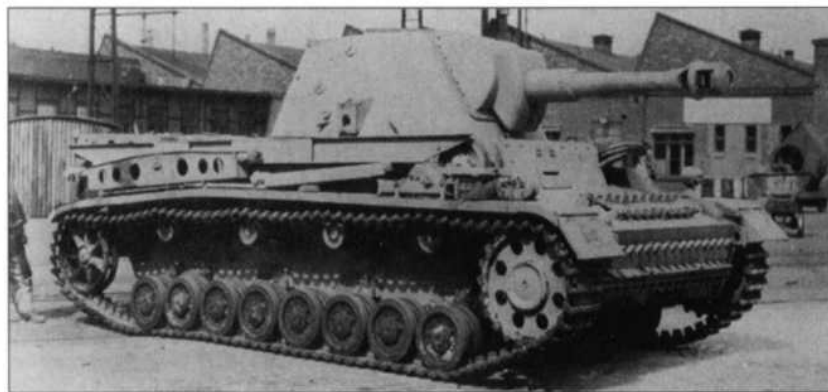
**The Heuschrecke (Grasshopper)** was armed with the light 105mm howitzer, and was based on a slightly lengthened version of the standard PzKpfw IV chassis. (RAC Tank Museum)

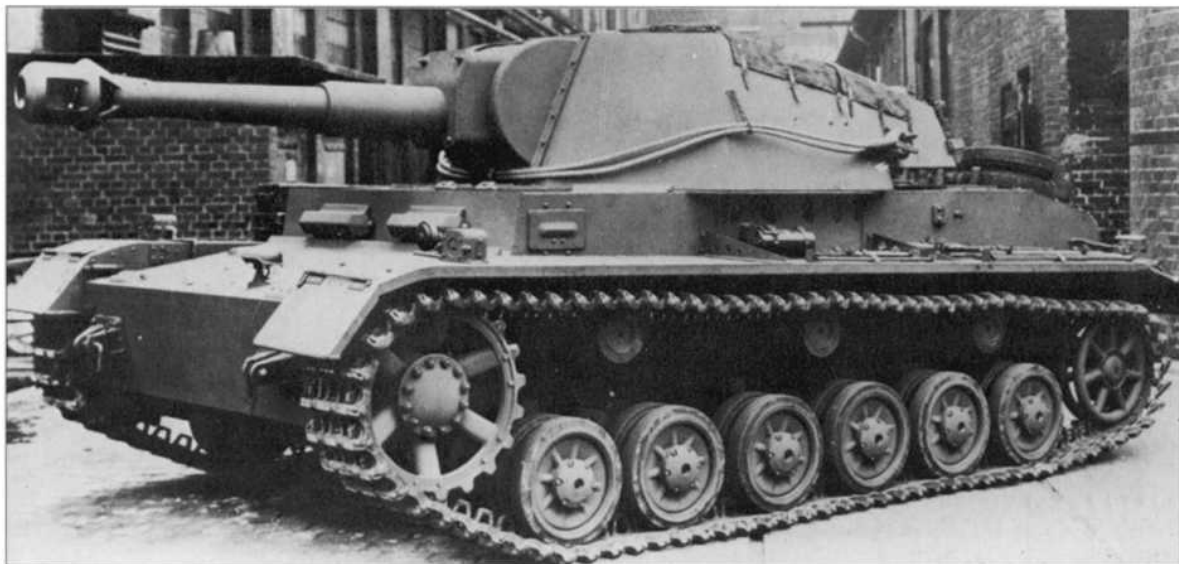
**The light 105mm SP howitzer employed a modified PzKpfw IV chassis. Only eight of these vehicles were built. (RAC Tank Museum)**

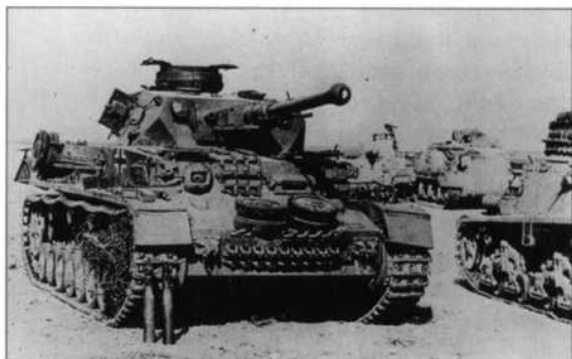
**PzKpfw IVF2 captured at Second Alamein; note the size of the two 75mm rounds of ammunition. The tank immediately to the right is an Italian M13/40.**

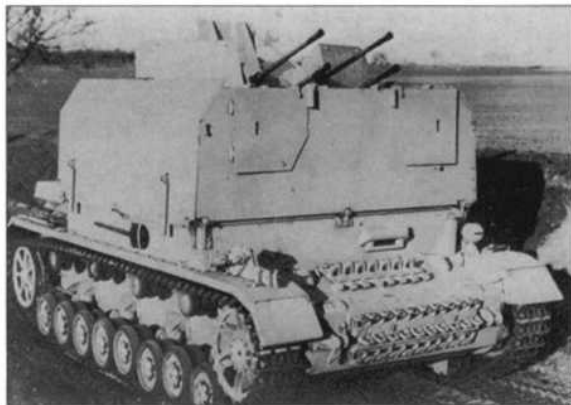
The Möbelwagen 20mm quadruple anti-aircraft vehicle with flaps raised. (RAC Tank Museum)

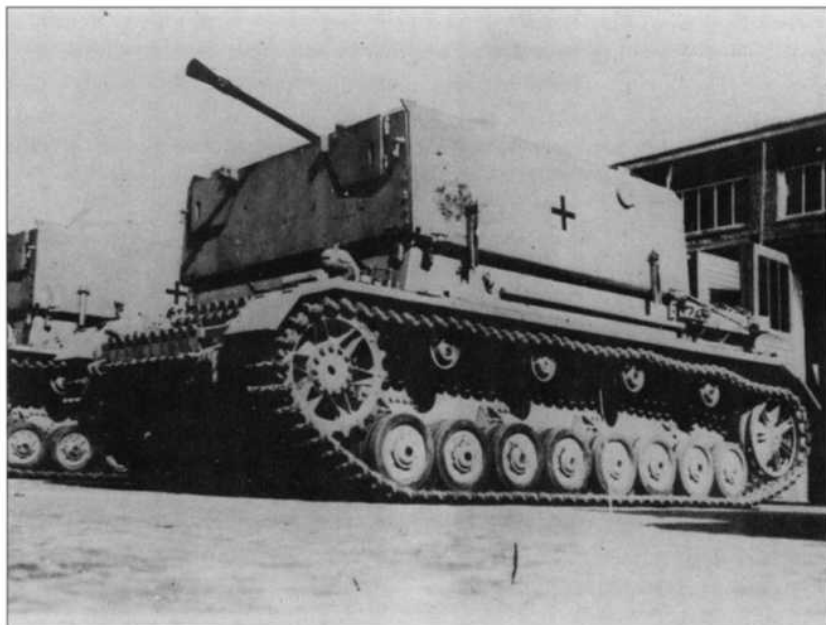
The 37mm version of the Mobeiwagen. A total of 211 Mobeiwagens of both types were built. (RAC Tank Museum)

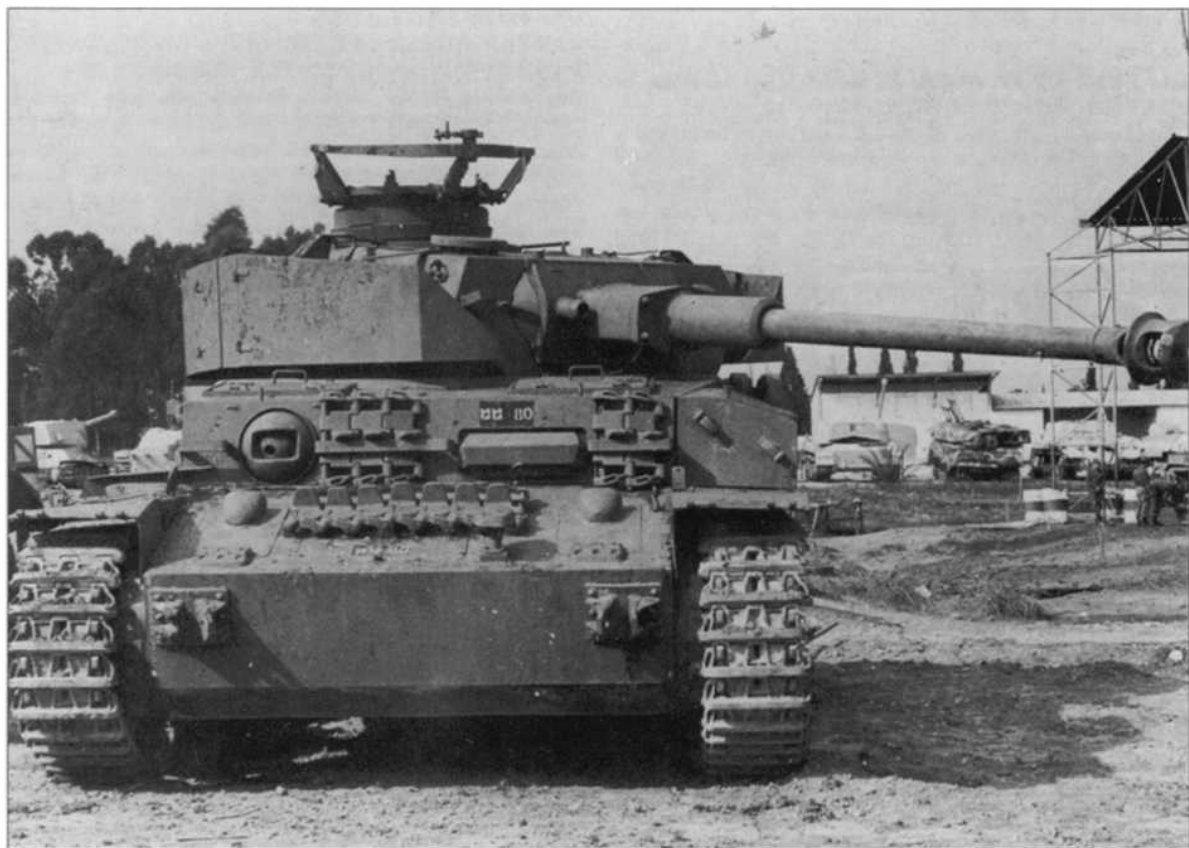
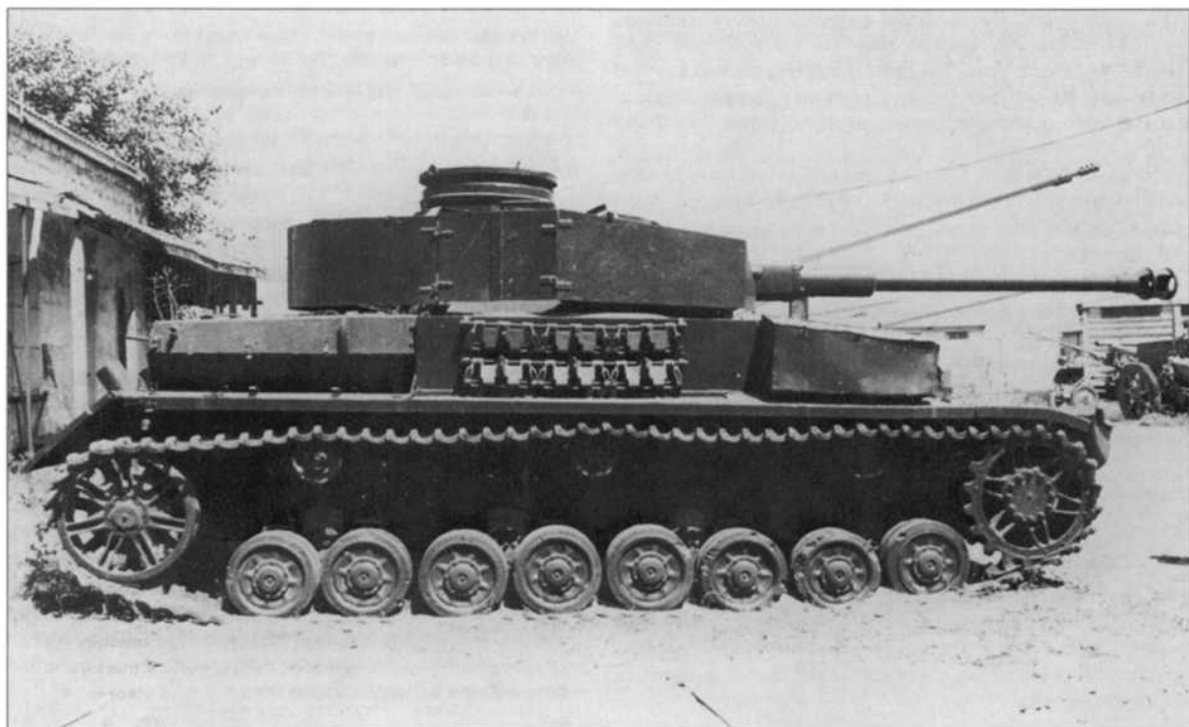
ABOVE AND RIGHT **Two views of forest green painted, late-model PzKpfw IVs captured by the Israelis during the fighting against the Syrian Army on the Golan Heights in June 1967; the Syrians are believed to have acquired these antiques from Spain. Note the modified cupola with mounting for the Russian heavy anti-aircraft machine gun. The white-on-black marking above the driver's visor was added after capture.**

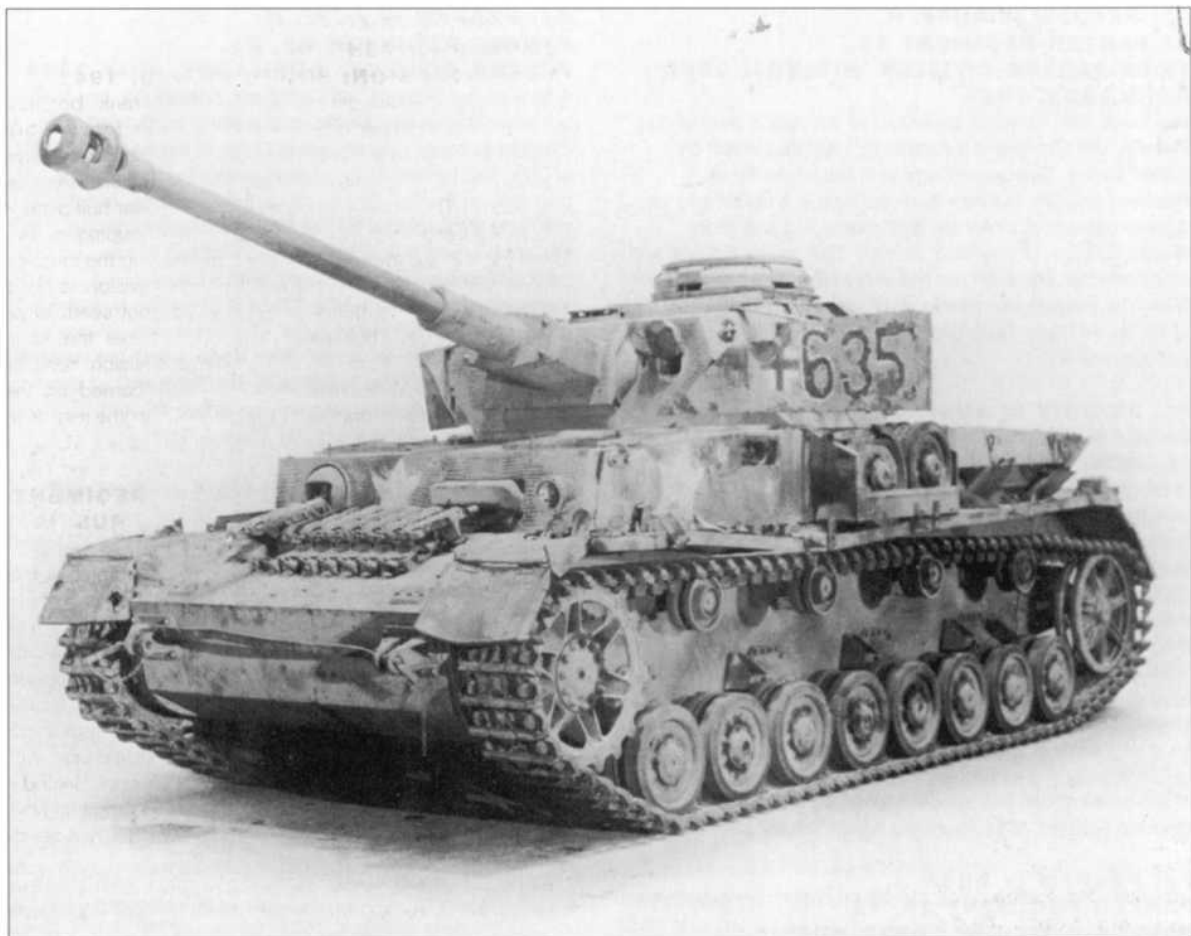
Front and rear three-quarter views of a battered Ausf. H captured more or less intact in Normandy by British forces. The accident that this tank bore non-symmetrical hand-painted turret numbers and a fluid designation on the gun allows certain identification as the subject of colour plate E1. This tank of II Abteilung, SS-Panzer-Regiment 12 'Hitlerjugend' was photographed from both sides while still under its original management; it is rare to find such complete 'before and after' reference material. Note that under the crude Allied star the number '635' is repeated on the rear of the turret girdle. (RAC Tank Museum)

A tank of the division which bore the brunt of the early fighting on the invasion front, this Ausf. H is finished in the overall dark yellow factory scheme ordered from February 1943, with *zimmerit* patterned plaster undercoating the vertical surfaces to repel magnetic and adhesive explosive charges. The tank has been camouflaged at unit level with the olive green and red-brown secondary colours, issued as pastes and diluted according to circumstances. The roughly hand-painted number on the turret girdle plates identifies this as the 5th tank of 3rd Platoon, 6th Company, II Abteilung. The buffer fluid designation is painted on both sides of the gun. Note that the camouflage painting extends over the track links fixed to the hull front. The commander wears black leather clothing and an odd grey cloth-and-fleece winter cap, apparently an individual whim, with the SS eagle on the front.
