# DX-70T EXTENDED RECEIVE MODIFICATION

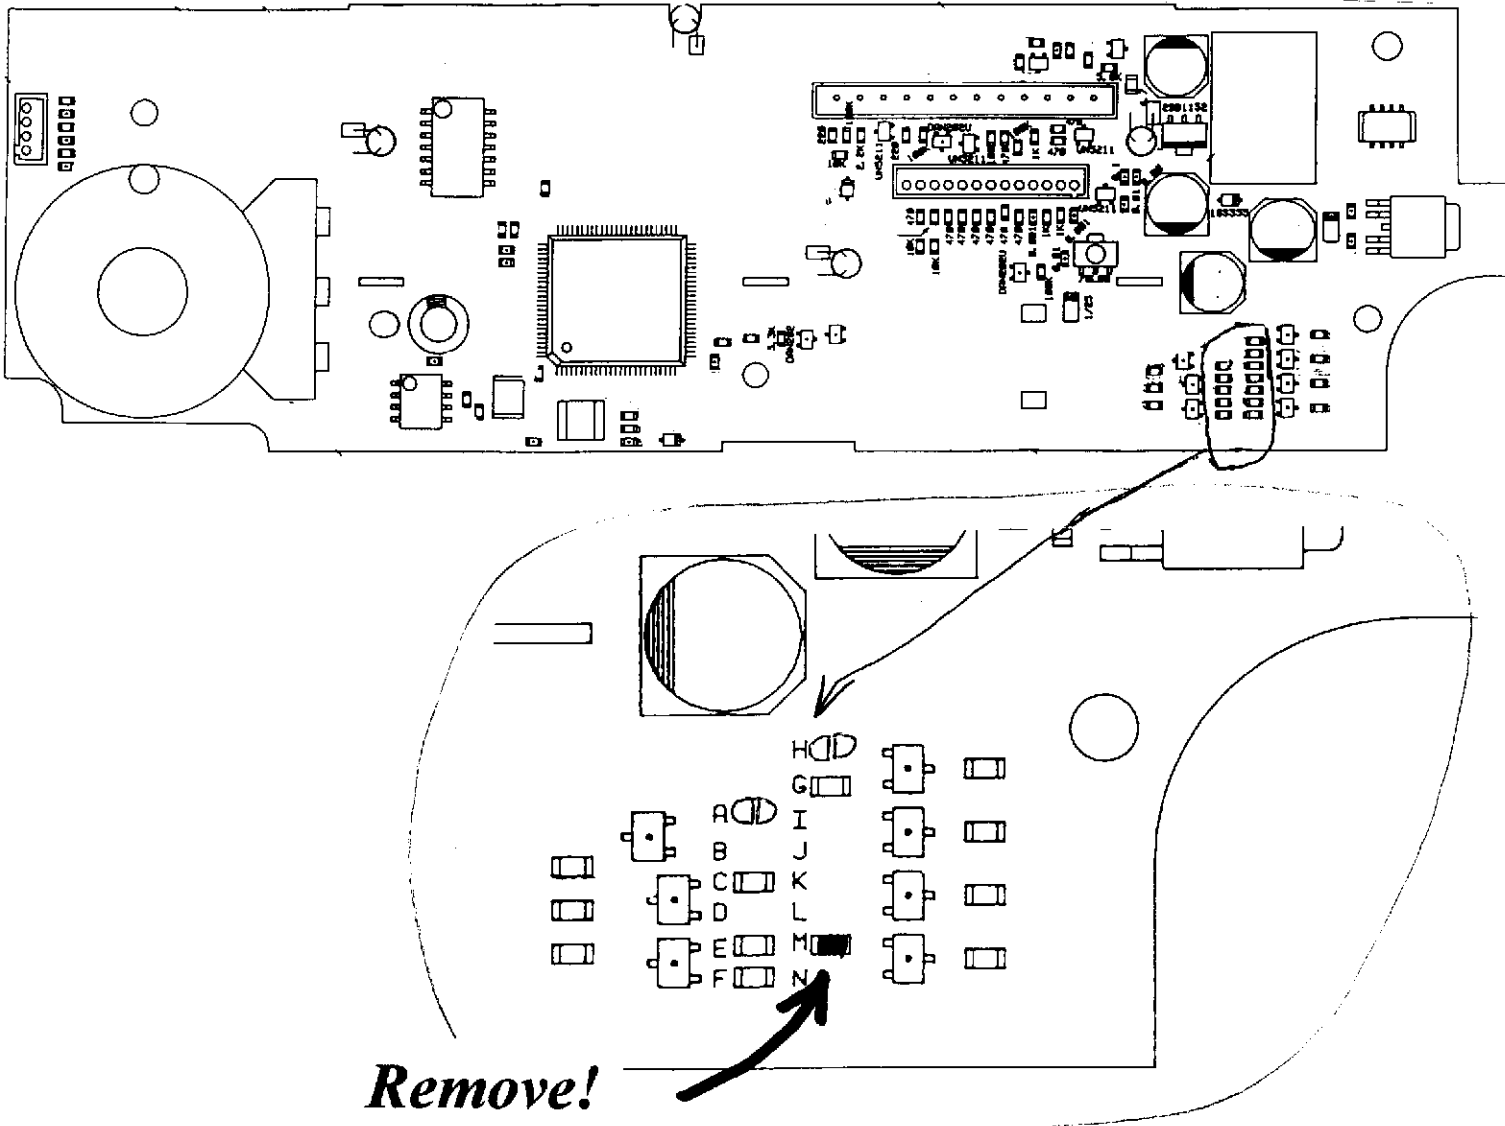
1. Disconnect from the power supply.
2. Disconnect from the antenna.
3. Remove the control head, then disconnect from the control cable.
4. Remove two screws on the back of the control head.
5. Remove the rear panel of the control head.
6. Locate and remove the "M" jumper behind the control unit as shown below.
7. Reassemble the unit.
8. Reset the Microprocessor. (With the radio off, press and hold the "F" button and simultaneously turning the power on.)

9. The lower edge of the HF band is now changed from 150KHz to 30KHz.
