TECHNICAL INFORMATION

No: 76/01/99/NAS
Ref:
Issue: 1
Date: 02/19/99

Seatbelt Adjustment Lubrication

DISCOVERY SERIES II (LT)

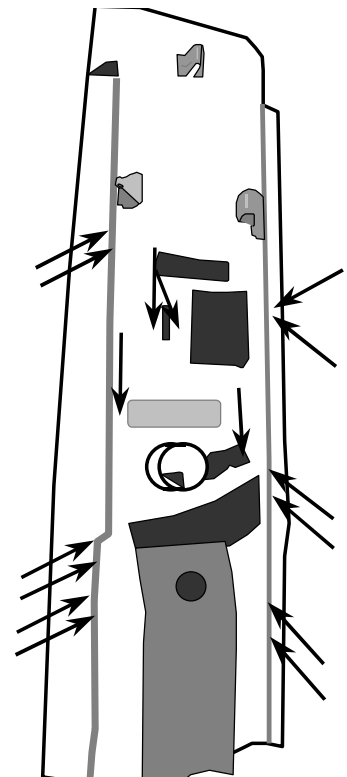
Figure 2

Apply Krytox lubricant to each slider tab on both the slider body and the actuator slide to ensure smooth movement of the seatbelt height adjuster.

**NOTE: The Krytox application is a droplet at each slider tab on both the slider body and the actuator slide.**

5. Remove head impact foam from slider (exposing release lever), and apply droplets of Krytox at locations shown on Figure 2.
6. Refit trim. Insure that the release lever on the trim lines up with the release mechanism before pushing trim back onto body.
7. Go to Step 1 and repeat procedure on other side of vehicle.
